Accessibility Survey

City of Downey Mueller Street - Pangborn Avenue To Lesterford Avenue

Date of Inspection
5/4/2017

Disability Access Consultants

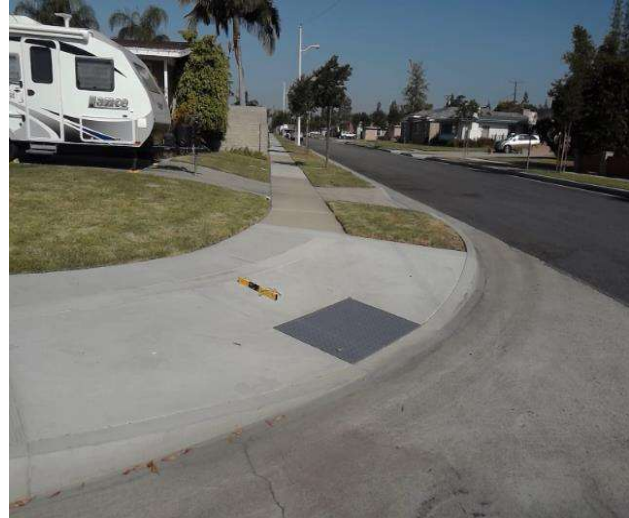
Recommendation Up to 8.33 percent

Install curb ramp \$1,300

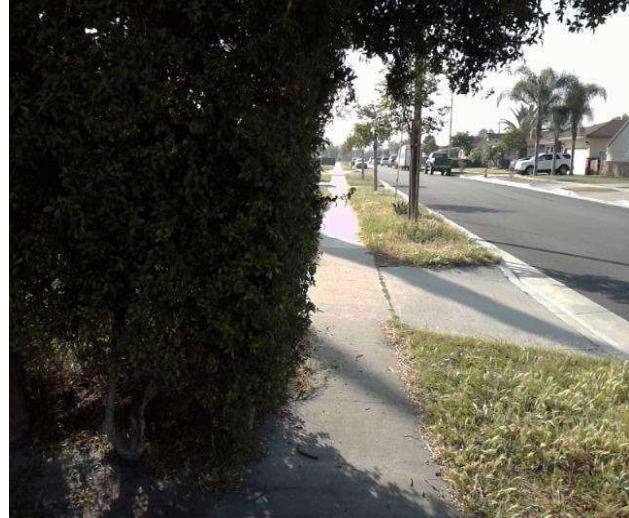
Sidewalks , Hazards & Gratings : Sidewalk Width at Obstruction

Recommendation At least 48.00 inches

Sidewalk width at the obstruction shall have the recommended value.

\$1,260

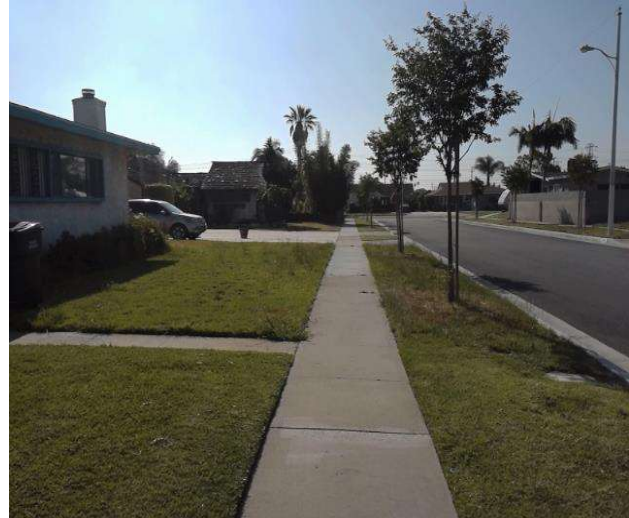
Recommendation Up to 2.08 percent

Repave the sidewalk surface with the recommended cross slope.

Repave surface \$1,092

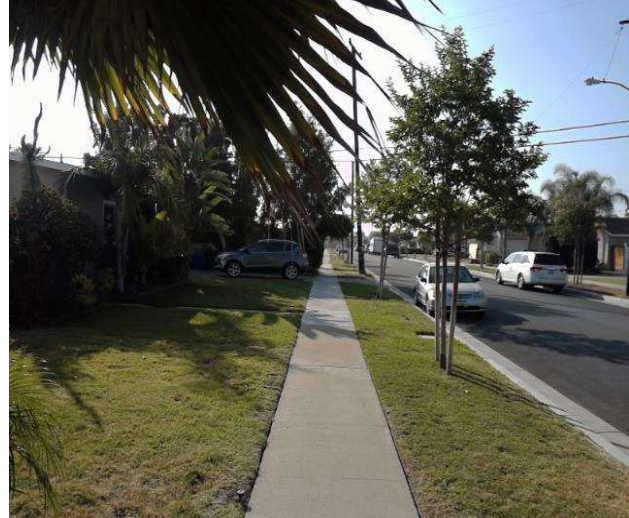
Sidewalks , Hazards & Gratings : Overhead Obstruction Height

Recommendation At least 80.00 inches

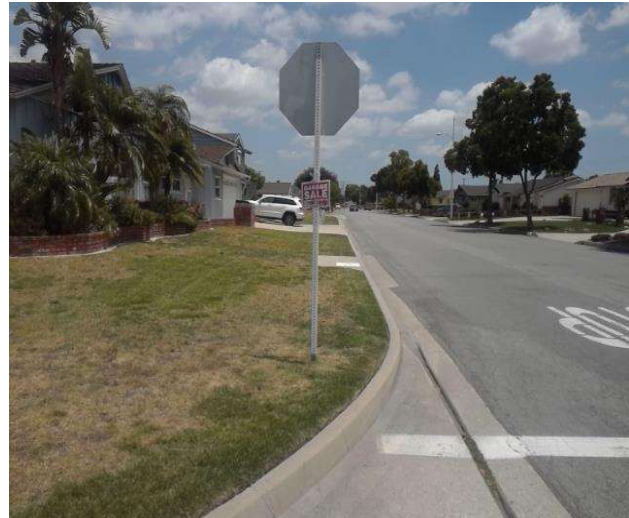
On-Site Finding Not Found

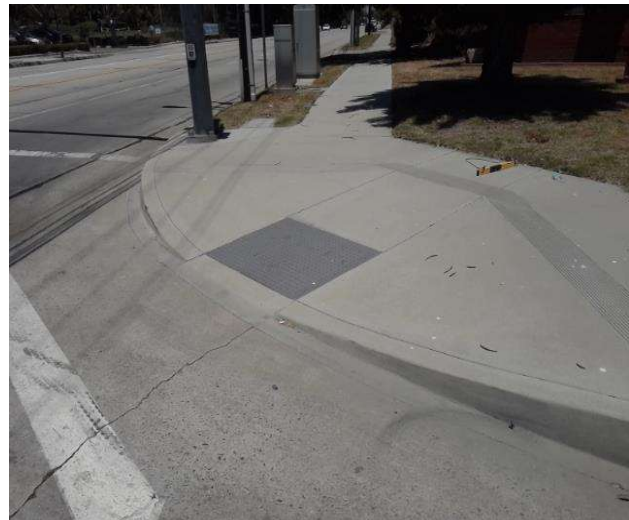
Recommendation Up to 2.08 percent

Provide compliant landing \$1,260

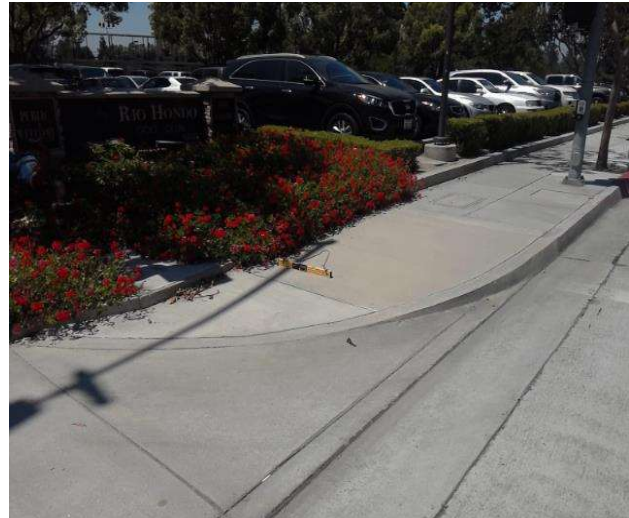
On-Site Finding Not Found

Provide detectable warning to surface \$248

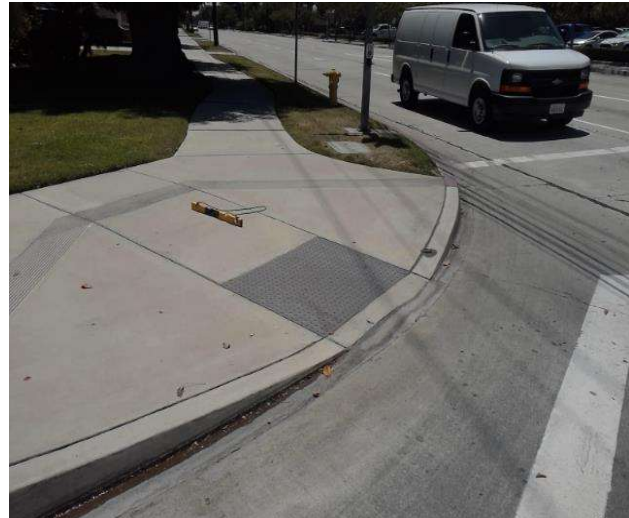
Recommendation Up to 8.33 percent

Install curb ramp \$1,300

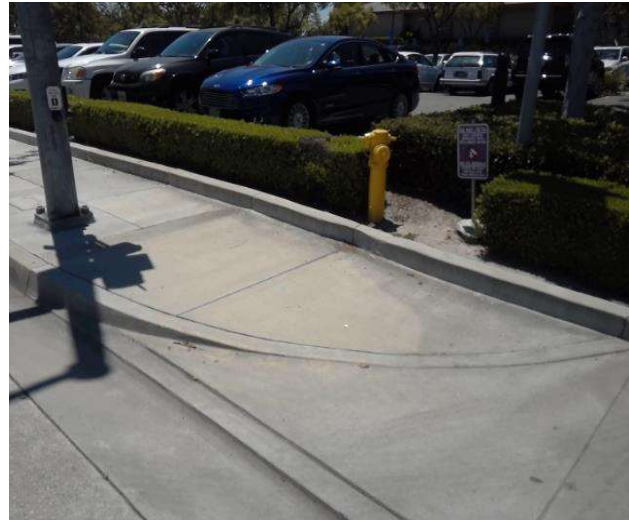
On-Site Finding Not Found

Provide detectable warning to surface \$248

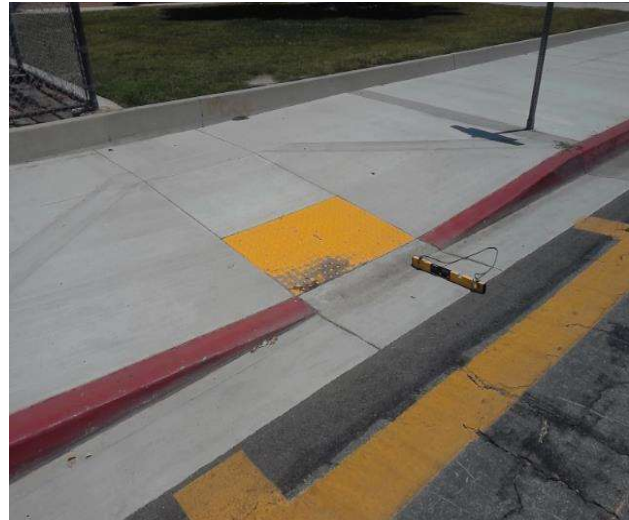
Curb Ramp , Landings and Transitions : Top Landing Clear Length - Landings

Provide compliant landing \$240

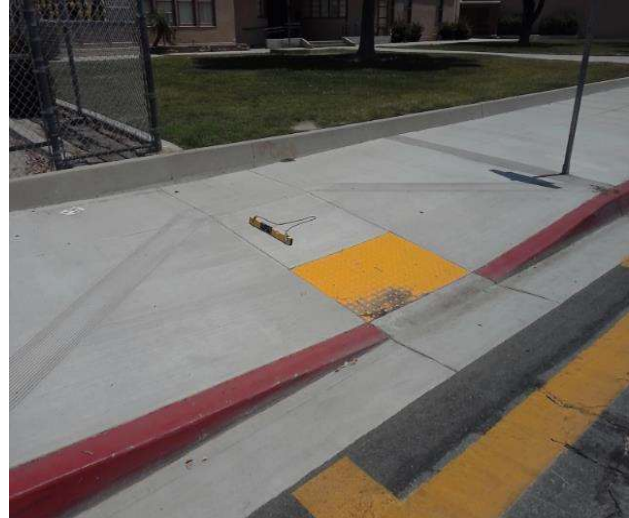
Recommendation Up to 8.33 percent

Install curb ramp \$1,300

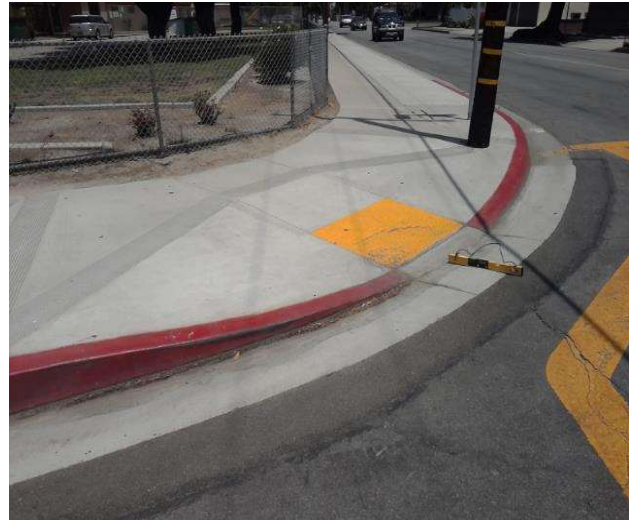
Recommendation Up to 5.00 percent

Repave landing \$1,260

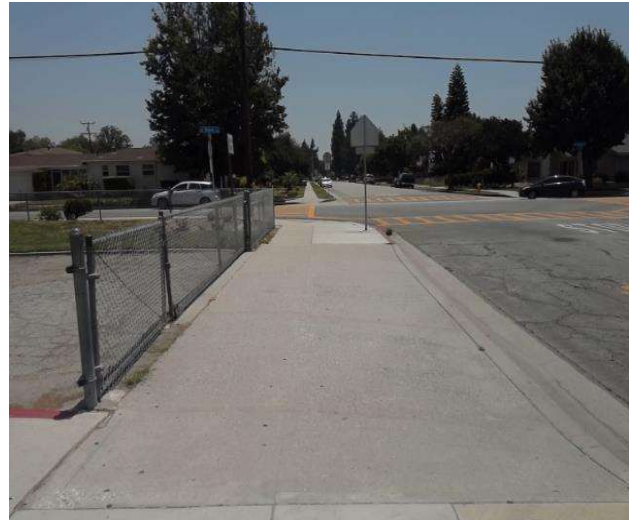
On-Site Finding Not Found

Install compliant detectable warnings \$190

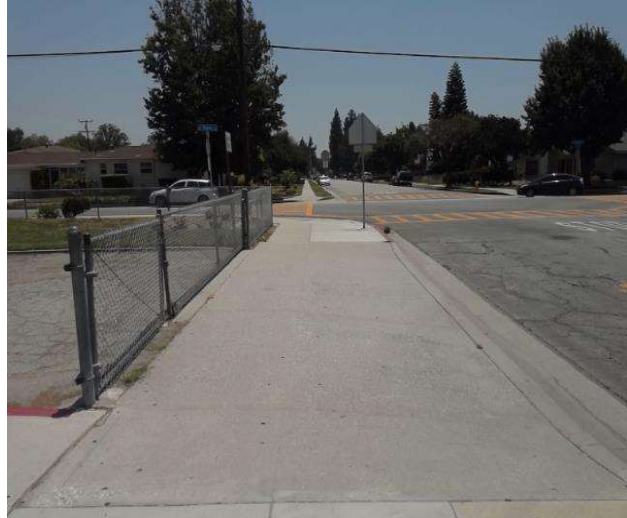
Recommendation Up to 2.08 percent

Repave surface \$1,092

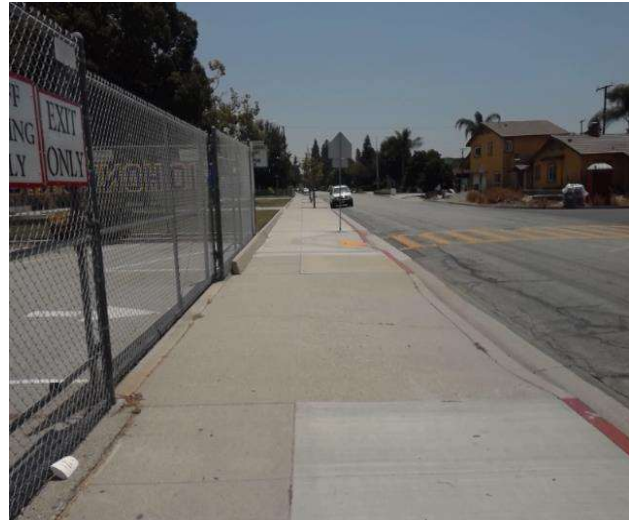
On-Site Finding Not Found

Install compliant detectable warnings \$190

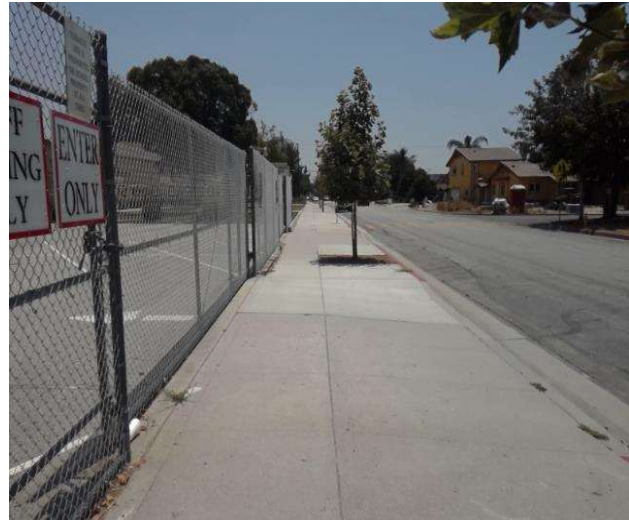
On-Site Finding Not Found

Install compliant detectable warnings \$190

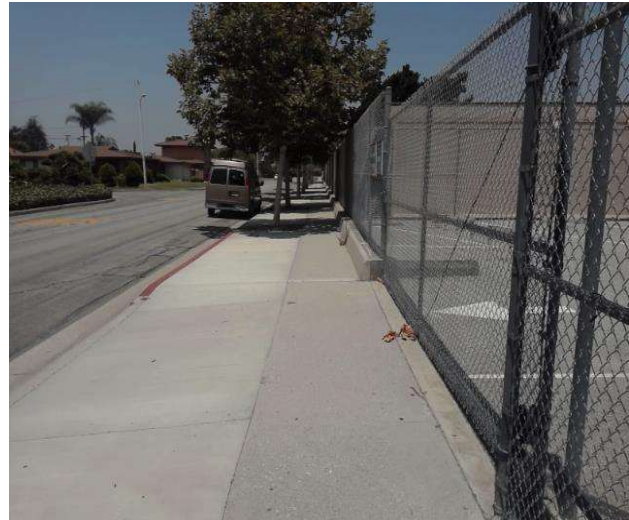
On-Site Finding Not Found

Install compliant detectable warnings \$190

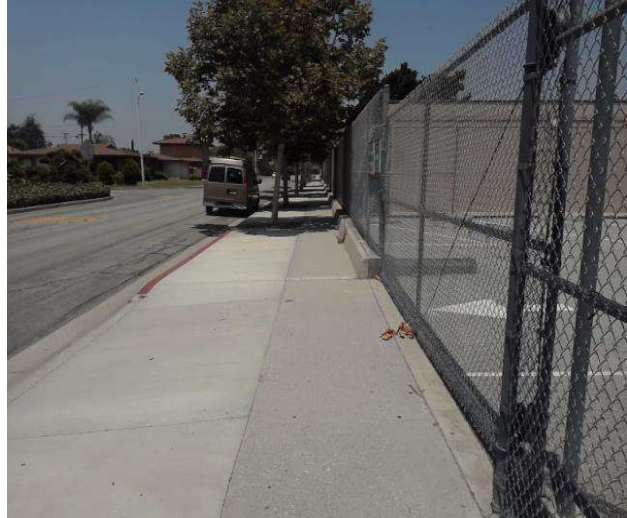
Recommendation Up to 2.08 percent

Repave surface \$1,092

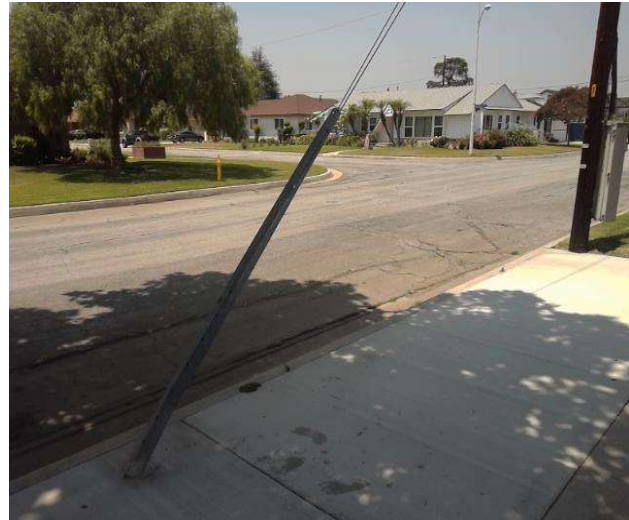
Sidewalks , Hazards & Gratings : Overhead Obstruction Height

Recommendation At least 80.00 inches

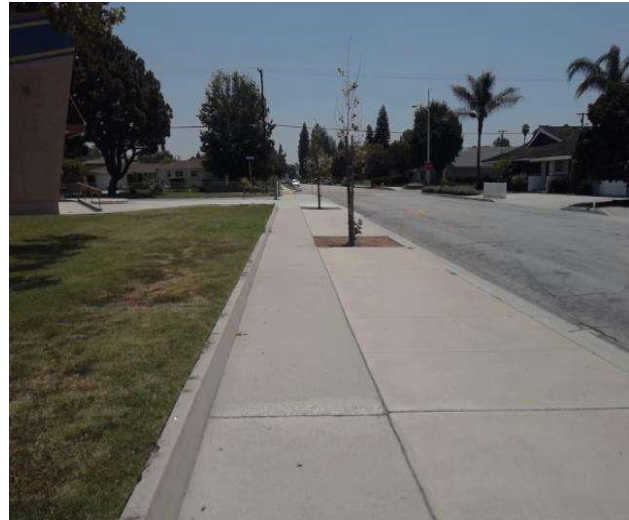
Recommendation Up to 2.08 percent

Repave the sidewalk surface with the recommended cross slope.

Repave surface \$1,092

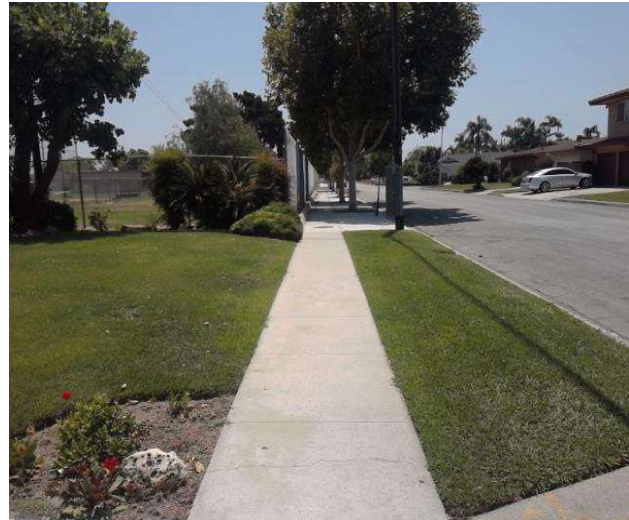
Recommendation Up to 2.08 percent

Repave the sidewalk surface with the recommended cross slope.

Repave surface \$1,092

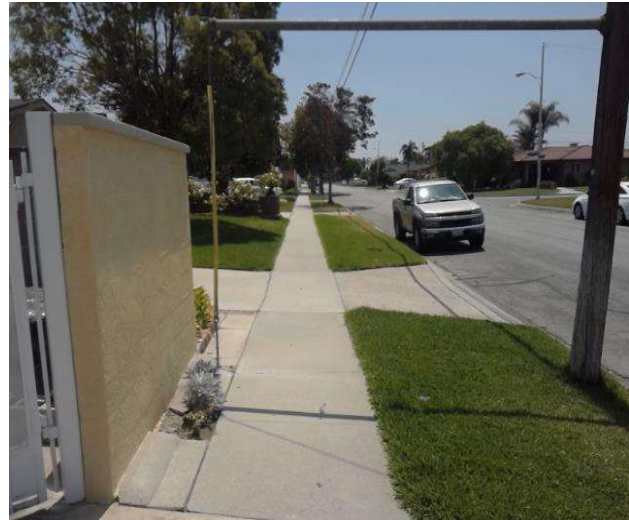
Recommendation Up to 2.08 percent

Repave the sidewalk surface with the recommended cross slope.

Repave surface \$1,092

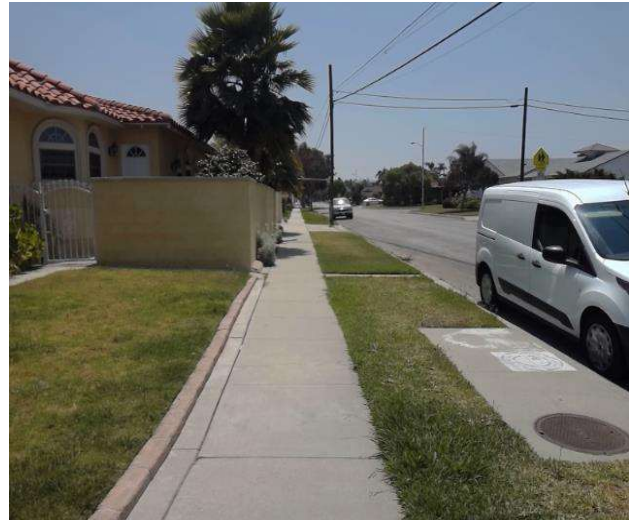
Recommendation Up to 2.08 percent

Repave the sidewalk surface with the recommended cross slope.

Repave surface \$1,092
