Accessibility Survey

City of Downey Tweedy Lane - Brookpark Road to Telegraph Road

Date of Inspection
6/22/2017

Prepared By
Disability Access Consultants
(800) 743-7067

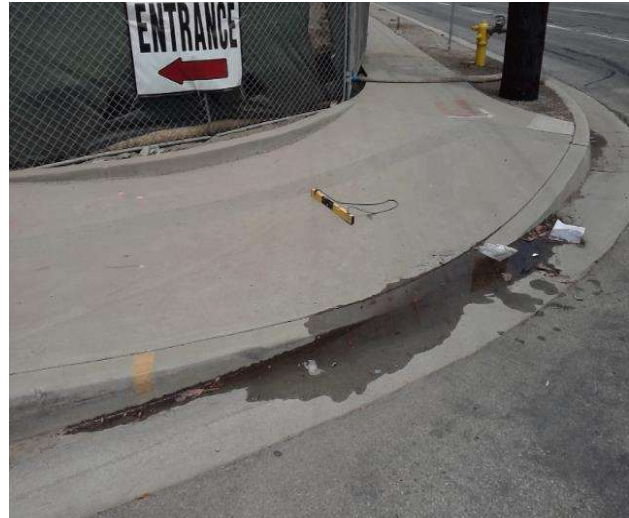
On-Site Finding Not Found

Recommendation See Recommendation

Provide detectable warning to surface \$248

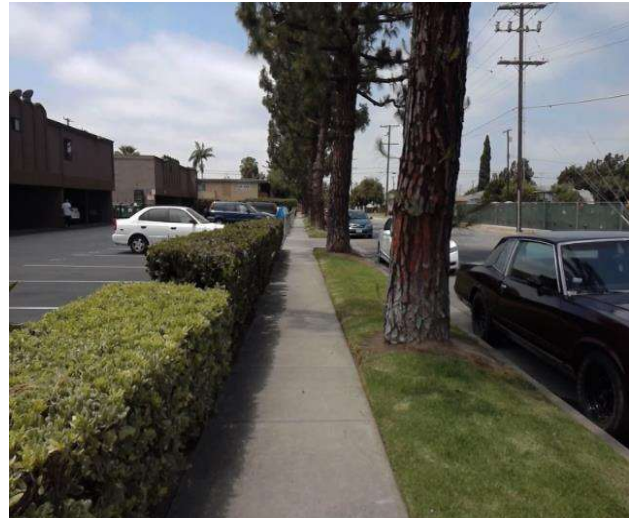
On-Site Finding Not Found

Recommendation See Recommendation

\$2,400

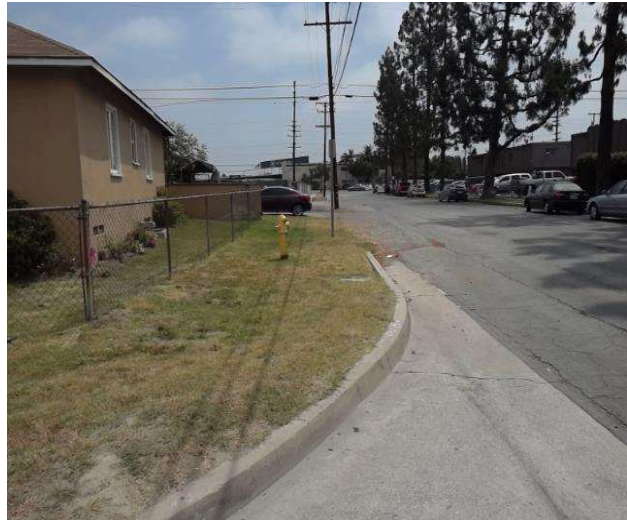
Sidewalks : Missing Sidewalk

Section of sidewalk is missing and consists of dirt, grass or gravel.

Provide a compliant sidewalk for the missing section.

\$1,260

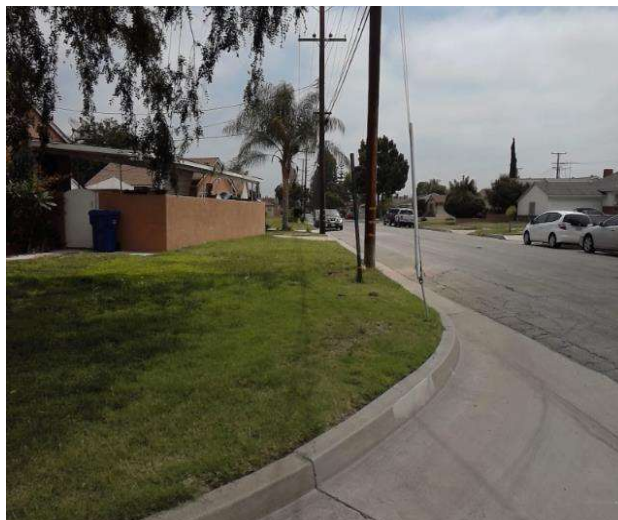
On-Site Finding Not Found

Recommendation See Recommendation

\$2,400

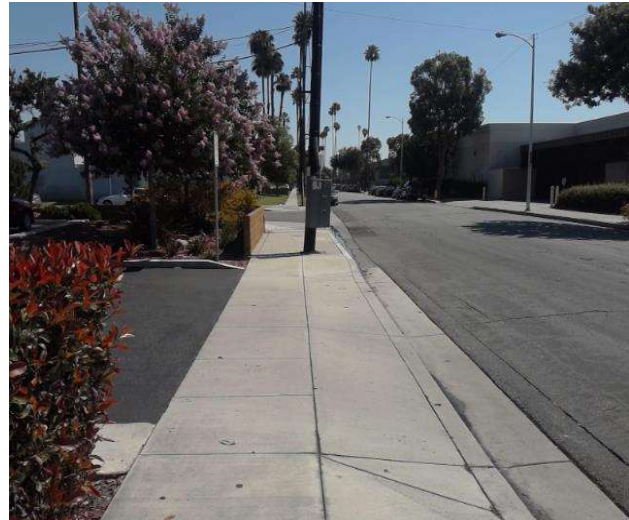
On-Site Finding Not Found

Install compliant detectable warnings \$190

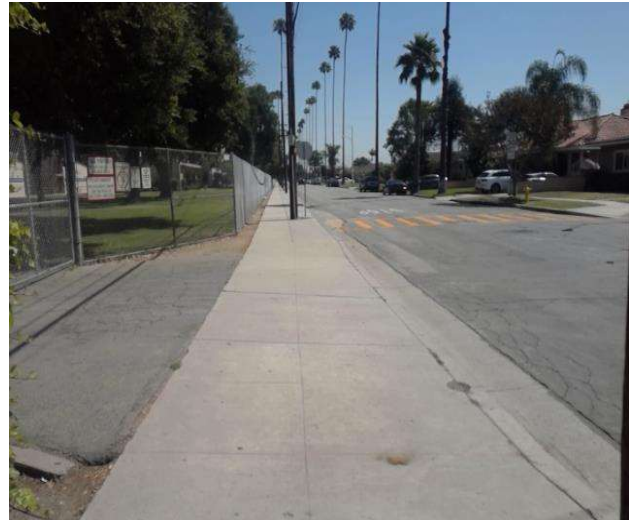
On-Site Finding Not Found

Install compliant detectable warnings \$190

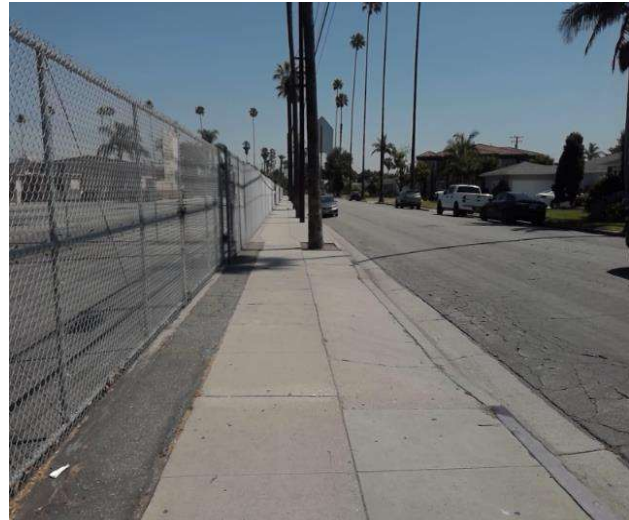
On-Site Finding Not Found

Install compliant detectable warnings \$190

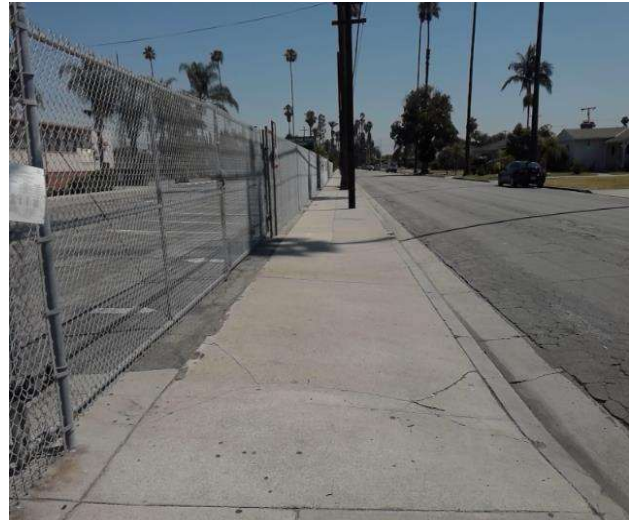
On-Site Finding Not Found

Install compliant detectable warnings \$190

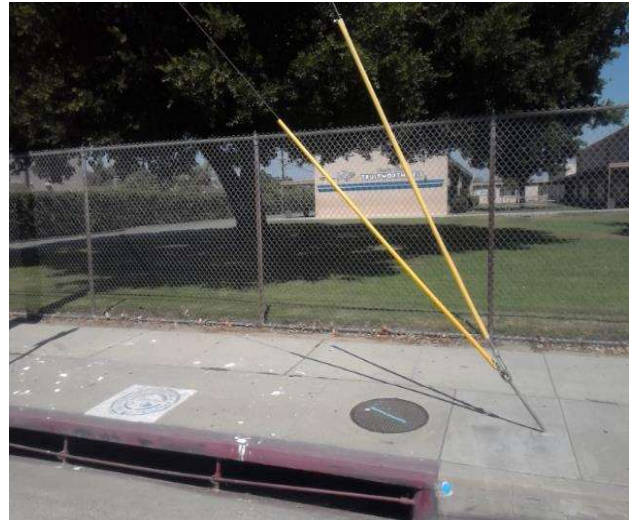
Sidewalks , Hazards & Gratings : Overhead Obstruction Height

Recommendation At least 80.00 inches

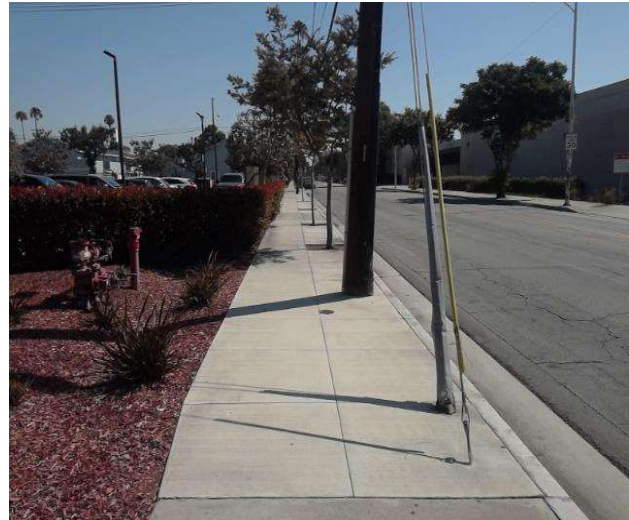
Sidewalks , Hazards & Gratings : Overhead Obstruction Height

Recommendation At least 80.00 inches

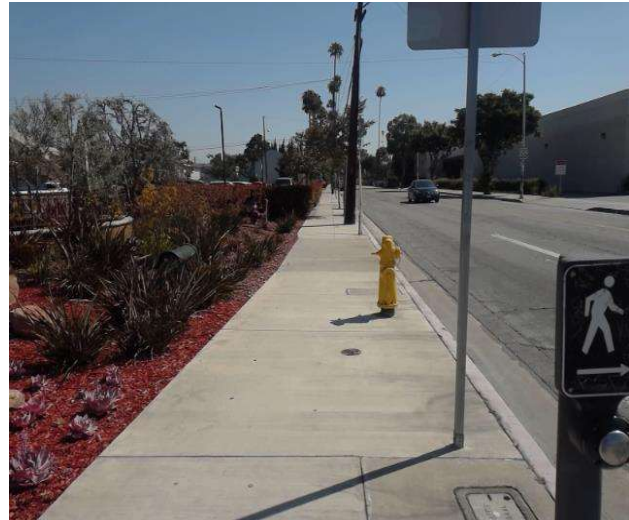
On-Site Finding Not Found

\$2,400

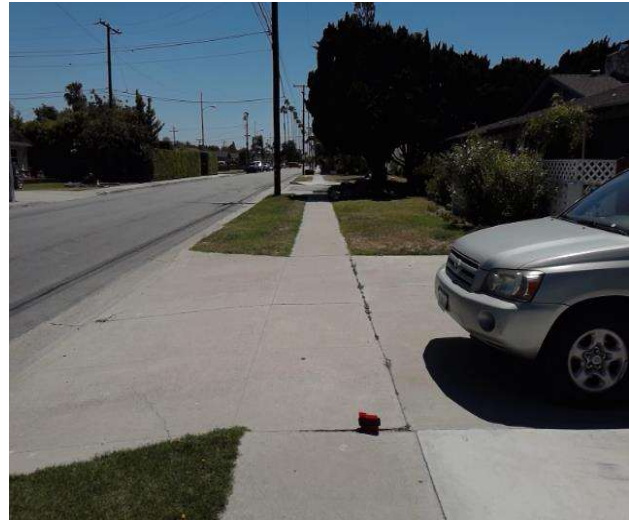
There is a change in elevation greater than recommended value.

Ensure that the change in elevation is within the recommended value.

Remove tripping hazards \$198

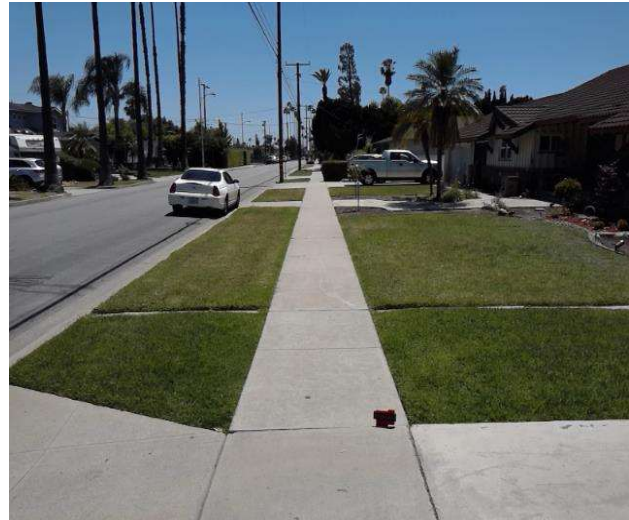
There is a change in elevation greater than recommended value.

Ensure that the change in elevation is within the recommended value.

Remove tripping hazards \$198

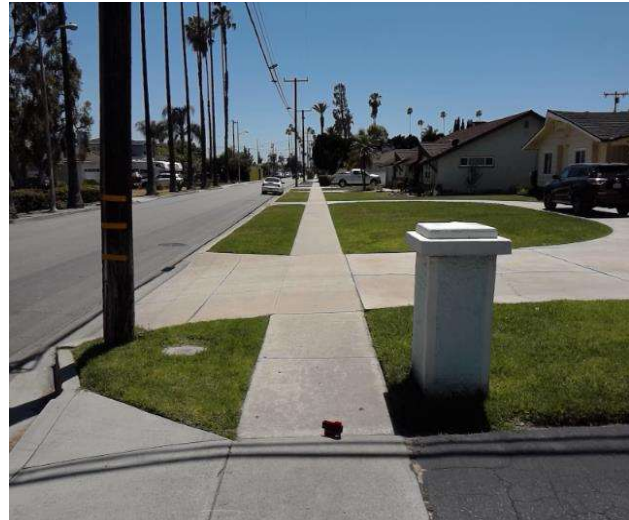
There is a change in elevation greater than recommended value.

Ensure that the change in elevation is within the recommended value.

Remove tripping hazards \$198

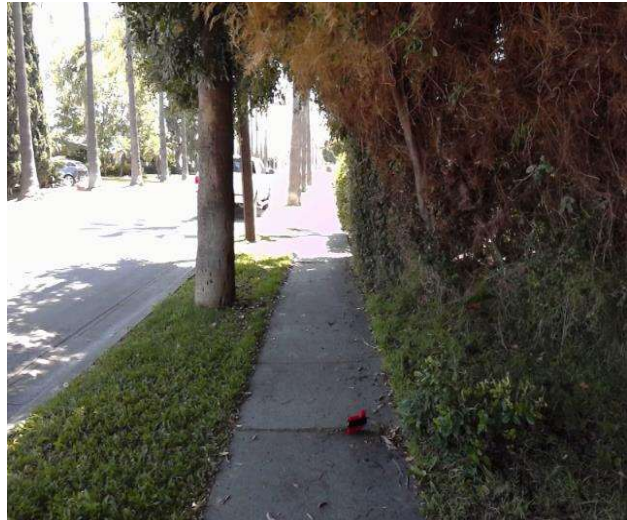
There is a change in elevation greater than recommended value.

Ensure that the change in elevation is within the recommended value.

Remove tripping hazards \$198

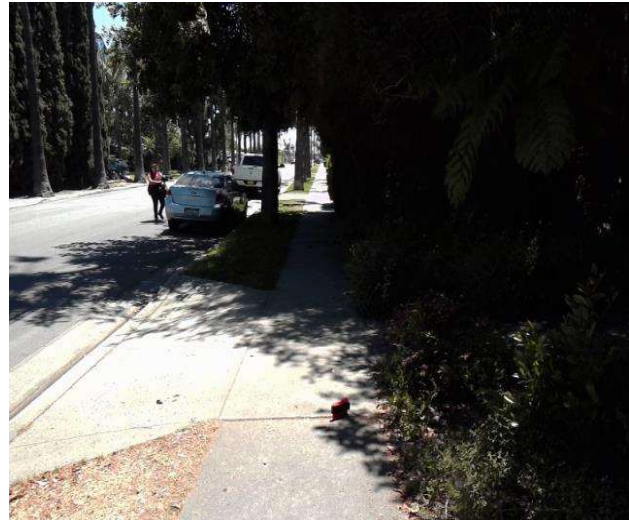
There is a change in elevation greater than recommended value.

Ensure that the change in elevation is within the recommended value.

Remove tripping hazards \$198

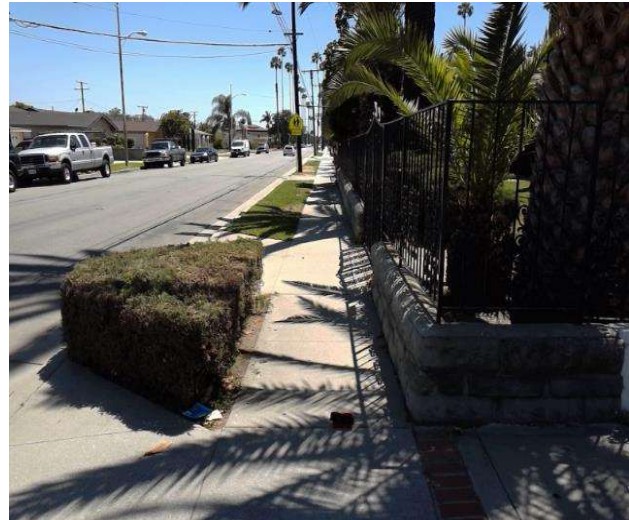
There is a change in elevation greater than recommended value.

Ensure that the change in elevation is within the recommended value.

Recommendation Up to 0.25 inches

Remove tripping hazards \$198

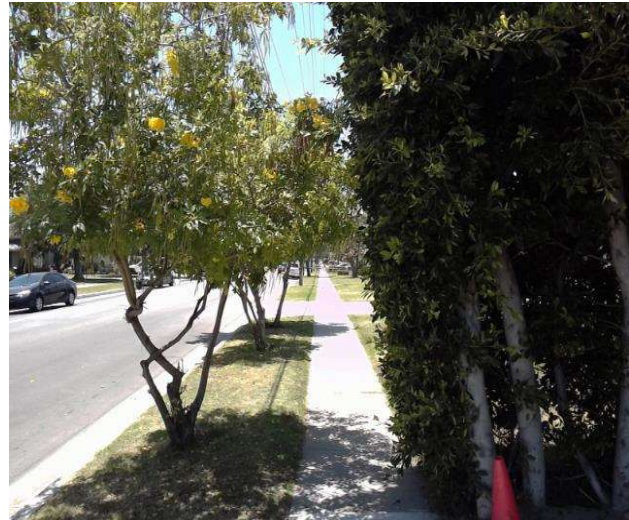
Sidewalks , Hazards & Gratings : Overhead Obstruction Height

Recommendation At least 80.00 inches

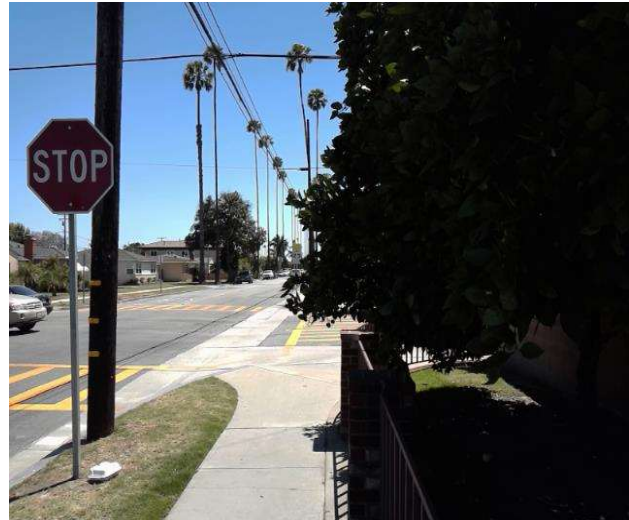
Sidewalks , Hazards & Gratings : Overhead Obstruction Height

Recommendation At least 80.00 inches

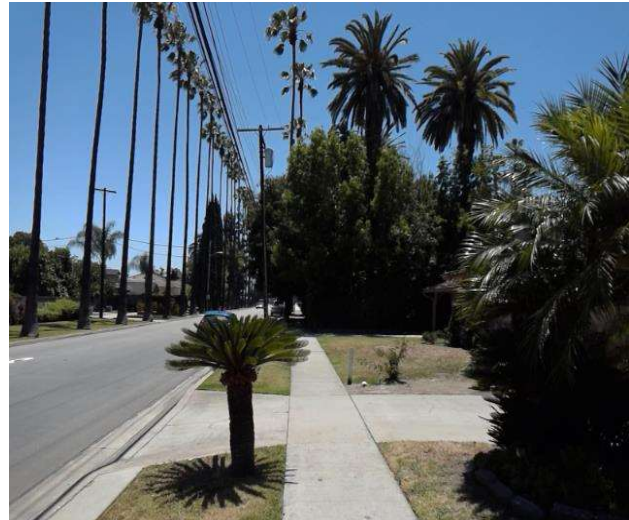
Sidewalks , Hazards & Gratings : Overhead Obstruction Height

Recommendation At least 80.00 inches

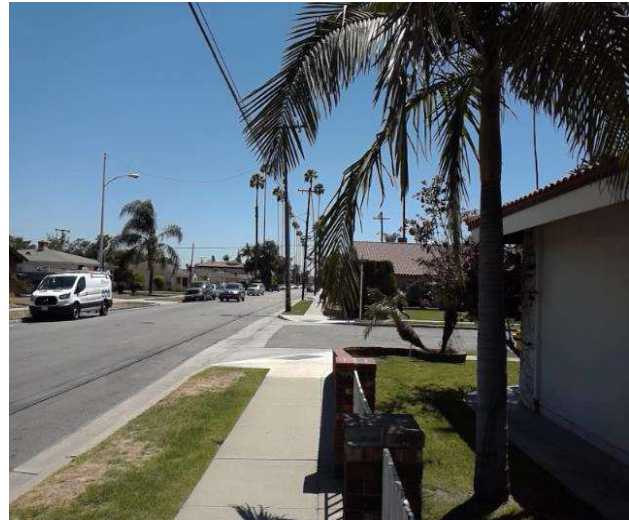
Sidewalks , Hazards & Gratings : Overhead Obstruction Height

Recommendation At least 80.00 inches

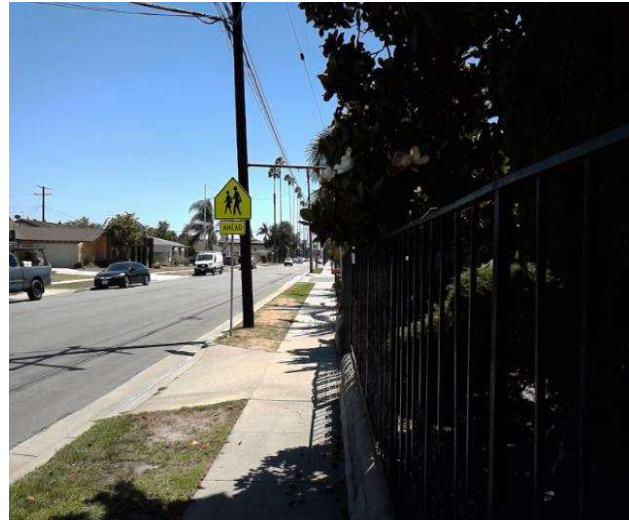
Sidewalks , Hazards & Gratings : Overhead Obstruction Height

Recommendation At least 80.00 inches

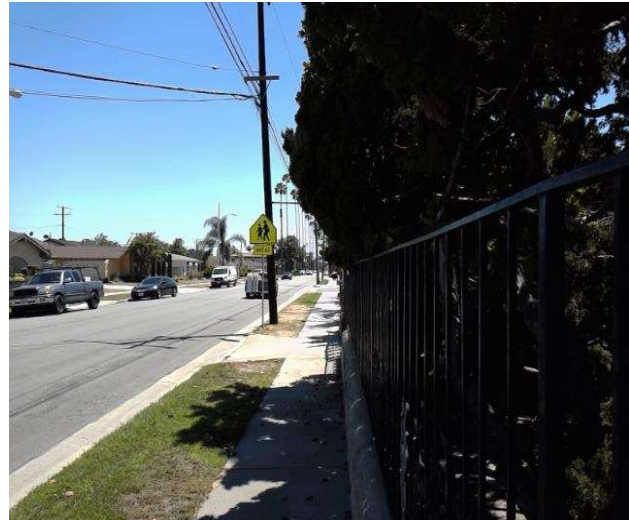
Sidewalks , Hazards & Gratings : Overhead Obstruction Height

Recommendation At least 80.00 inches

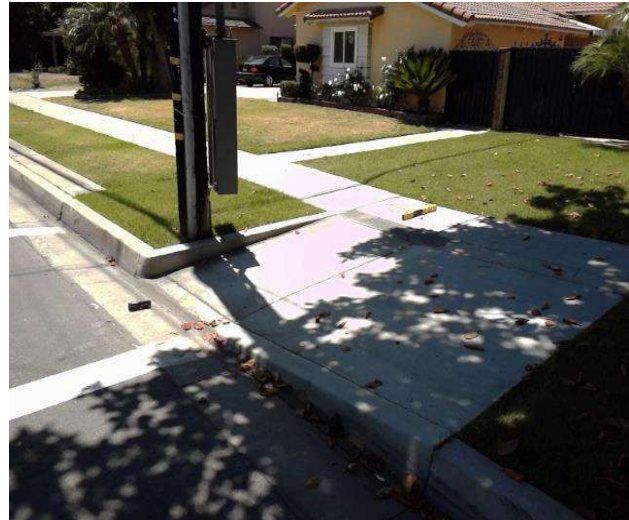
On-Site Finding Not Found

Provide detectable warning to surface \$248

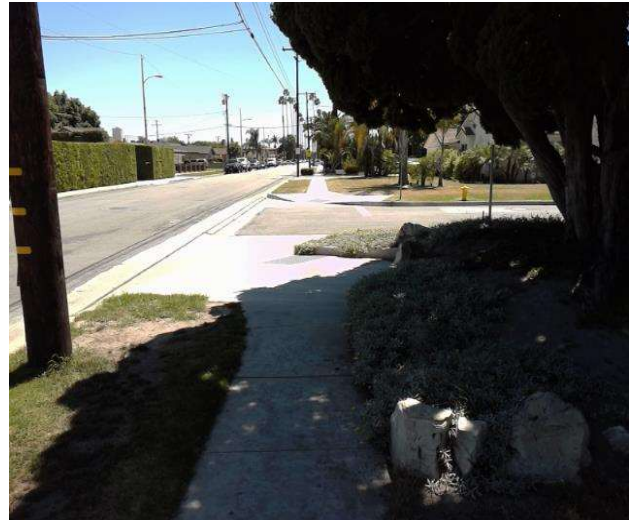
Sidewalks , Hazards & Gratings : Sidewalk Width at Obstruction

Sidewalk width at the obstruction shall have the recommended value.

Recommendation At least 48.00 inches

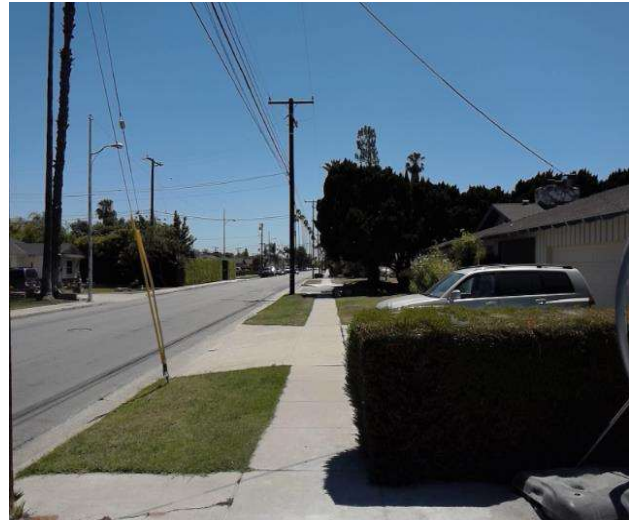
Sidewalks , Hazards & Gratings : Sidewalk Width at Obstruction

Sidewalk width at the obstruction shall have the recommended value.

Recommendation At least 48.00 inches

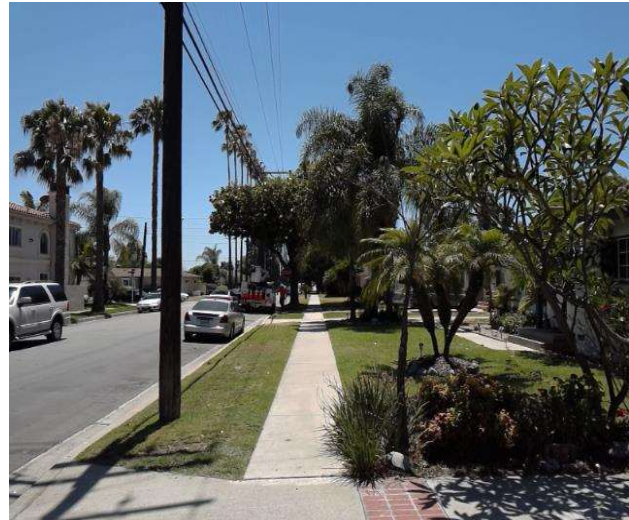
Sidewalks , Hazards & Gratings : Sidewalk Width at Obstruction

Sidewalk width at the obstruction shall have the recommended value.

Recommendation At least 48.00 inches

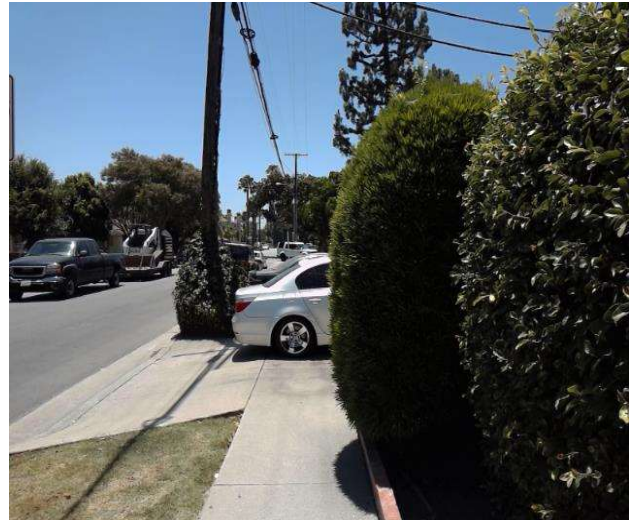
Sidewalks , Hazards & Gratings : Sidewalk Width at Obstruction

Sidewalk width at the obstruction shall have the recommended value.

Recommendation At least 48.00 inches

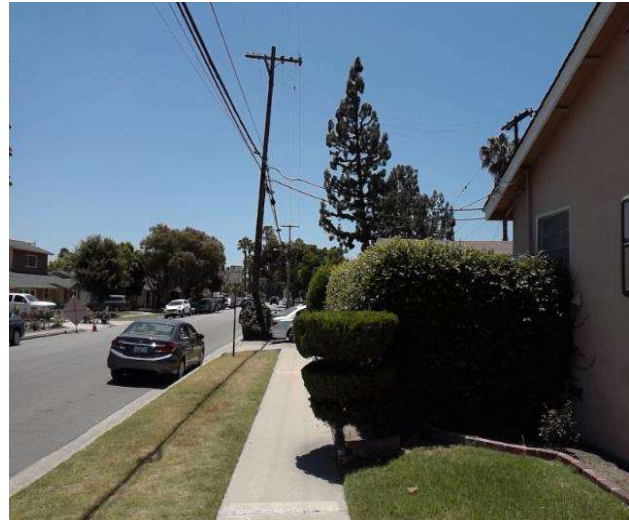
Sidewalks , Hazards & Gratings : Sidewalk Width at Obstruction

Sidewalk width at the obstruction shall have the recommended value.

Recommendation At least 48.00 inches

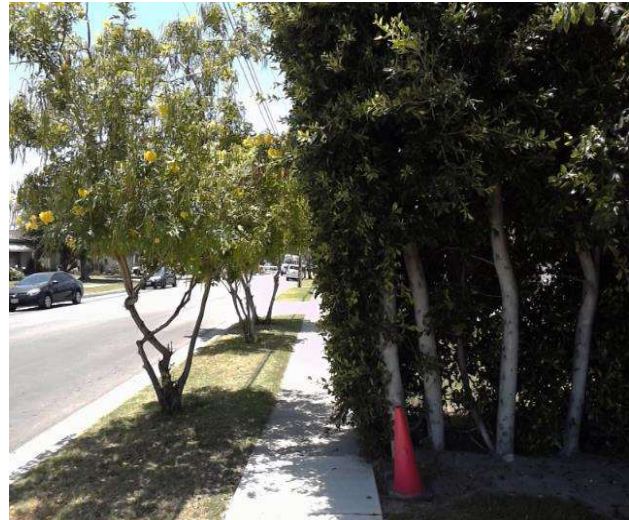
Sidewalks , Hazards & Gratings : Sidewalk Width at Obstruction

Sidewalk width at the obstruction shall have the recommended value.

Recommendation At least 48.00 inches

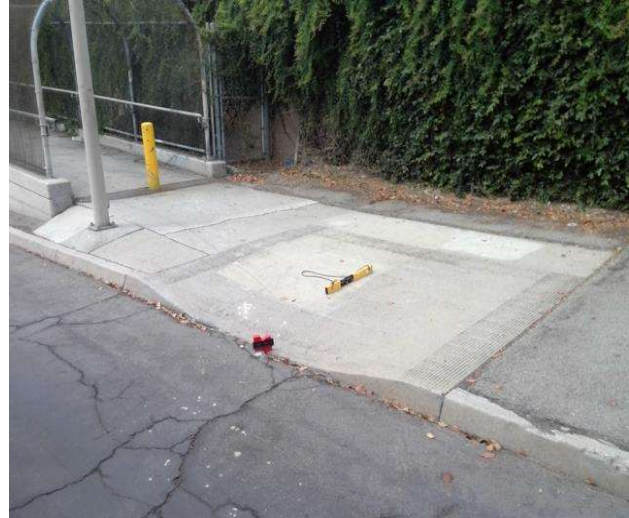
On-Site Finding Not Found

Provide detectable warning to surface \$248

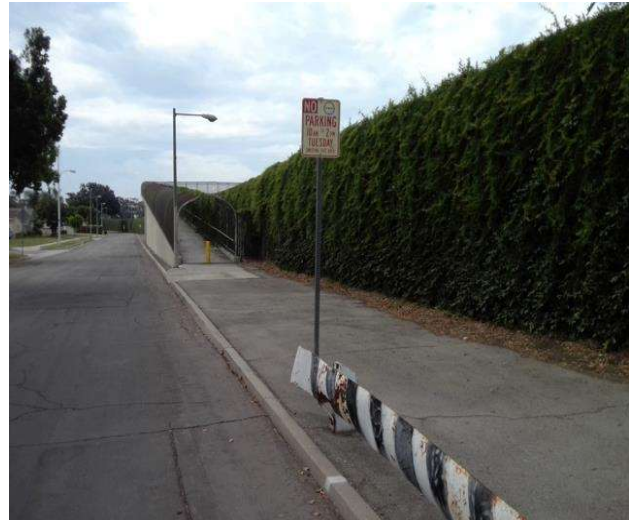
On-Site Finding None Found

Install Pathway \$1,840
