Accessibility Survey

City of Downey Downey Avenue & De Palma Street

Date of Inspection
1/31/2017

Prepared By
Disability Access Consultants
(800) 743-7067

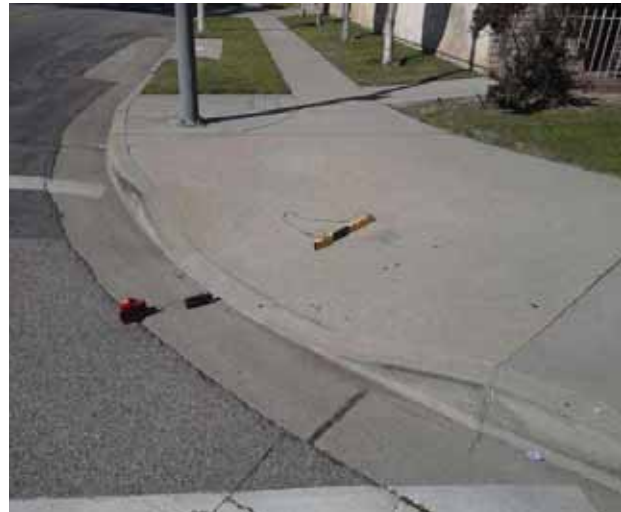
Northwest Corner @ 33.933496470239, -118.137798160315

Curb Ramp : No Detectable Warnings

The curb ramp does not provide a detectable warning surface which includes truncated domes.

Code Reference CA 11B-406.5.12

Provide compliant detectable warnings to surface.

Provide detectable warning to surface \$248

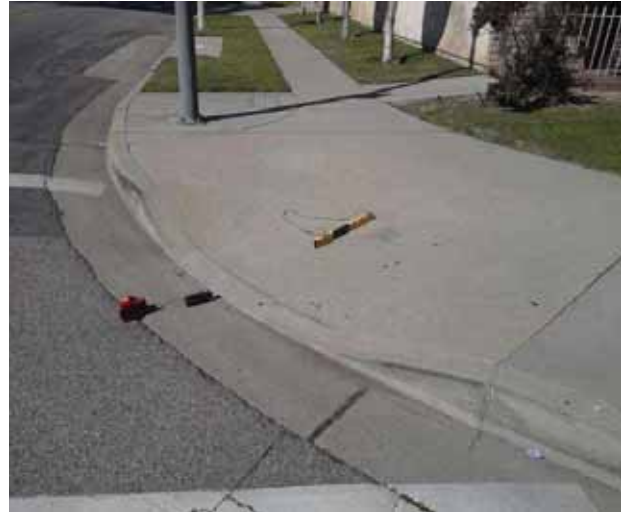
Code Reference ADA 406, 406.3,CA 11B-406.2.2

Install flared sides \$1,300

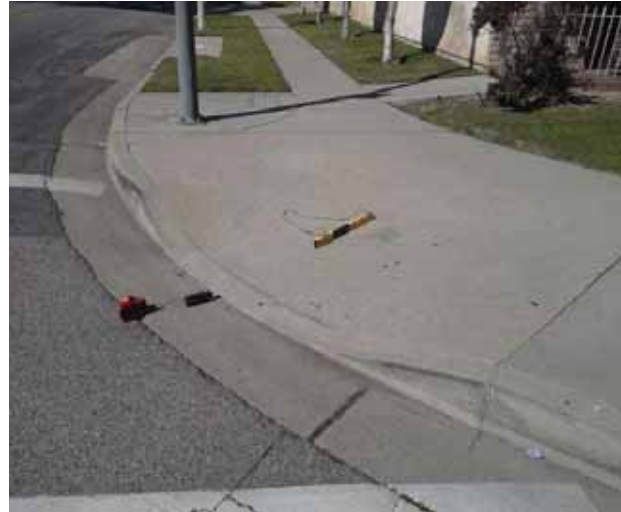
Code Reference ADA 406, 406.2, CA 11B-406.5.8

Repave landing \$1,260

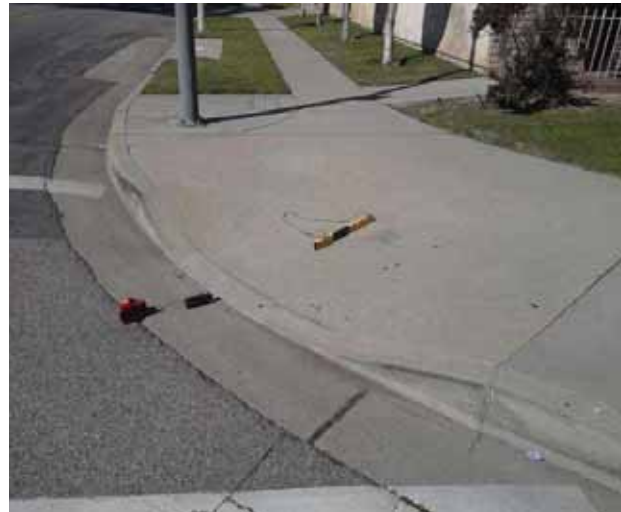
Code Reference ADA 302, 303, 406.2, 303.1

Patch lip at curb ramp \$255

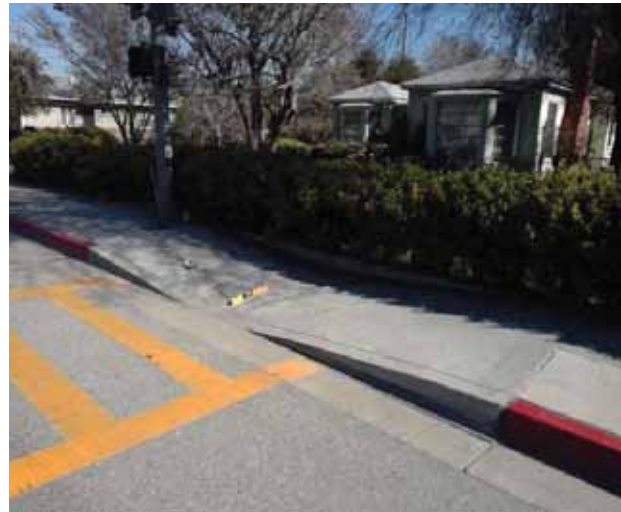
Code Reference CA 11B-406.5.12

Provide detectable warning to surface \$248

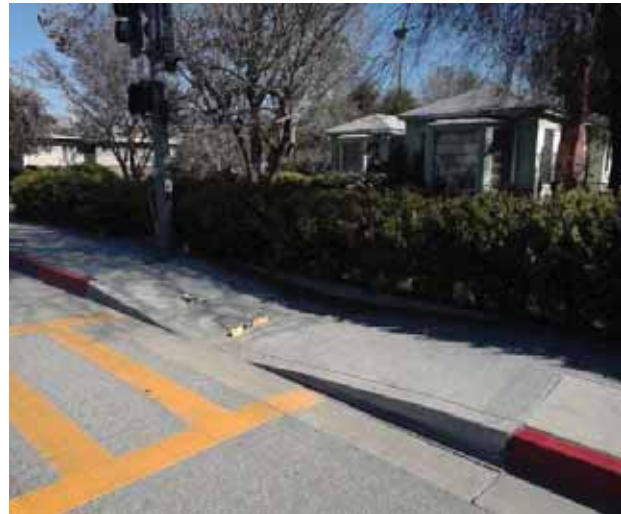
Code Reference ADA 402, 406.4, 406.2, 403.3, 406.1, CA 11B-406.5.3

Provide compliant landing \$240

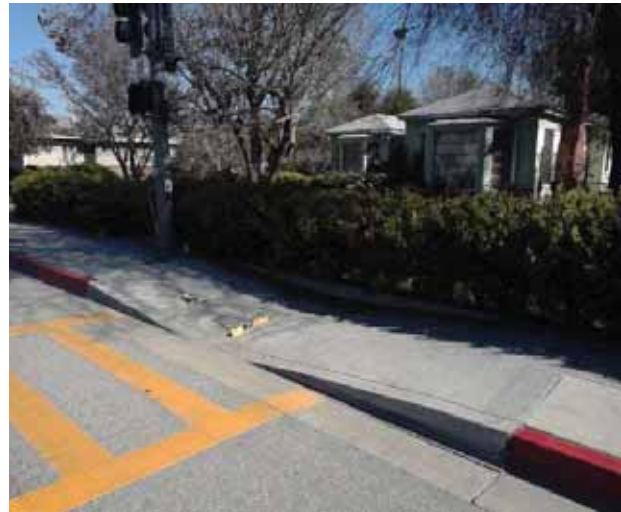
Code Reference ADA 402, 406.4, 403.3, 406.1, CA 11B-406.5.3

Provide compliant landing \$1,260

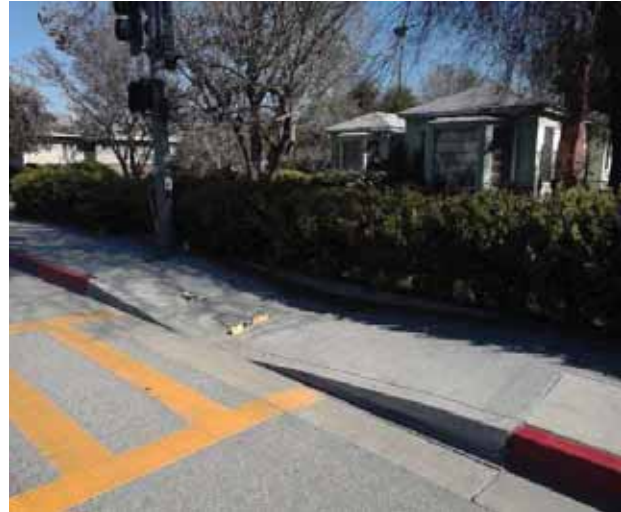
Code Reference ADA 302, 303.1

Patch lip at curb ramp \$155

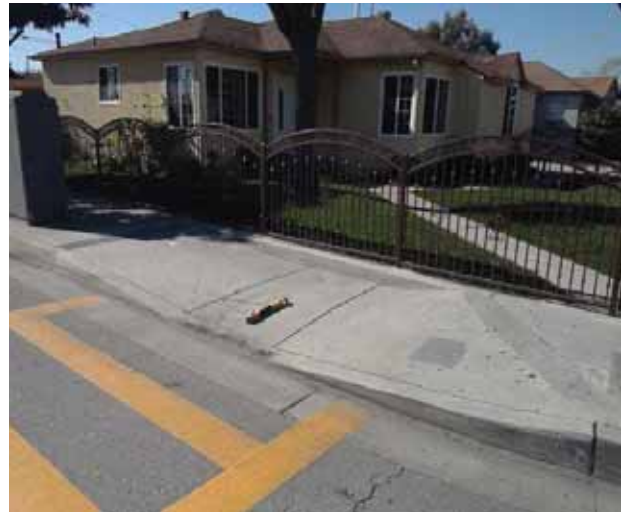
Code Reference CA 11B-406.5.12

Provide detectable warning to surface \$248

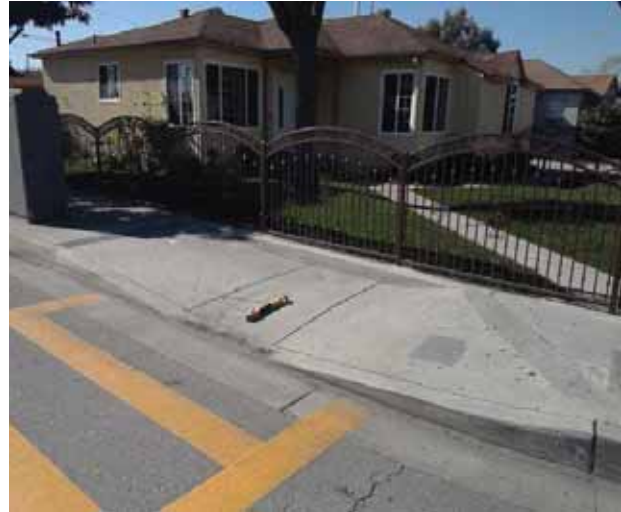
Code Reference ADA 406.1, 405.2, CA 11B-406

Install curb ramp \$1,300

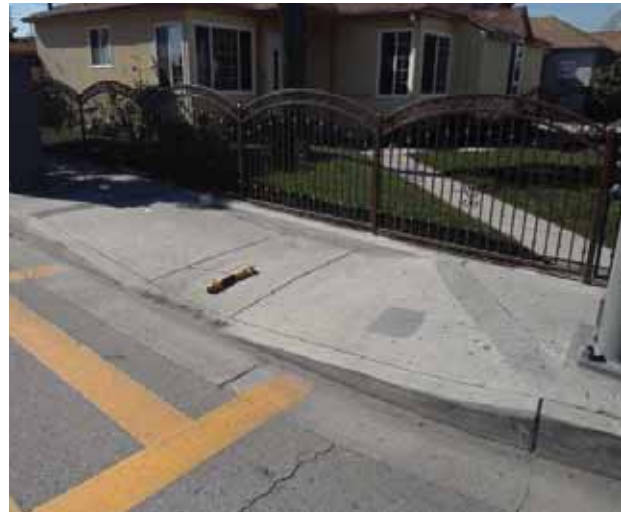
Code Reference ADA 402, 406.4, 406.2, 403.3, 406.1, CA 11B-406.5.3

Provide compliant landing \$240

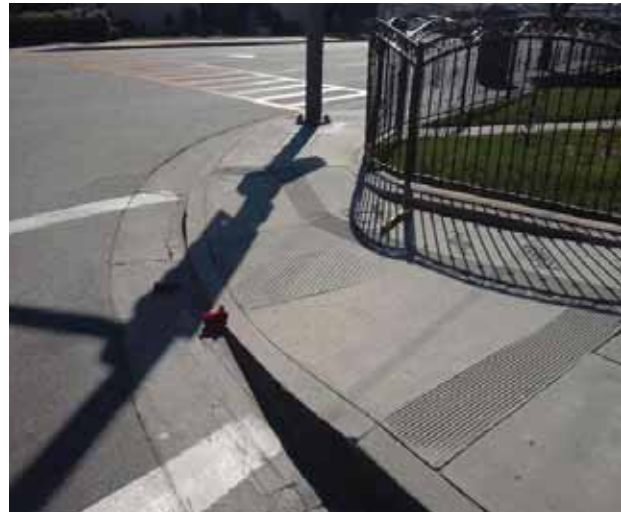
Code Reference CA 11B-406.5.12

Provide detectable warning to surface \$248

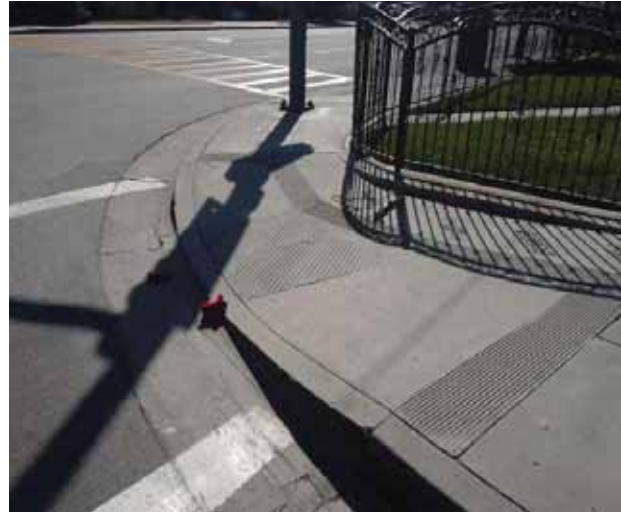
Code Reference ADA 406, 406.2,CA 11B-406.5.8

Repave landing \$1,260

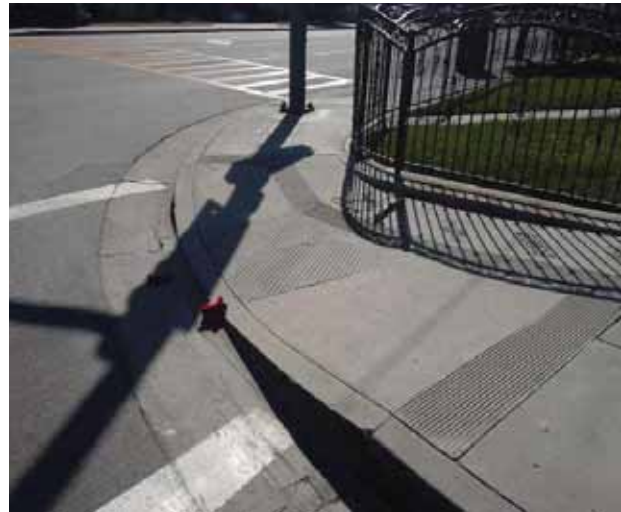
Code Reference ADA 302, 303, 406.2, 303.1

Patch lip at curb ramp \$255

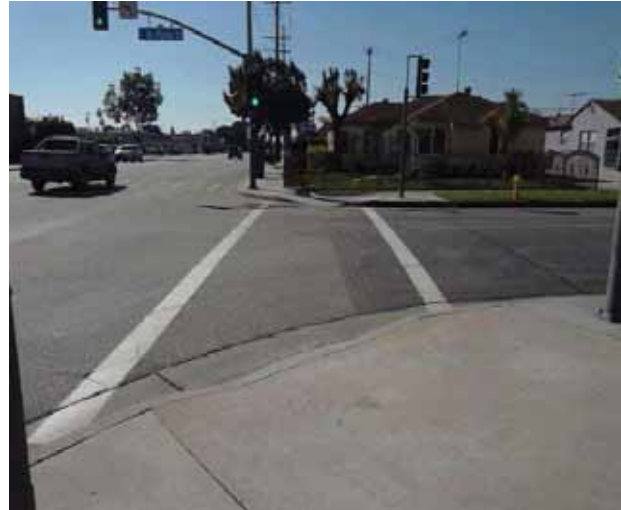
Notes : No APS for West Crossing

Repave the walking surface with recommended cross slope.

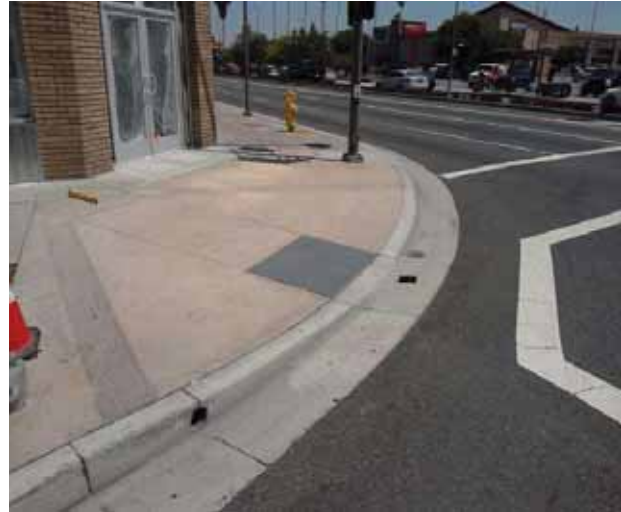
Code Reference ADA 406, 406.2, CA 11B-406.5.8

Repave landing \$1,260

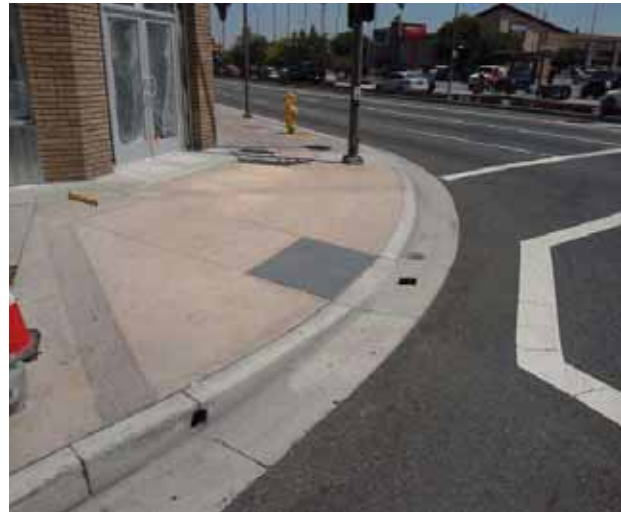
Code Reference ADA 402, 406.4, 403.3, 406.1, CA 11B-406.5.3

Provide compliant landing \$1,260

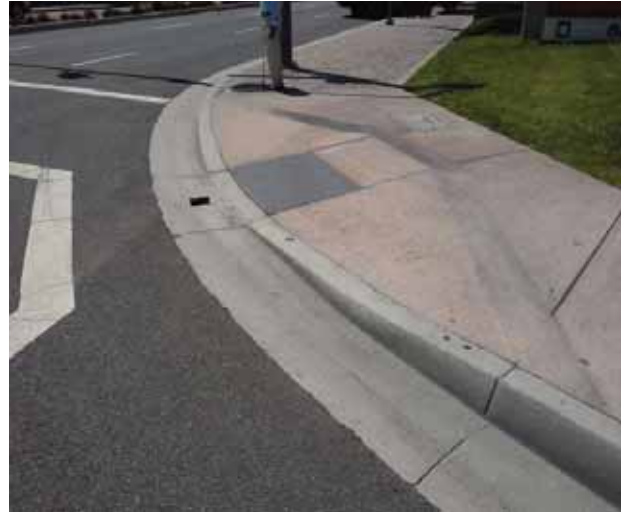
Code Reference ADA 303.3, CA 11B-303.3

Install curb ramp \$1,440

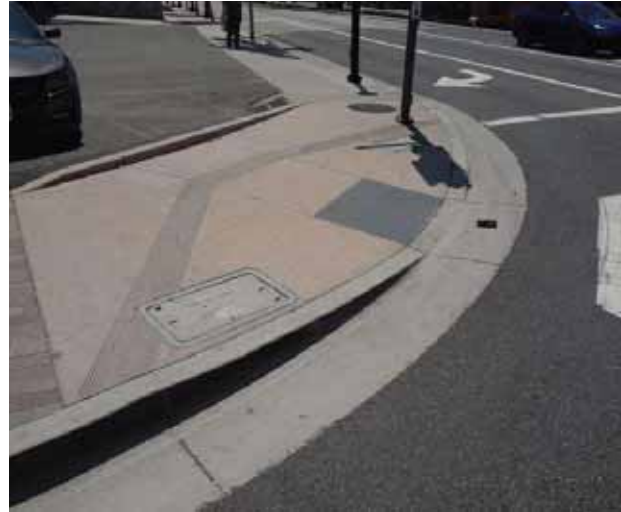
Code Reference ADA 303.3, CA 11B-303.3

Install curb ramp \$1,440

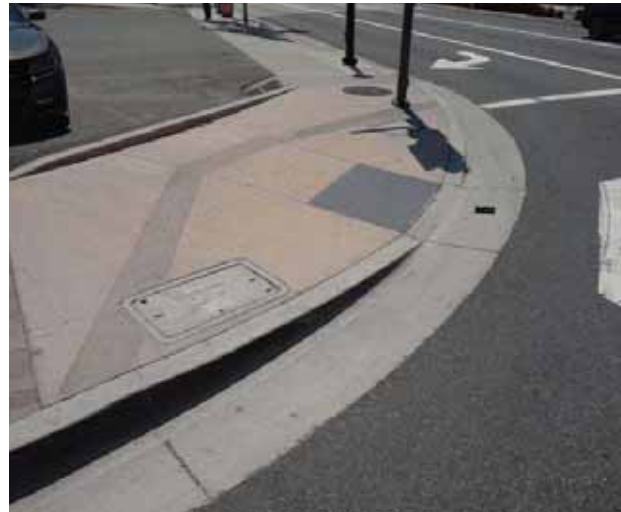
Code Reference ADA 406, 406.2, CA 11B-406.5.8

Repave landing \$1,260

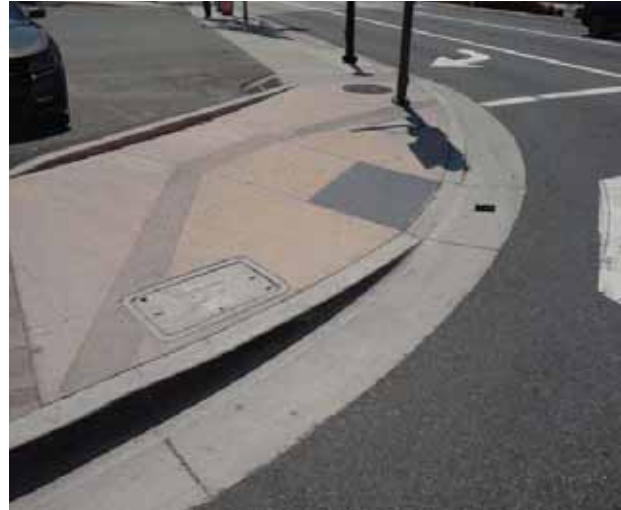
Code Reference ADA 406, 406.4,CA 11B-406.5.3

Provide compliant landing \$240

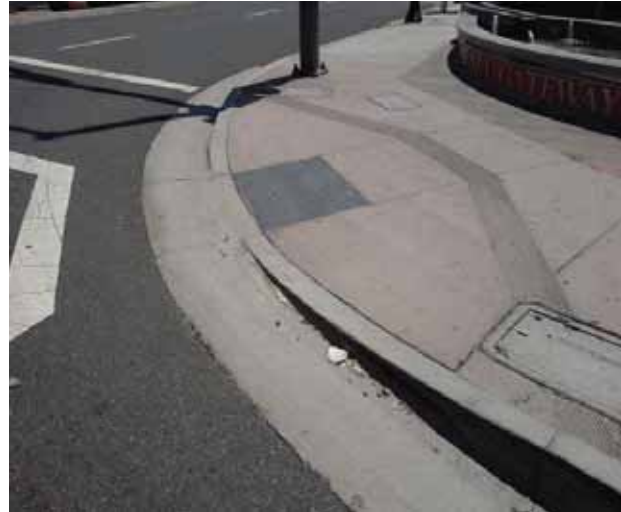
Code Reference ADA 303.3, CA 11B-303.3

Install curb ramp \$1,440

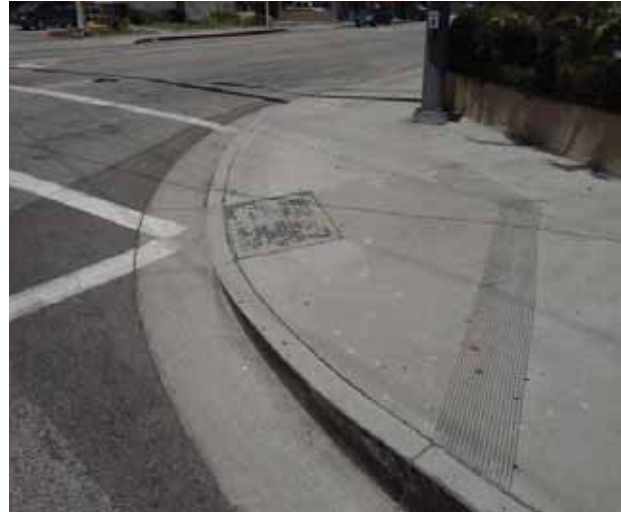
On-Site Finding Not Found

Provide detectable warning to surface \$248

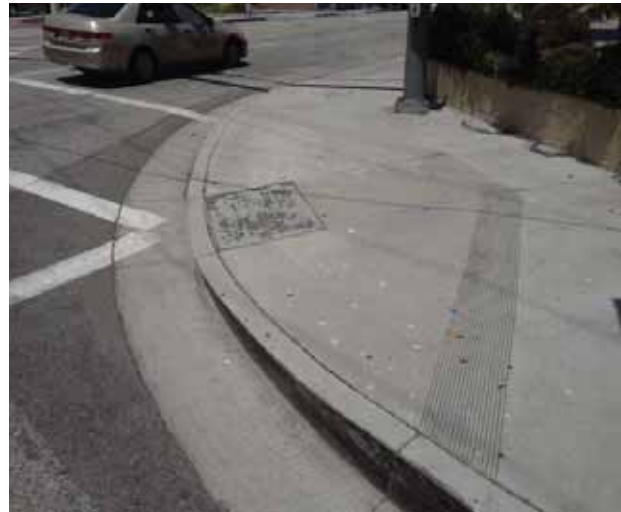
Recommendation At least 48.00 inches

Provide compliant landing \$255

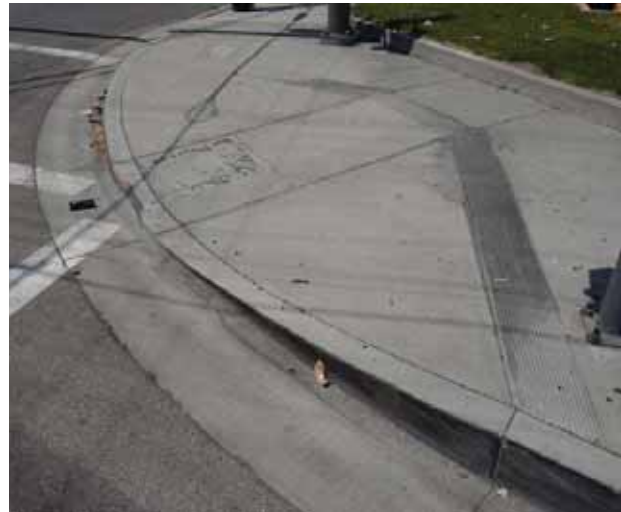
On-Site Finding Not Found

Provide detectable warning to surface \$248

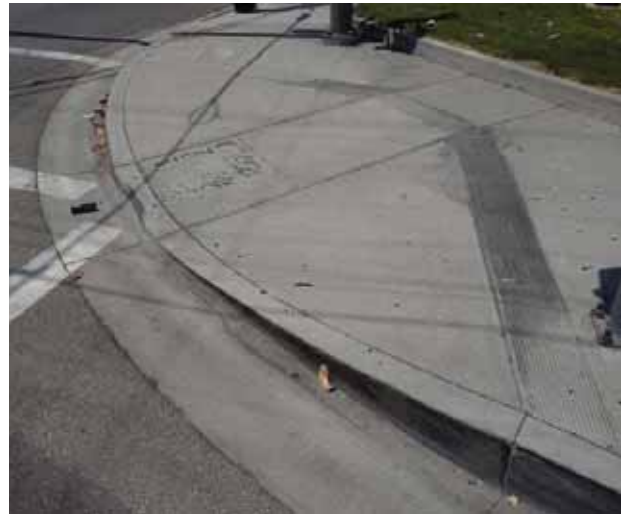
Recommendation Up to 5.00 percent

Repave landing \$1,260

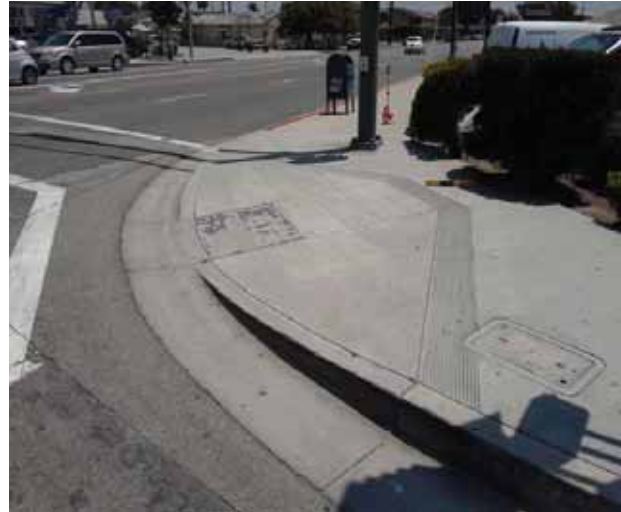
On-Site Finding Not Found

Provide detectable warning to surface \$248

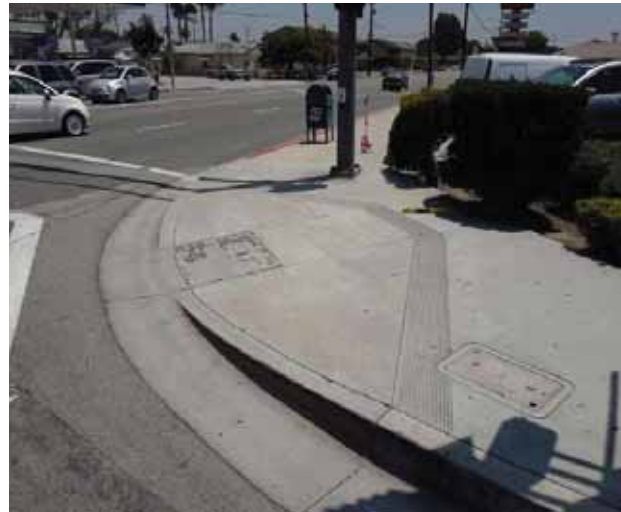
Recommendation Up to 2.08 percent

Provide compliant landing \$1,260

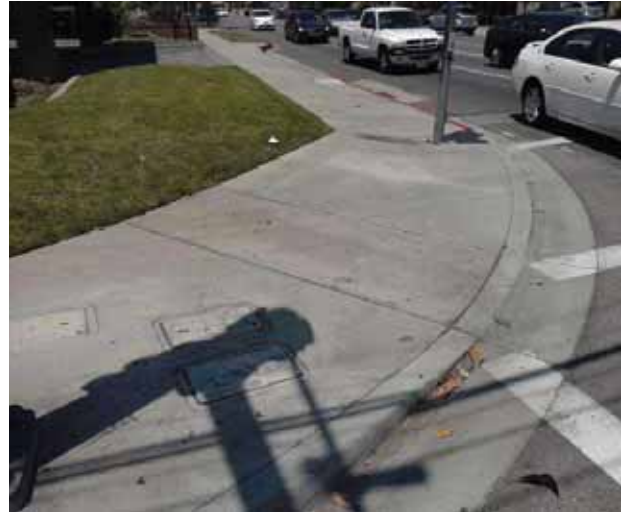
On-Site Finding Not Found

Provide detectable warning to surface \$248

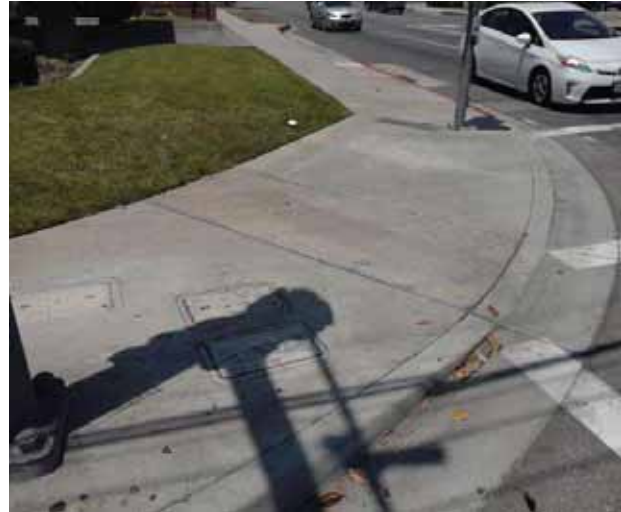
Recommendation Up to 2.08 percent

Provide compliant landing \$1,260

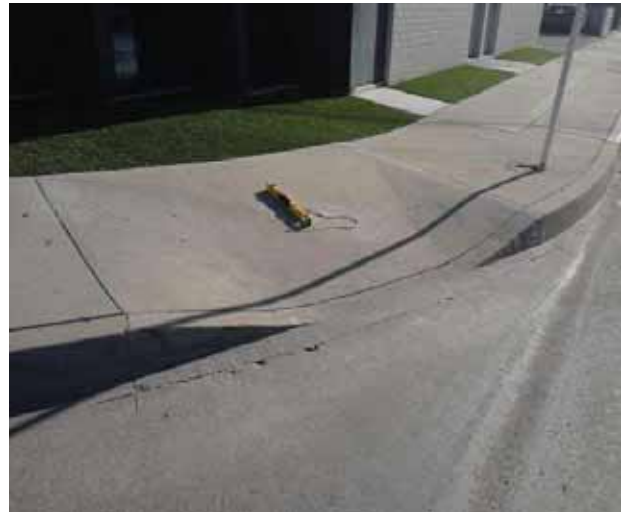
Code Reference CA 11B-406.5.12

Provide detectable warning to surface \$248

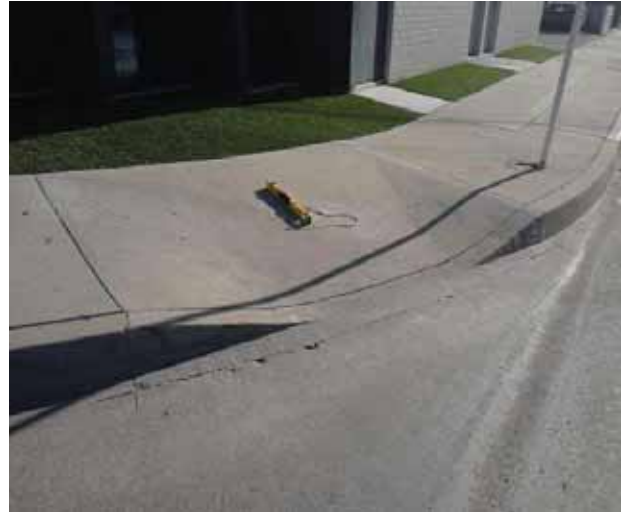
Code Reference ADA 406, 406.1, 405.2, CA 11B-406

Install curb ramp \$1,300

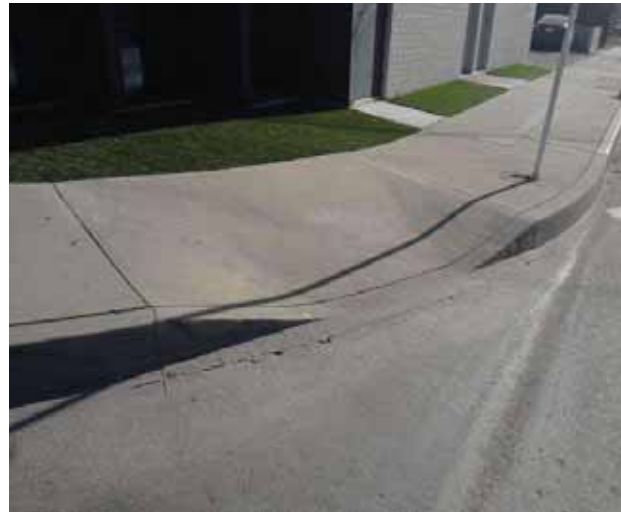
Code Reference ADA 406, 406.2, CA 11B-406.5.8

Repave landing \$1,260

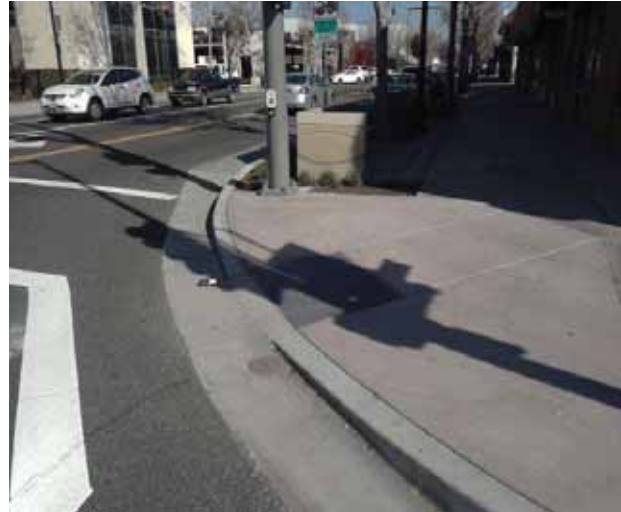
Code Reference ADA 406, 406.2,CA 11B-406.5.8

Repave landing \$1,260

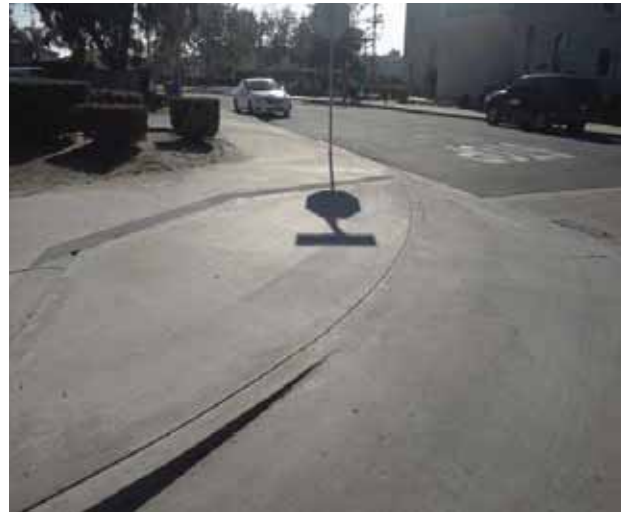
Code Reference CA 11B-406.5.12

Provide detectable warning to surface \$248

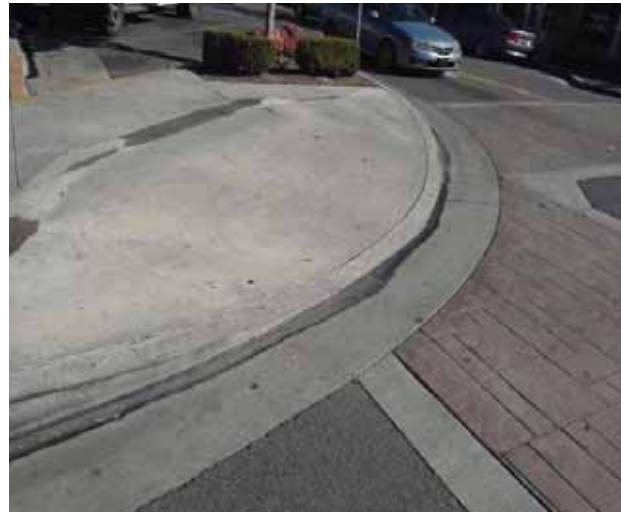
Code Reference CA 11B-406.5.12

Provide detectable warning to surface \$248

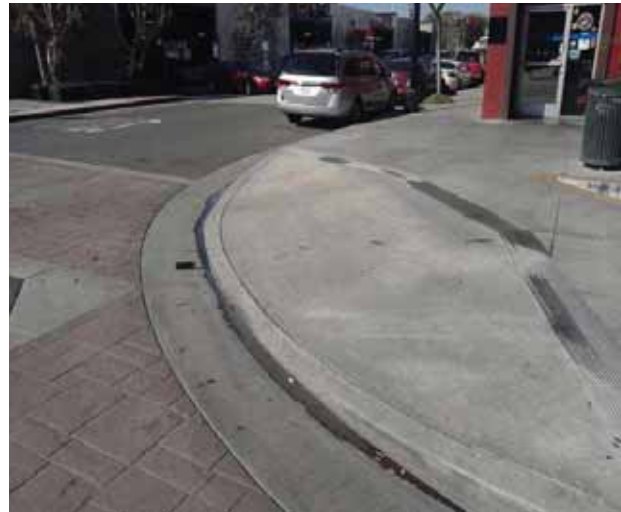
Code Reference ADA 406, 406.2, CA 11B-406.5.8

Repave landing \$1,260

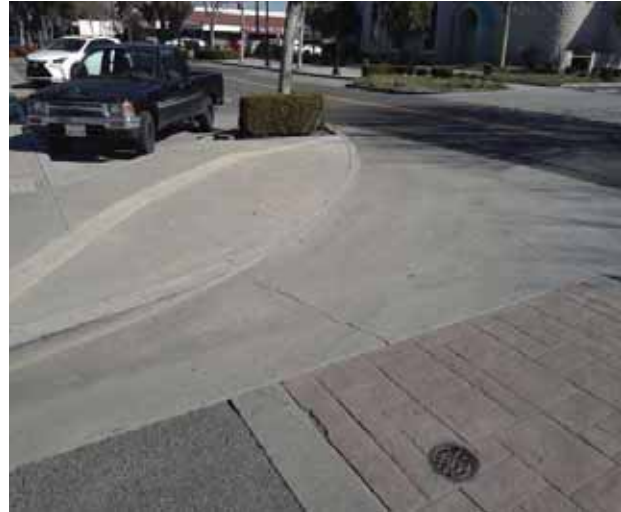
Code Reference CA 11B-406.5.12

Provide detectable warning to surface \$248

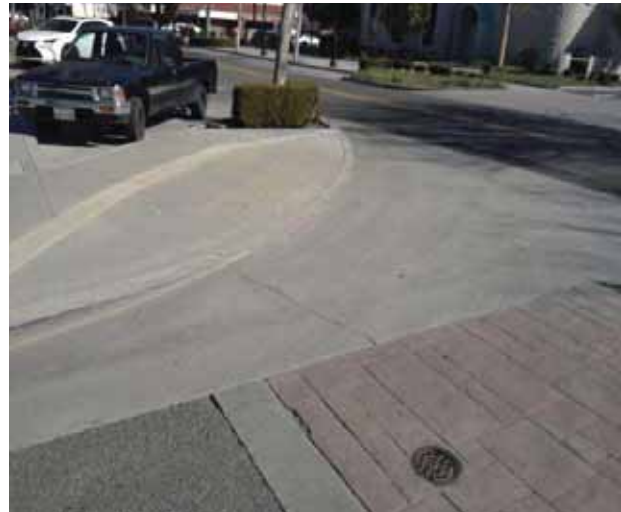
Code Reference ADA 406, 406.4, CA 11B-406.5.3

Provide compliant landing \$240

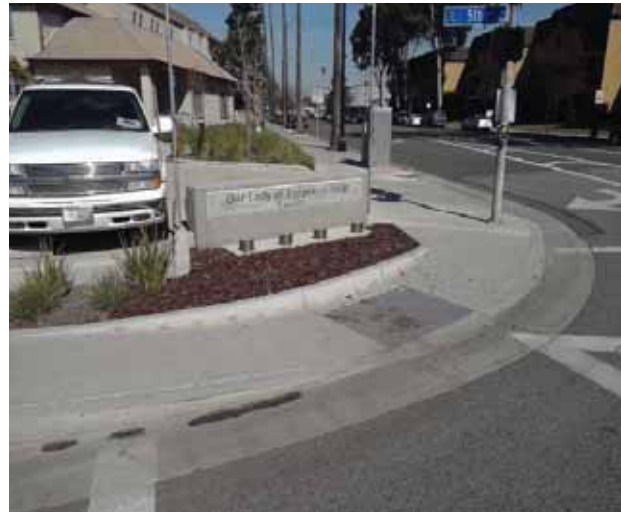
Code Reference ADA 406, 406.5

Install crosswalk \$800

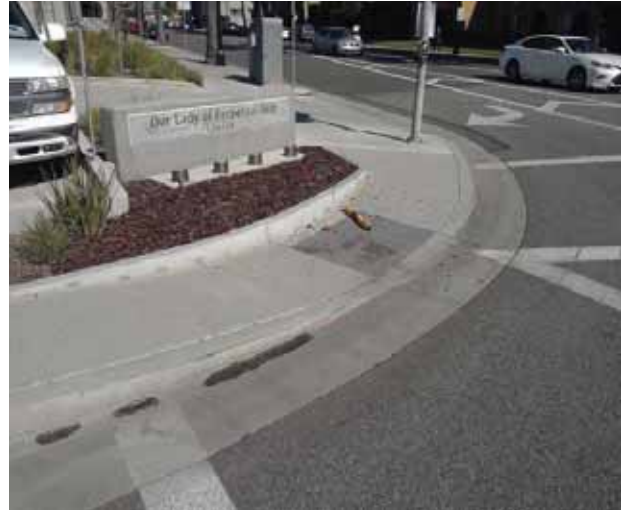
Code Reference ADA 402, 406.4, 406.2, 403.3, 406.1, CA 11B-406.5.3

Provide compliant landing \$240

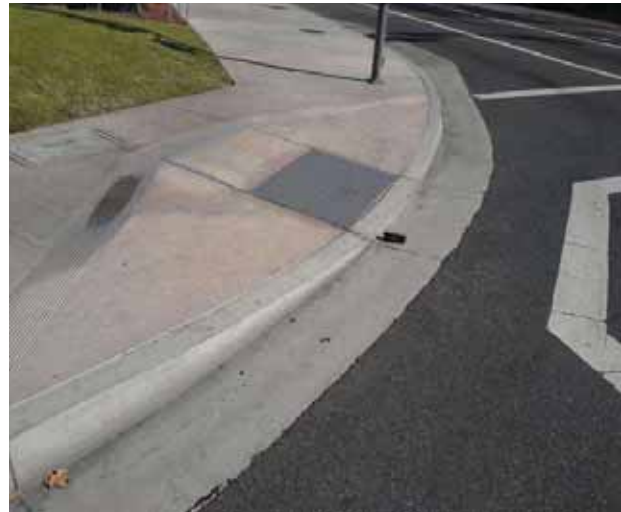
Code Reference ADA 406, 406.2, CA 11B-406.5.8

Repave landing \$1,260

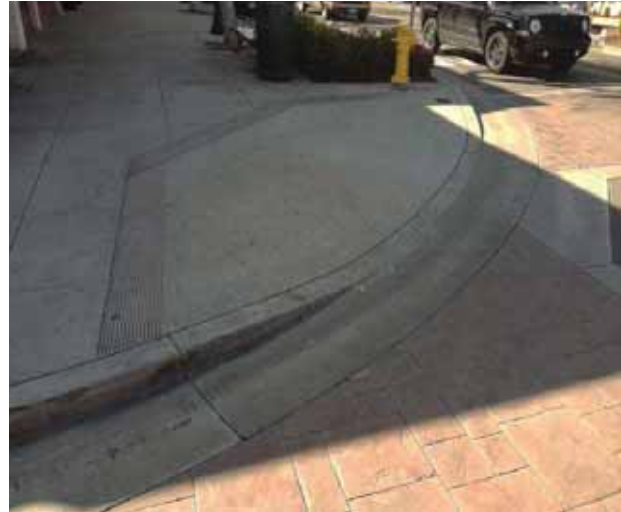
Code Reference CA 11B-406.5.12

Provide detectable warning to surface \$248

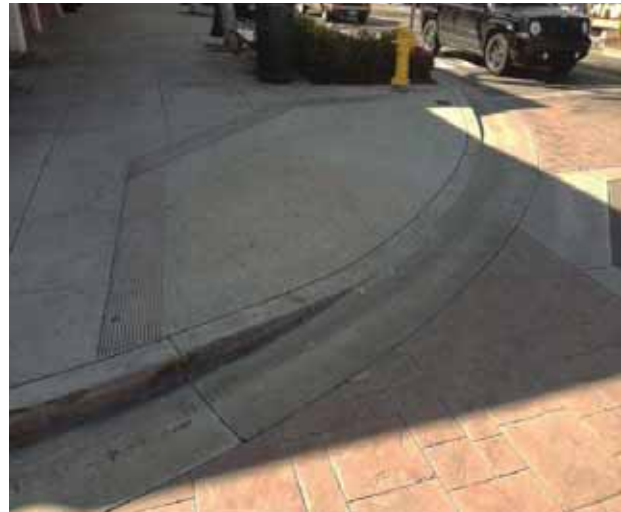
Code Reference ADA 406, 406.5

Install crosswalk \$800

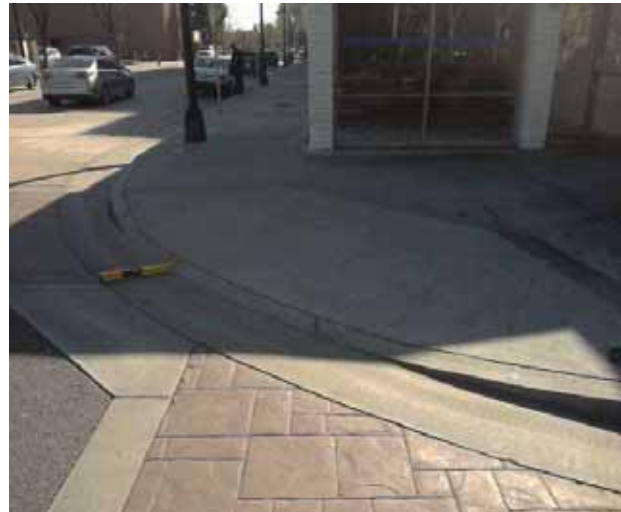
Code Reference ADA 406, 406.2, CA 11B-406.5.8

Repave landing \$1,260

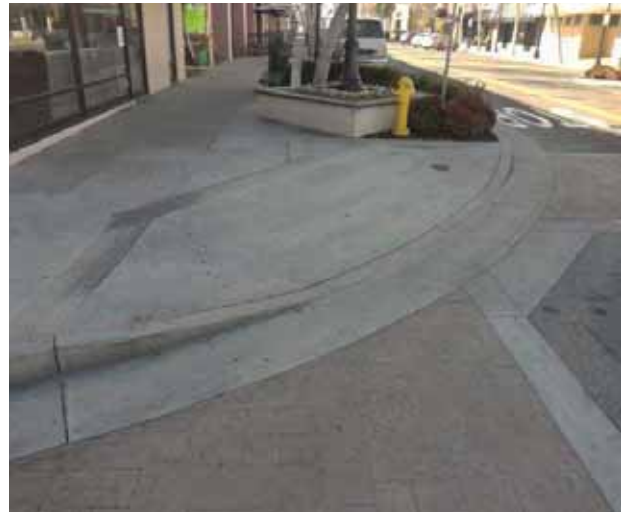
Code Reference CA 11B-406.5.12

Provide detectable warning to surface \$248

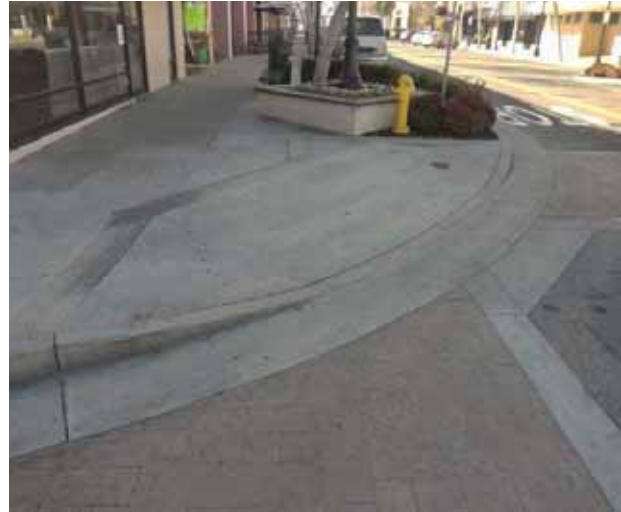
Code Reference ADA 406, 406.5

Install crosswalk \$800

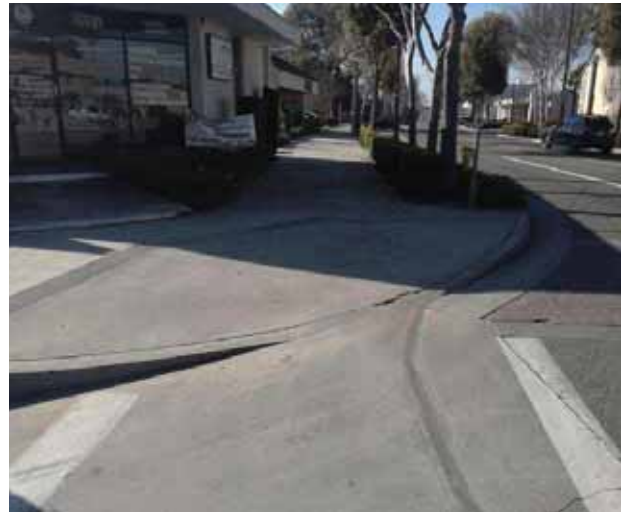
Code Reference CA 11B-406.5.12

Provide detectable warning to surface \$248

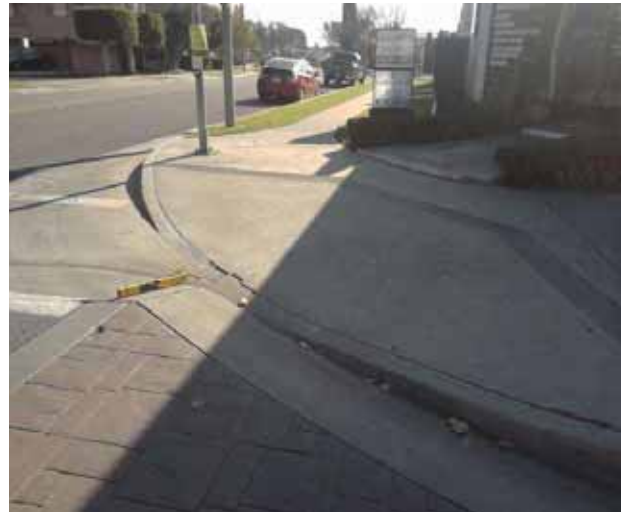
Code Reference ADA 402, 406.4, 406.2, 403.3, 406.1, CA 11B-406.5.3

Provide compliant landing \$240

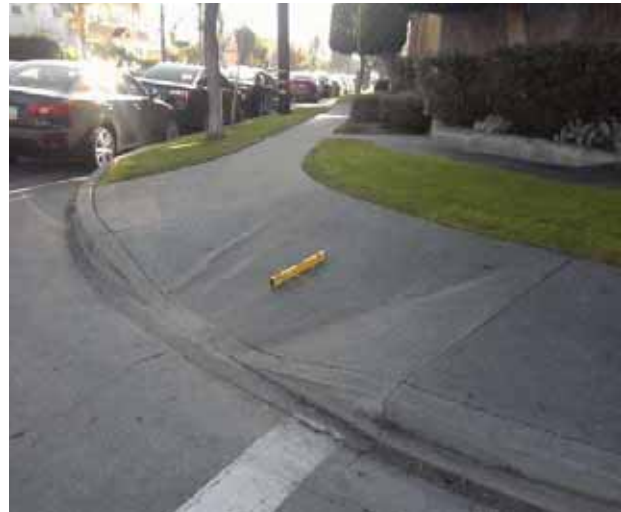
Code Reference CA 11B-406.5.12

Provide detectable warning to surface \$248

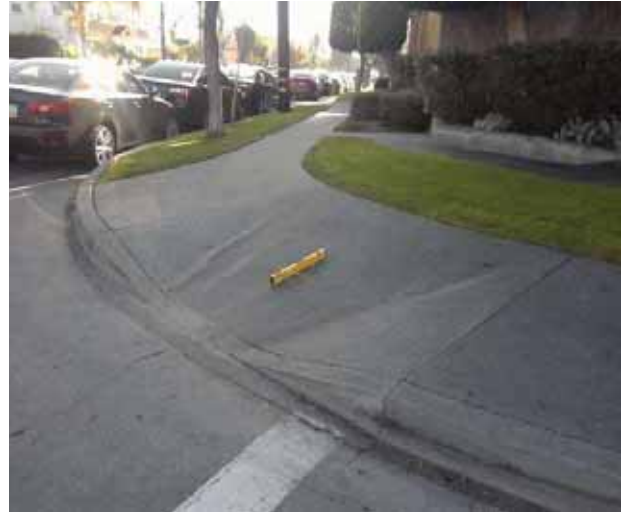
Code Reference ADA 406, 406.3, CA 11B-406.2.2

Install flared sides \$1,300

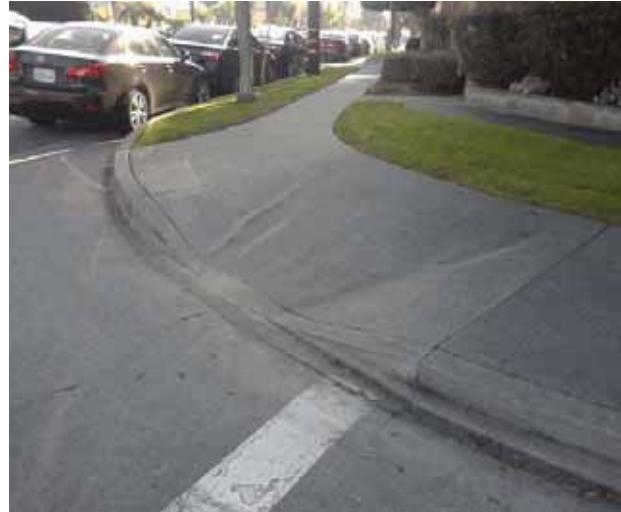
Code Reference ADA 302, 406.2

Patch lip at curb ramp \$255

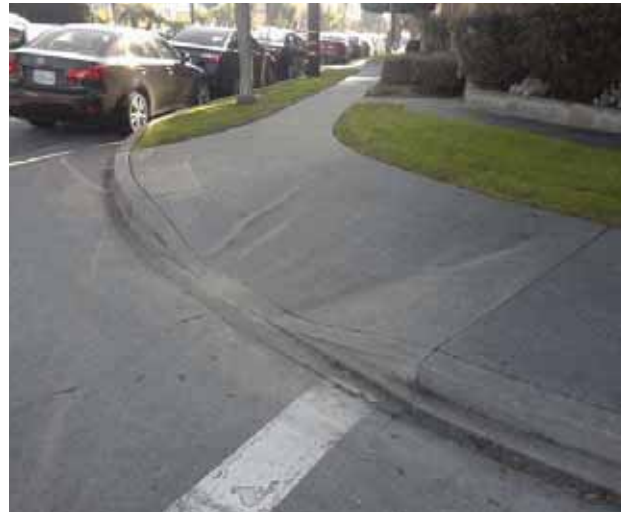
Code Reference ADA 406, 406.4, CA 11B-406.5.3

Provide compliant landing \$240

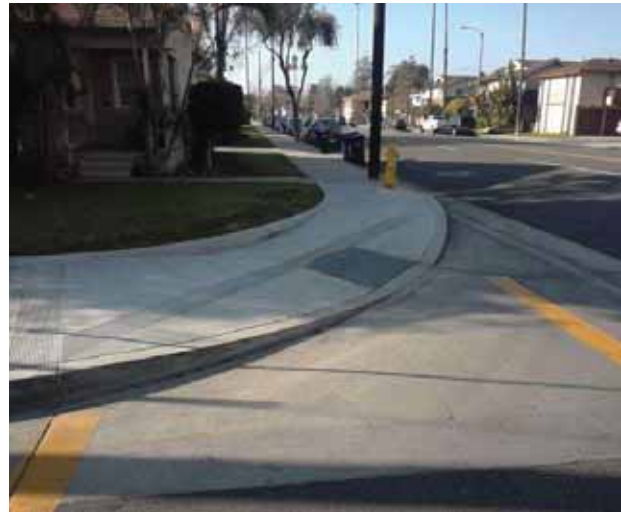
Code Reference ADA 406, 406.6, 406.1, 405.10

Provide compliant landing \$255

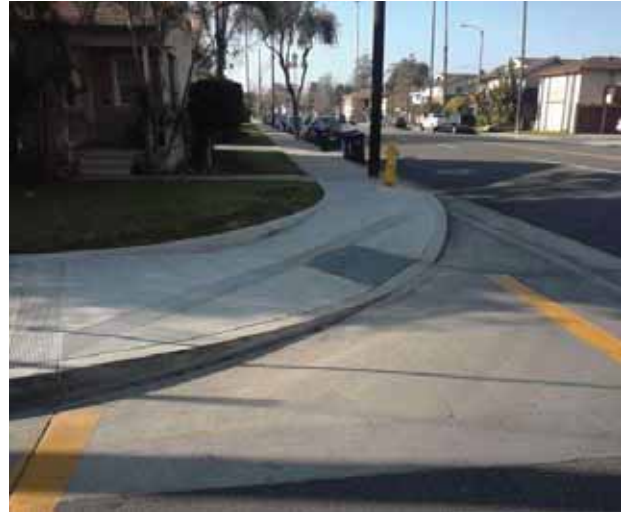
Code Reference ADA 406, 406.4,CA 11B-406.5.3

Provide compliant landing \$240

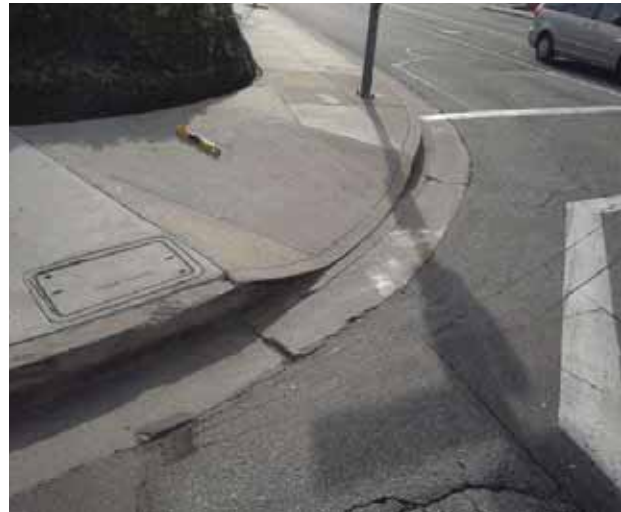
Code Reference CA 11B-406.5.12

Provide detectable warning to surface \$248

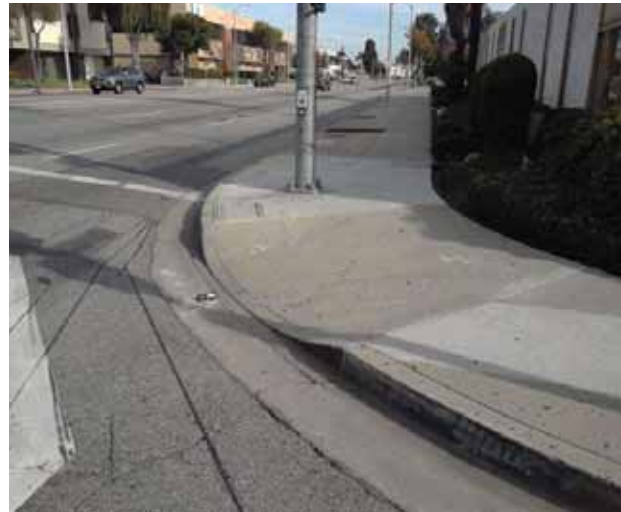
Code Reference ADA 406, 406.2,CA 11B-406.5.8

Repave landing \$1,260

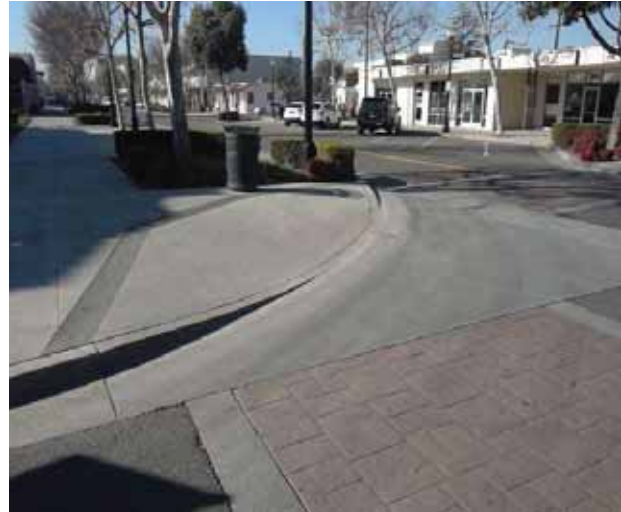
Code Reference CA 11B-406.5.12

Provide detectable warning to surface \$248

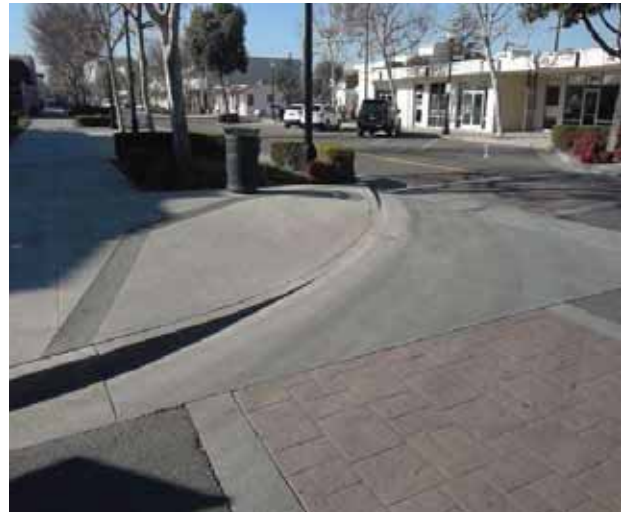
Code Reference ADA 406, 406.5

Install crosswalk \$800

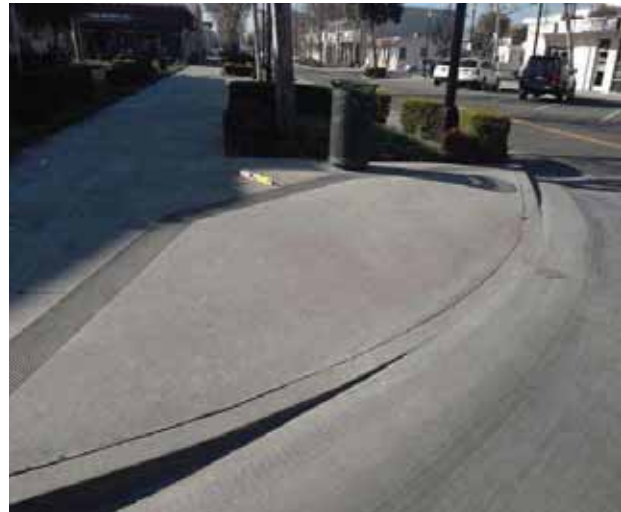
Code Reference ADA 402, 406.4, 403.3, 406.1, CA 11B-406.5.3

Provide compliant landing \$1,260

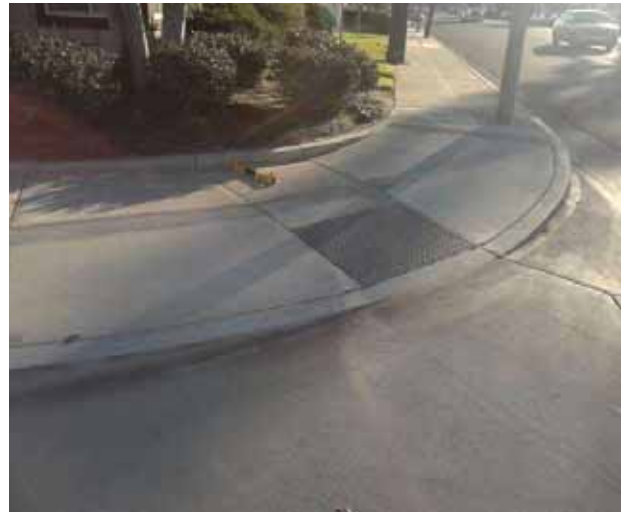
Code Reference ADA 402, 406.4, 403.3, 406.1, CA 11B-406.5.3

Provide compliant landing \$1,260

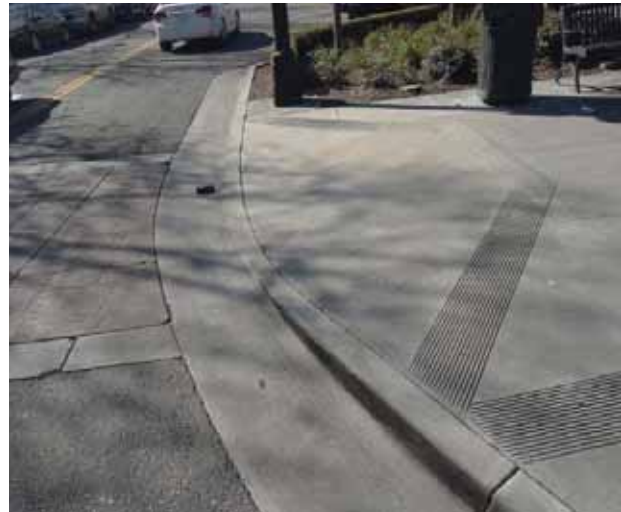
Code Reference CA 11B-406.5.12

Provide detectable warning to surface \$248

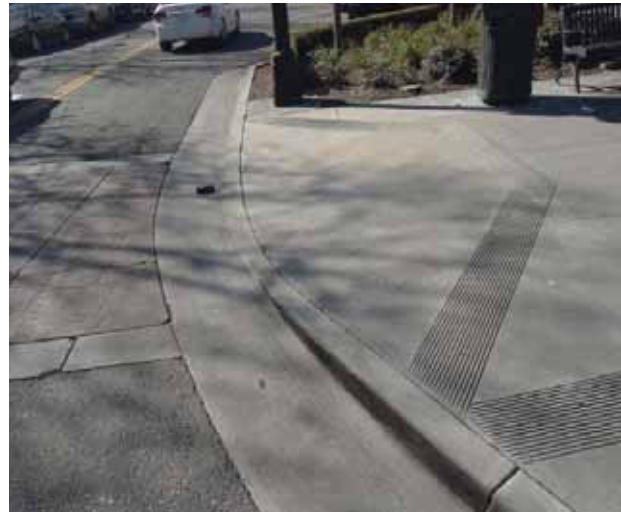
Code Reference ADA 406, 406.2,CA 11B-406.5.8

Repave landing \$1,260

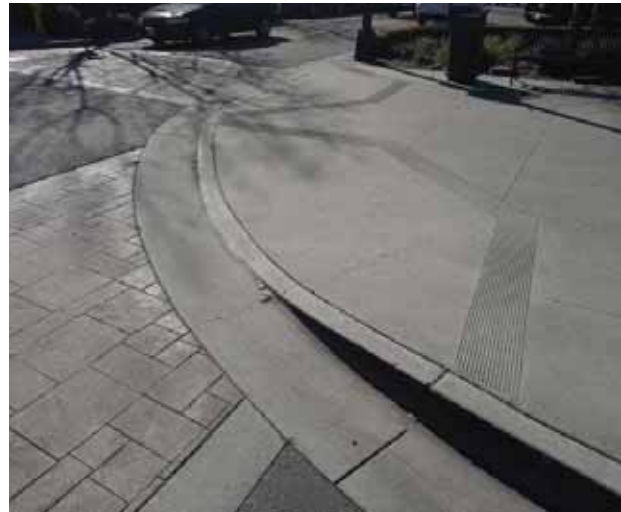
Code Reference CA 11B-406.5.12

Provide detectable warning to surface \$248

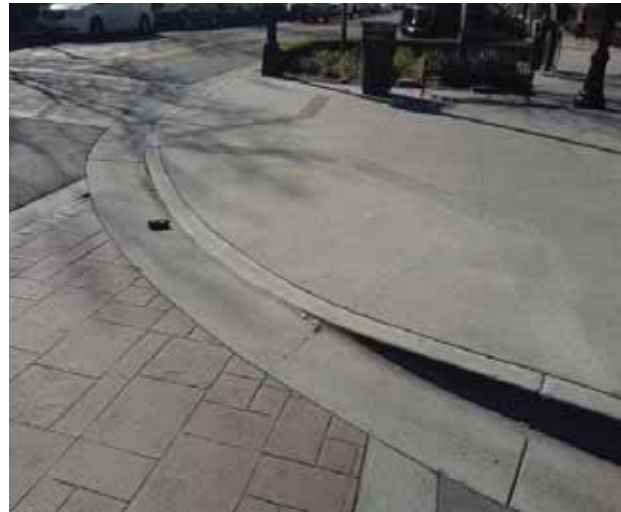
Code Reference ADA 406, 406.2, CA 11B-406.5.8

Repave landing \$1,260

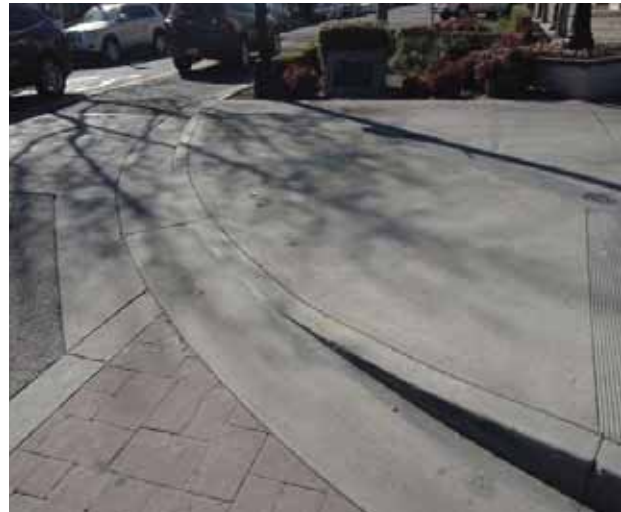
Code Reference CA 11B-406.5.12

Provide detectable warning to surface \$248

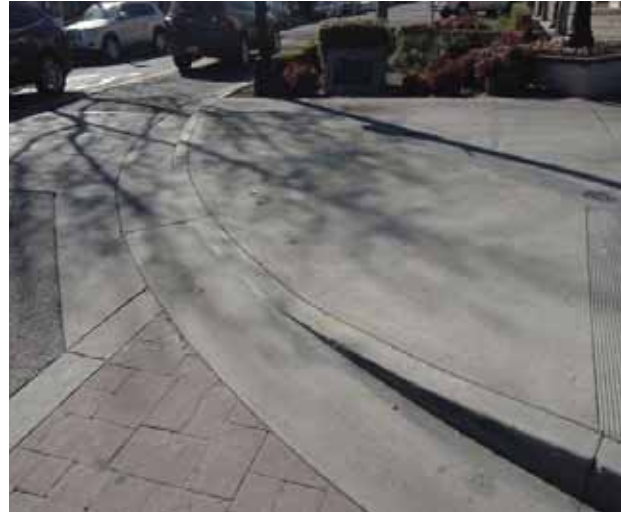
Code Reference ADA 406, 406.5

Install crosswalk \$800

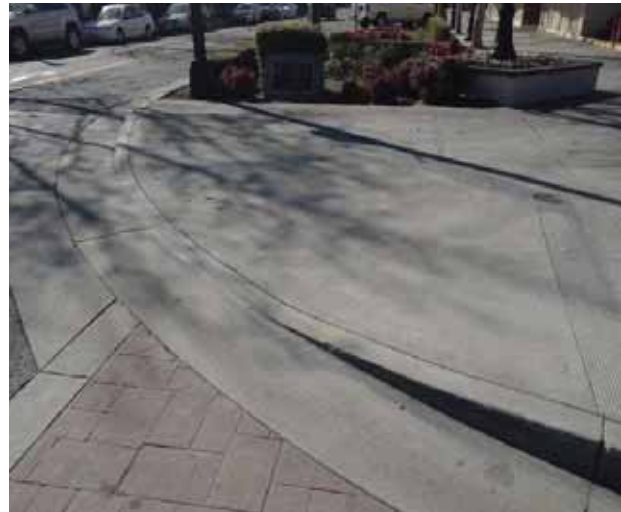
Code Reference ADA 406, 406.6, 406.1, 405.10

Provide compliant landing \$255
