Accessibility Survey

City of Downey Downey Avenue & De Palma Street

Date of Inspection
1/31/2017

Prepared By
Disability Access Consultants
(800) 743-7067

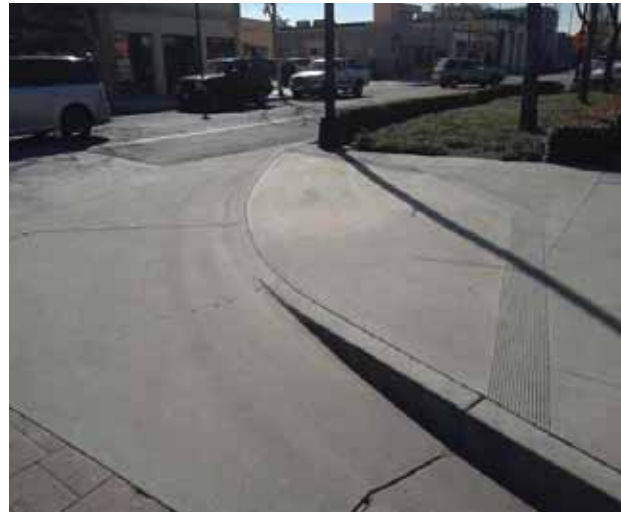
Code Reference CA 11B-406.5.12

Provide detectable warning to surface \$248

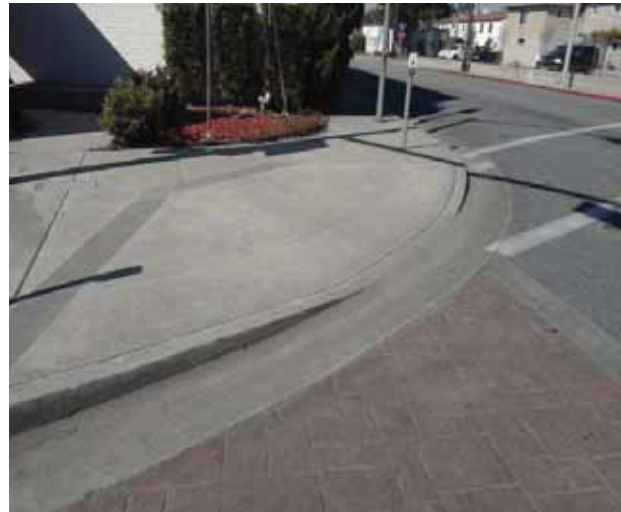
Code Reference CA 11B-406.5.12

Provide detectable warning to surface \$248

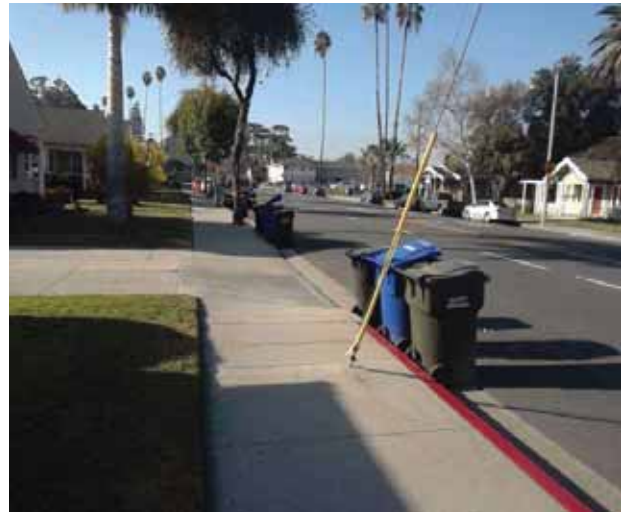
Sidewalks , Hazards & Gratings : Overhead Obstruction Height

Recommendation At least 80.00 inches

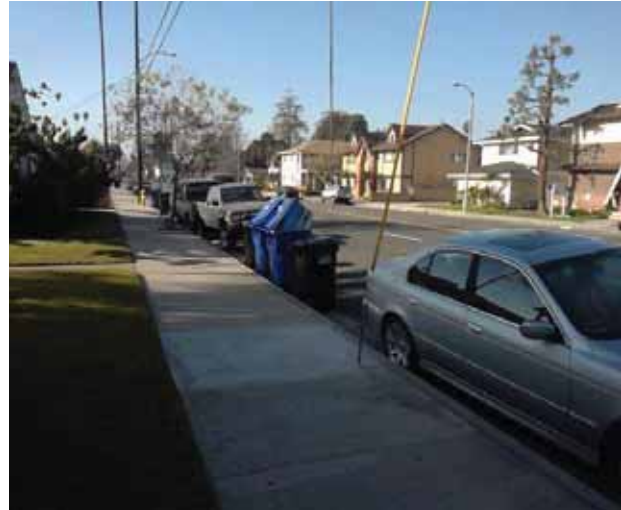
Sidewalks , Hazards & Gratings : Overhead Obstruction Height

Recommendation At least 80.00 inches

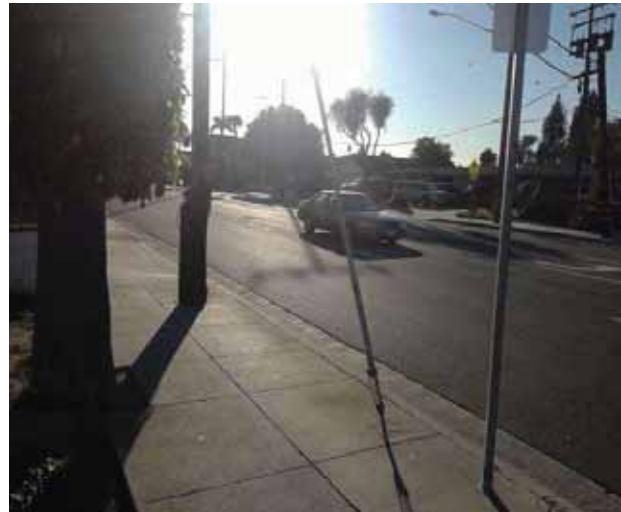
Sidewalks , Hazards & Gratings : Overhead Obstruction Height

Recommendation At least 80.00 inches

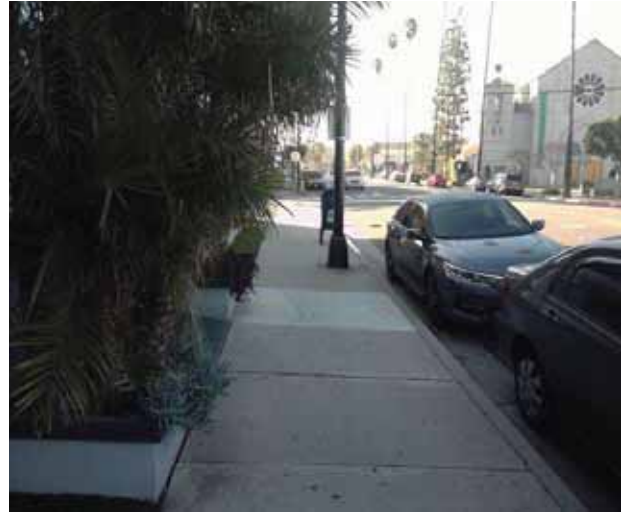
Sidewalks , Hazards & Gratings : Overhead Obstruction Height

Recommendation At least 80.00 inches

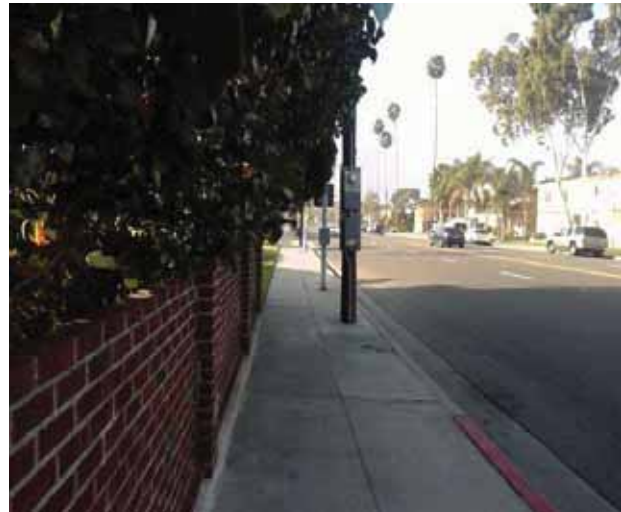
Sidewalks , Hazards & Gratings : Overhead Obstruction Height

Recommendation At least 80.00 inches

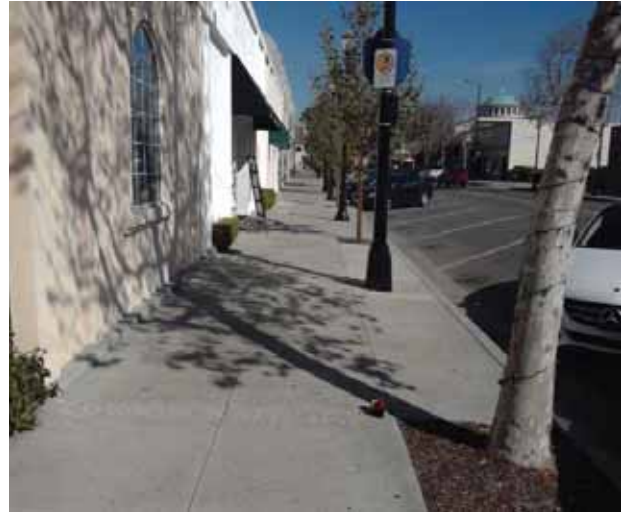
There is a change in elevation greater than recommended value.

Ensure that the change in elevation is within the recommended value.

Remove tripping hazards \$198

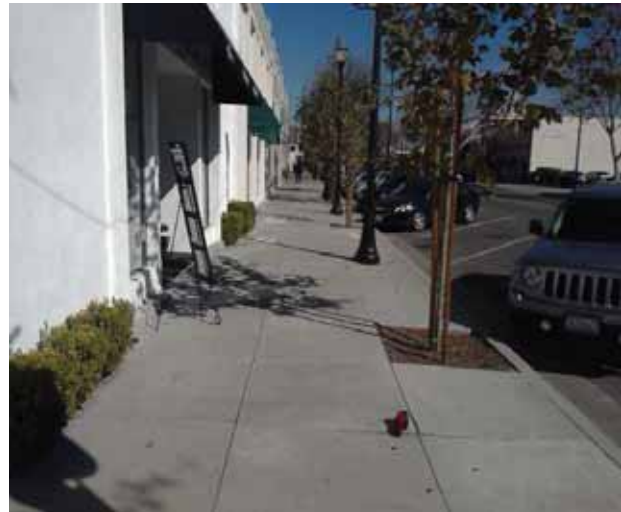
There is a change in elevation greater than recommended value.

Ensure that the change in elevation is within the recommended value.

Remove tripping hazards \$198

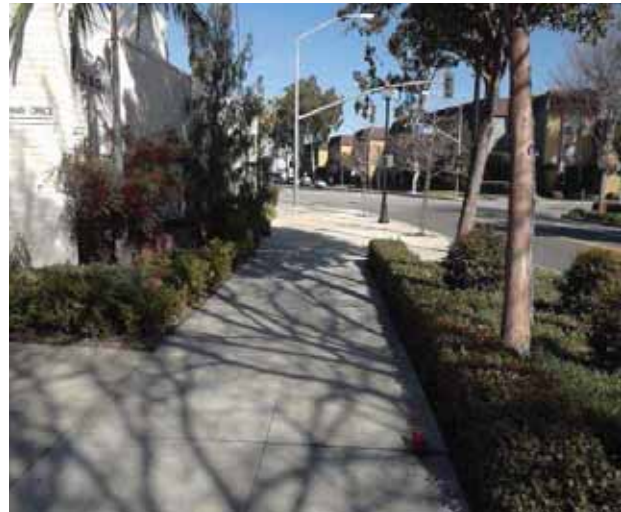
There is a change in elevation greater than recommended value.

Ensure that the change in elevation is within the recommended value.

Remove tripping hazards \$198

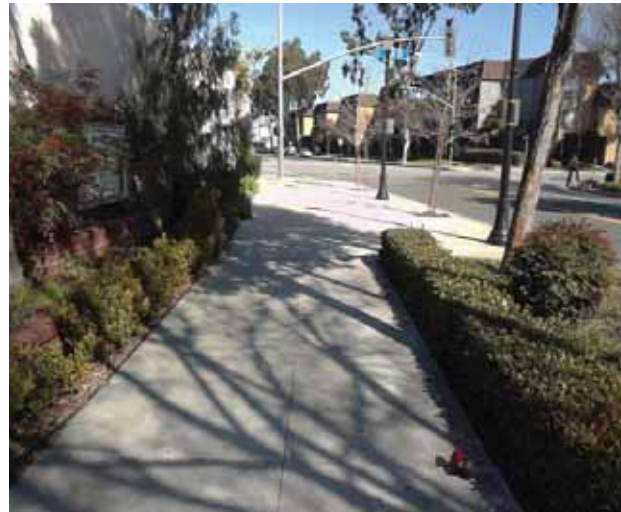
There is a change in elevation greater than recommended value.

Ensure that the change in elevation is within the recommended value.

Remove tripping hazards \$198

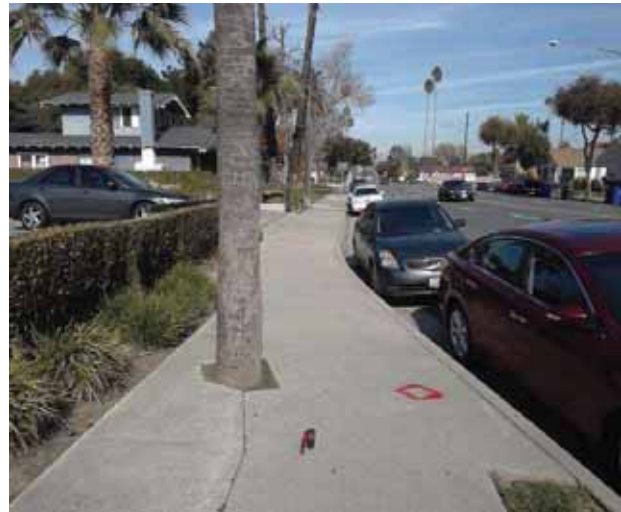
There is a change in elevation greater than recommended value.

Ensure that the change in elevation is within the recommended value.

Remove tripping hazards \$198

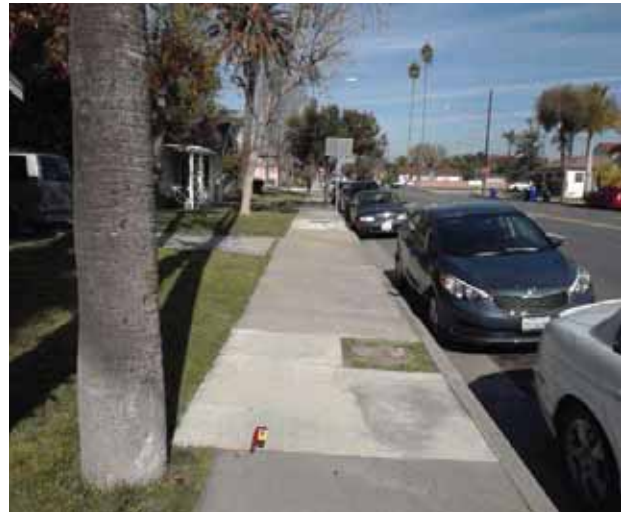
There is a change in elevation greater than recommended value.

Ensure that the change in elevation is within the recommended value.

Remove tripping hazards \$198

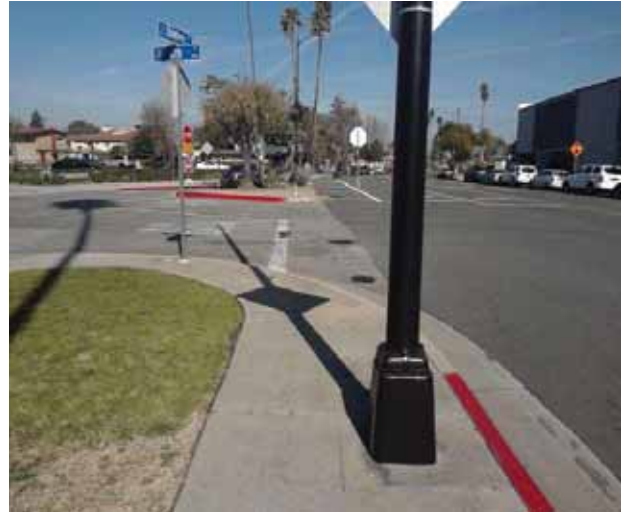
Sidewalks , Hazards & Gratings : Sidewalk Width at Obstruction

Sidewalk width at the obstruction shall have the recommended value.

Recommendation At least 48.00 inches

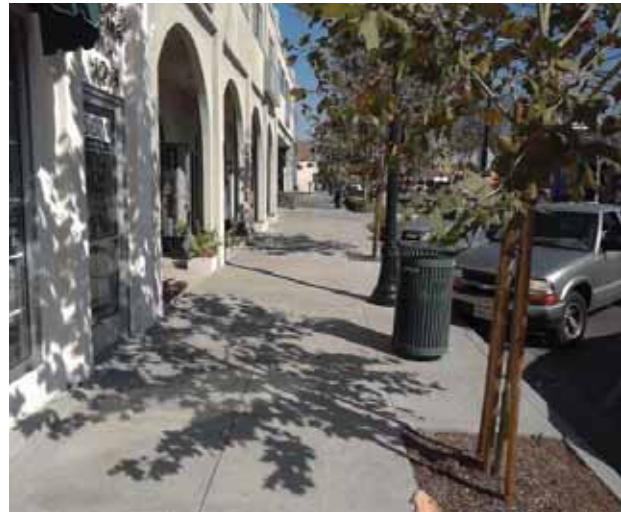
Sidewalks , Hazards & Gratings : Overhead Obstruction Height

Recommendation At least 80.00 inches

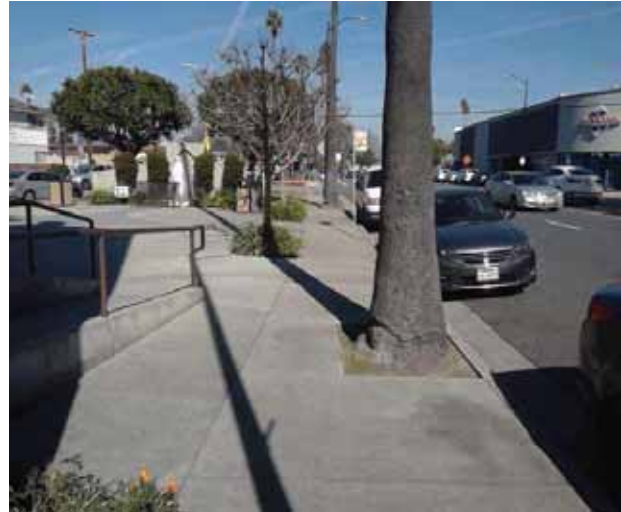
Sidewalks , Hazards & Gratings : Sidewalk Width at Obstruction

Sidewalk width at the obstruction shall have the recommended value.

Recommendation At least 48.00 inches

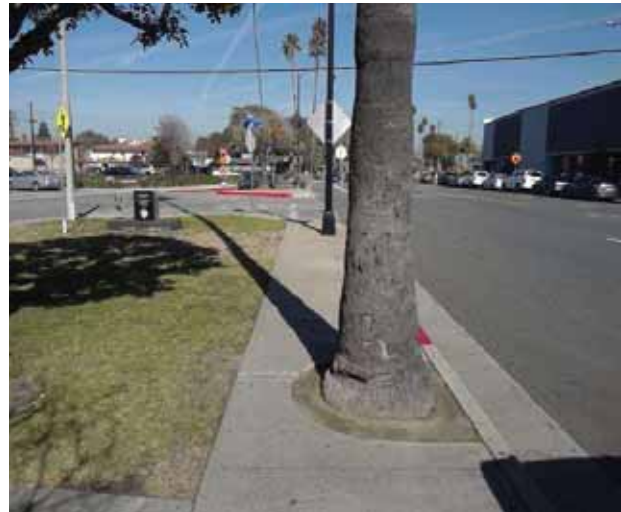
Sidewalks , Hazards & Gratings : Sidewalk Width at Obstruction

Sidewalk width at the obstruction shall have the recommended value.

Recommendation At least 48.00 inches

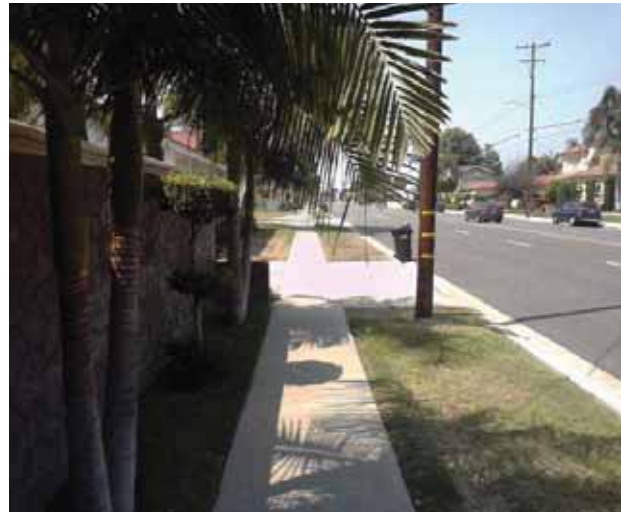
Sidewalks , Hazards & Gratings : Overhead Obstruction Height

Recommendation At least 80.00 inches

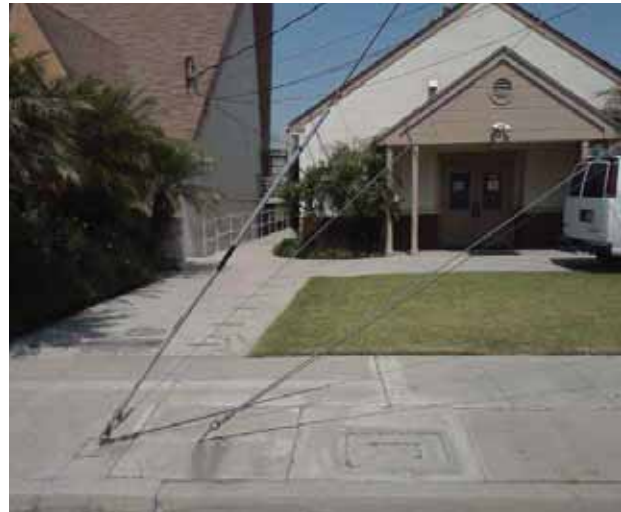
Sidewalks , Hazards & Gratings : Overhead Obstruction Height

Recommendation At least 80.00 inches

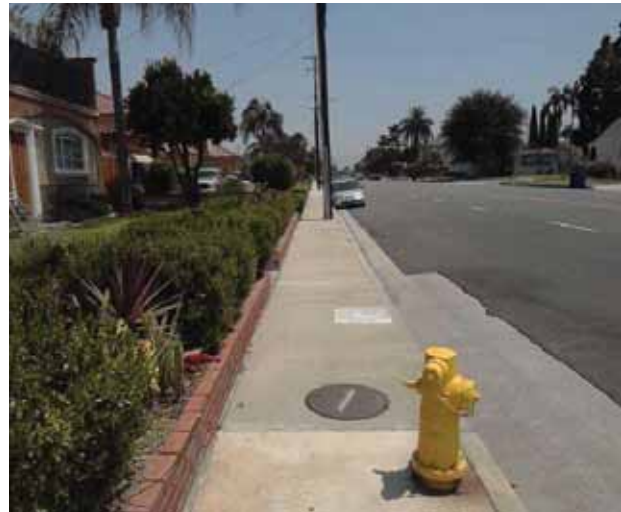
Sidewalks , Hazards & Gratings : Sidewalk Width at Obstruction

Sidewalk width at the obstruction shall have the recommended value.

Recommendation At least 48.00 inches

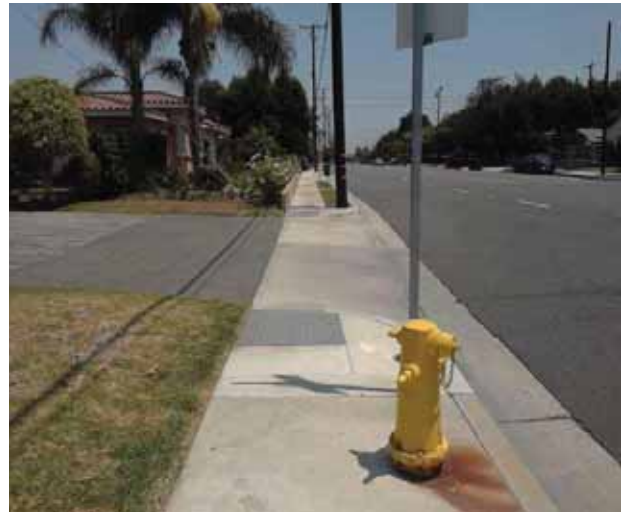
Sidewalks , Hazards & Gratings : Sidewalk Width at Obstruction

Sidewalk width at the obstruction shall have the recommended value.

Recommendation At least 48.00 inches

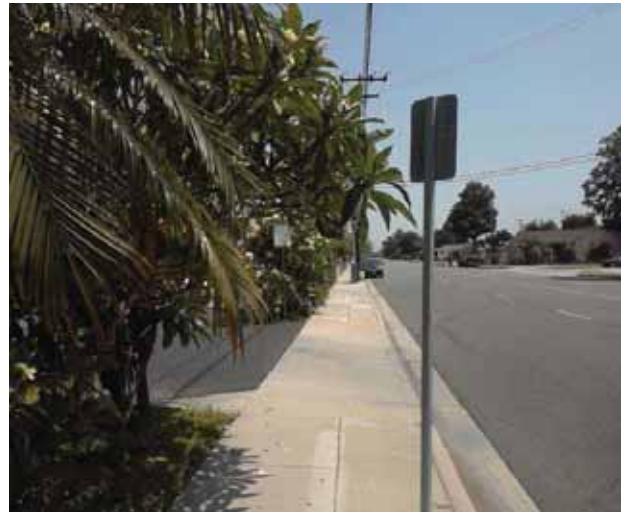
Sidewalks , Hazards & Gratings : Overhead Obstruction Height

Recommendation At least 80.00 inches

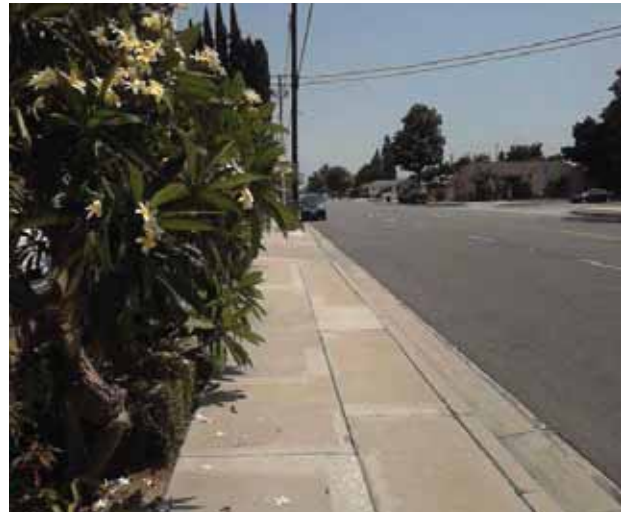
Sidewalks , Hazards & Gratings : Overhead Obstruction Height

Recommendation At least 80.00 inches

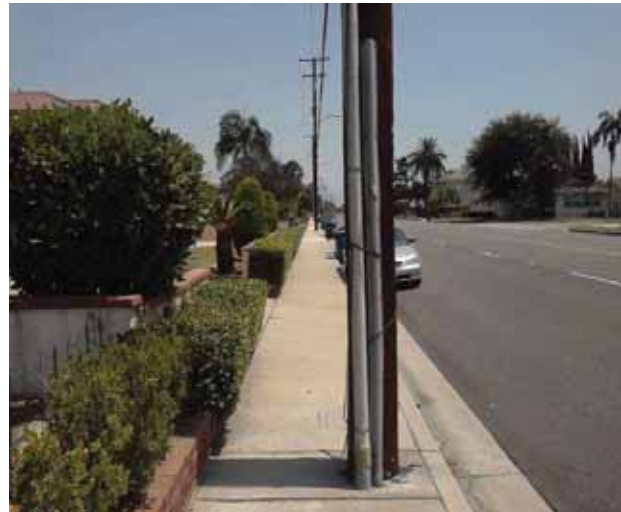
Sidewalks , Hazards & Gratings : Sidewalk Width at Obstruction

Sidewalk width at the obstruction shall have the recommended value.

Recommendation At least 48.00 inches

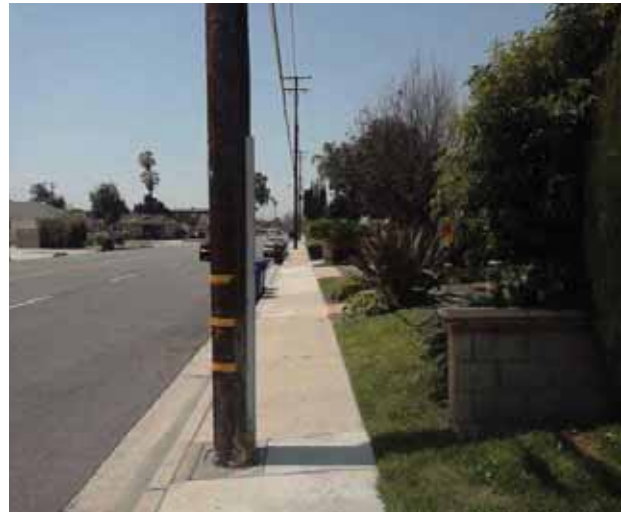
Sidewalks , Hazards & Gratings : Sidewalk Width at Obstruction

Sidewalk width at the obstruction shall have the recommended value.

Recommendation At least 48.00 inches

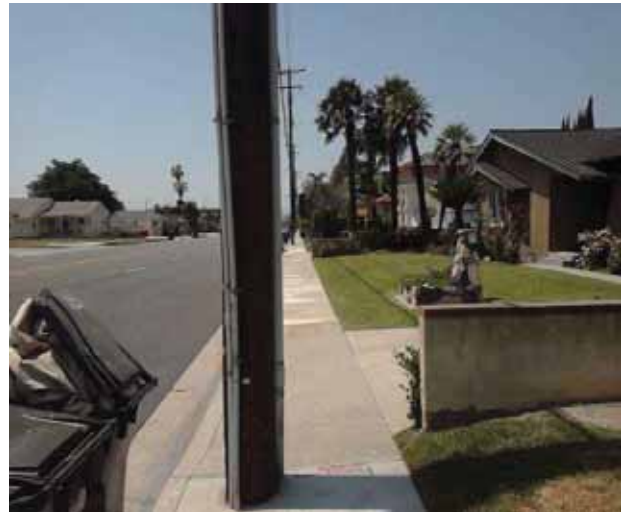
Sidewalks , Hazards & Gratings : Sidewalk Width at Obstruction

Sidewalk width at the obstruction shall have the recommended value.

Recommendation At least 48.00 inches

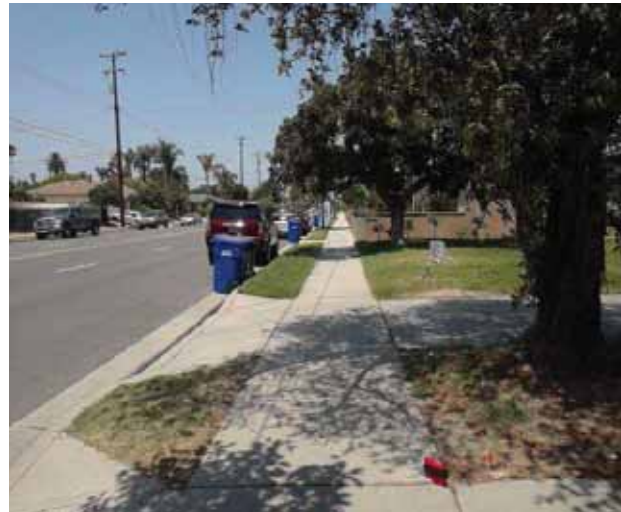
There is a change in elevation greater than recommended value.

Ensure that the change in elevation is within the recommended value.

Recommendation Up to 0.25 inches

Remove tripping hazards \$198

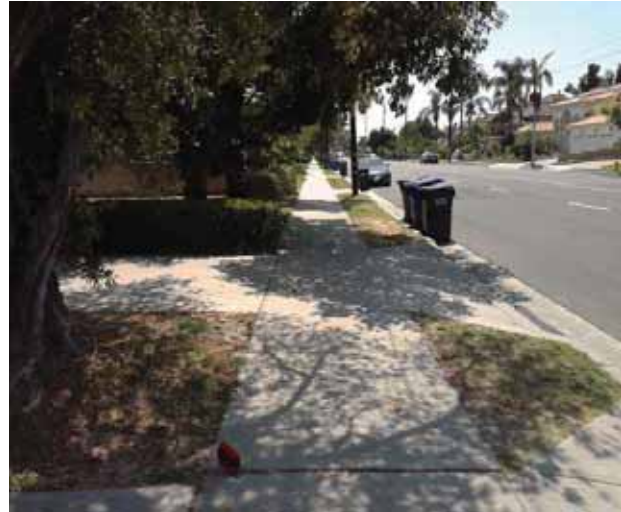
There is a change in elevation greater than recommended value.

Ensure that the change in elevation is within the recommended value.

Recommendation Up to 0.25 inches

Remove tripping hazards \$198

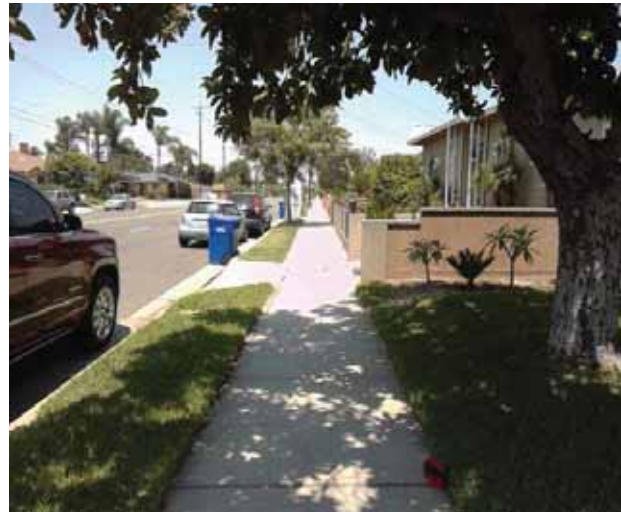
There is a change in elevation greater than recommended value.

Ensure that the change in elevation is within the recommended value.

Recommendation Up to 0.25 inches

Remove tripping hazards \$198

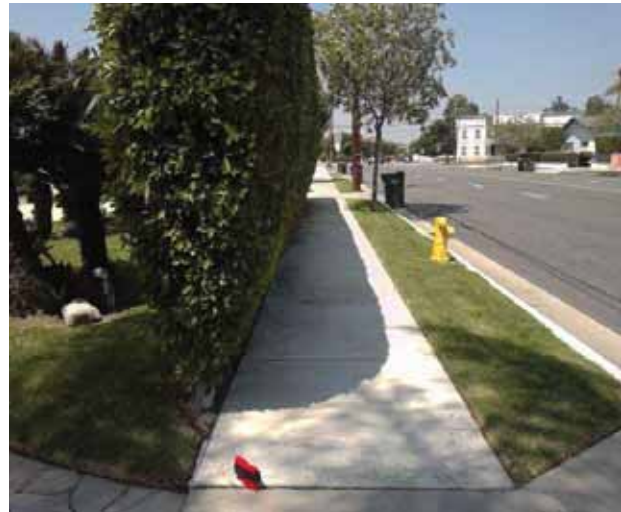
There is a change in elevation greater than recommended value.

Ensure that the change in elevation is within the recommended value.

Recommendation Up to 0.25 inches

Remove tripping hazards \$198

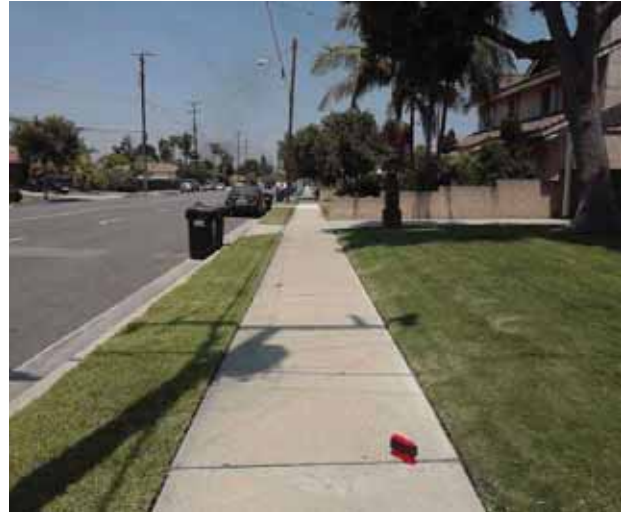
There is a change in elevation greater than recommended value.

Ensure that the change in elevation is within the recommended value.

Recommendation Up to 0.25 inches

Remove tripping hazards \$198

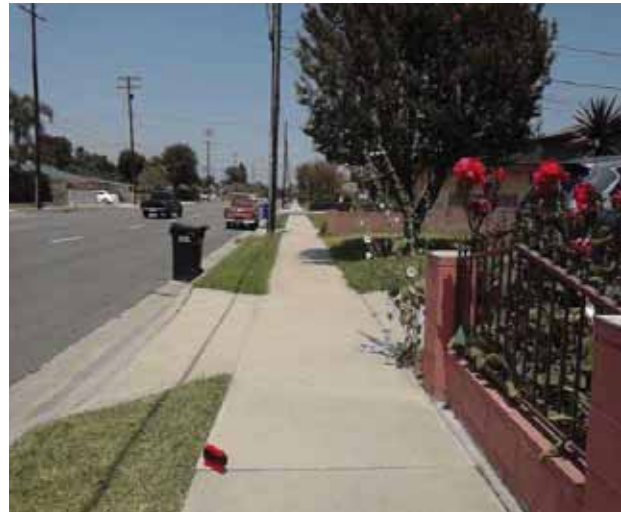
There is a change in elevation greater than recommended value.

Ensure that the change in elevation is within the recommended value.

Recommendation Up to 0.25 inches

Remove tripping hazards \$198

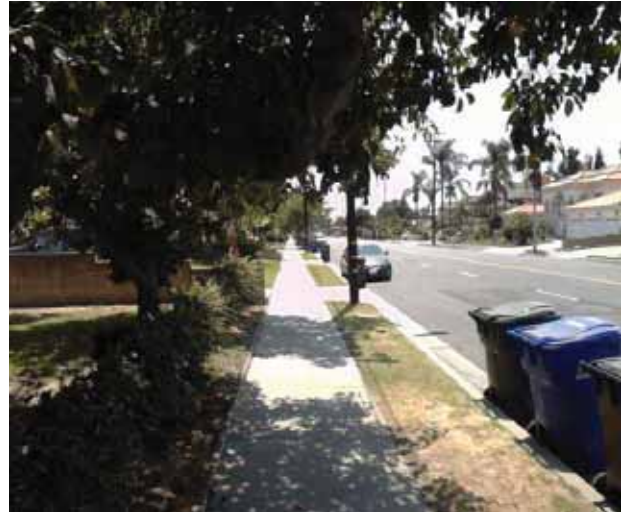
Sidewalks , Hazards & Gratings : Overhead Obstruction Height

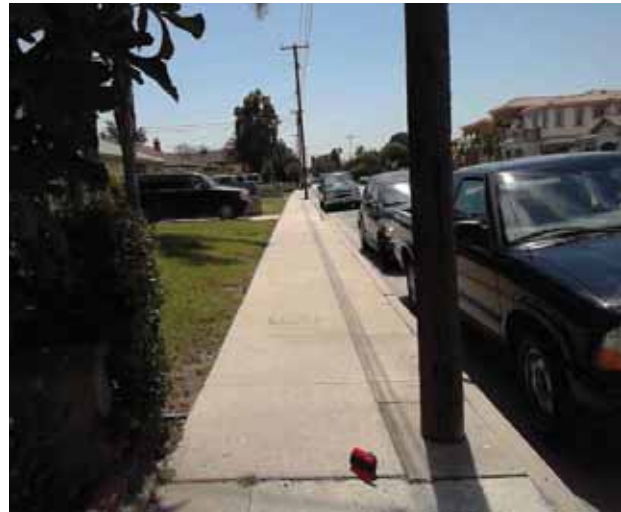
There is a change in elevation greater than recommended value.

Ensure that the change in elevation is within the recommended value.

Recommendation Up to 0.25 inches

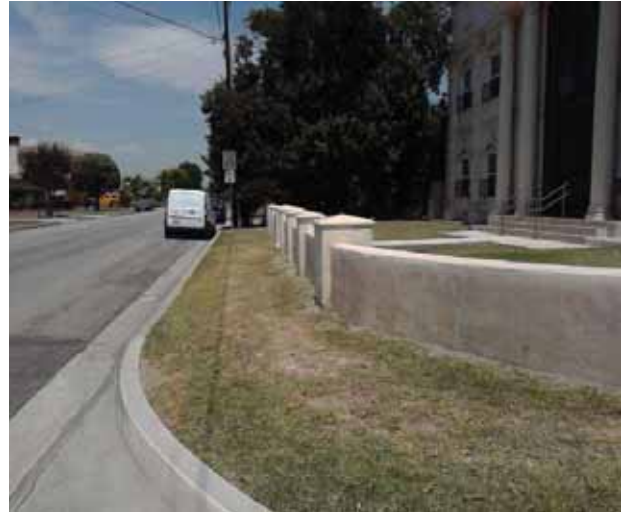
Sidewalks : Missing Sidewalk

Section of sidewalk is missing and consists of dirt, grass or gravel.

Provide a compliant sidewalk for the missing section.

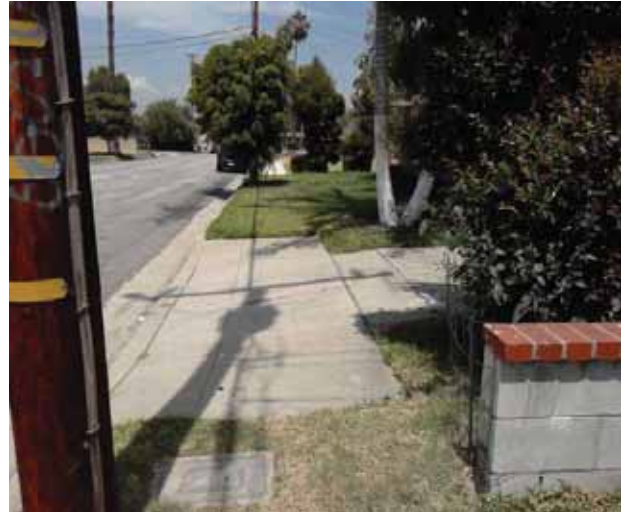
Sidewalks : Missing Sidewalk

Section of sidewalk is missing and consists of dirt, grass or gravel.

Provide a compliant sidewalk for the missing section.

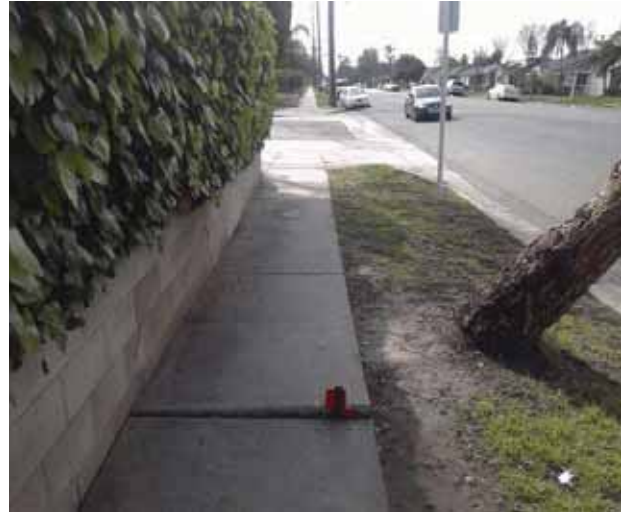
There is a change in elevation greater than recommended value.

Ensure that the change in elevation is within the recommended value.

Recommendation Up to 0.25 inches

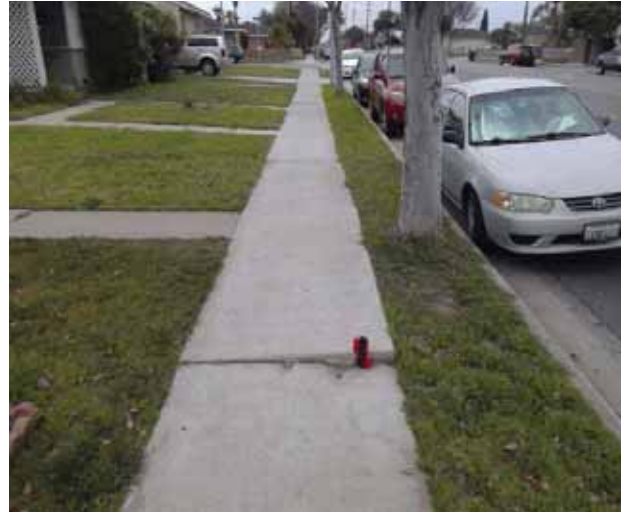
There is a change in elevation greater than recommended value.

Ensure that the change in elevation is within the recommended value.

Recommendation Up to 0.25 inches

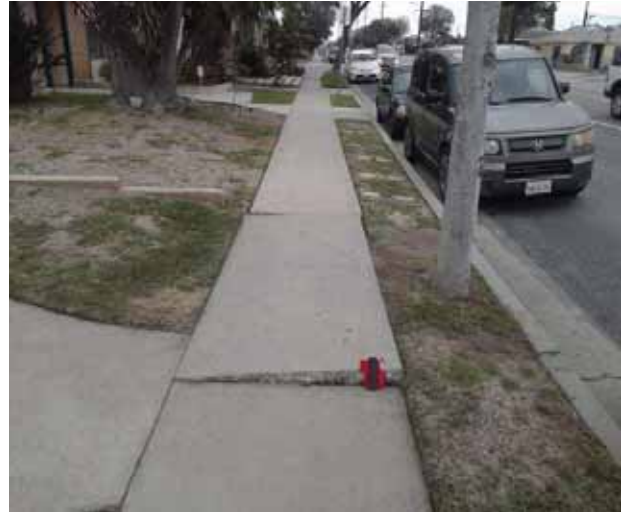
There is a change in elevation greater than recommended value.

Ensure that the change in elevation is within the recommended value.

Recommendation Up to 0.25 inches

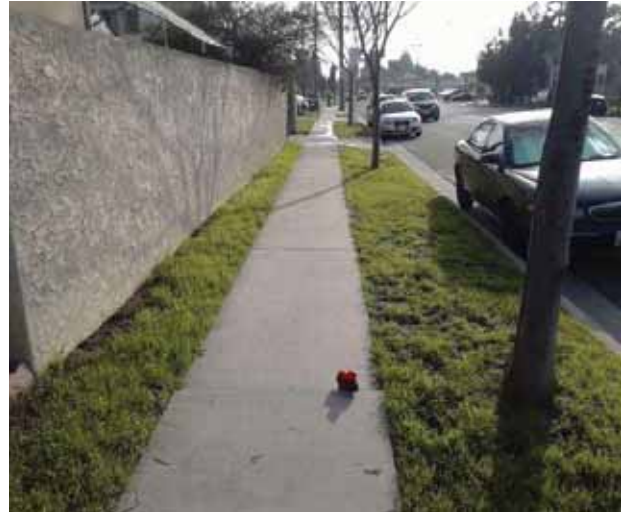
There is a change in elevation greater than recommended value.

Ensure that the change in elevation is within the recommended value.

Recommendation Up to 0.25 inches

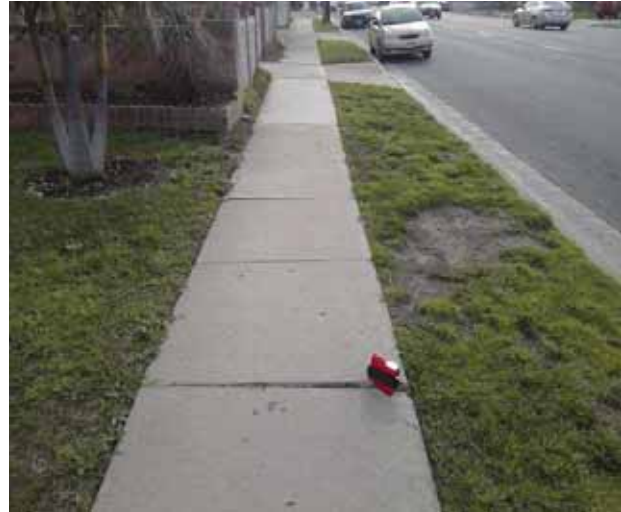
There is a change in elevation greater than recommended value.

Ensure that the change in elevation is within the recommended value.

Recommendation Up to 0.25 inches

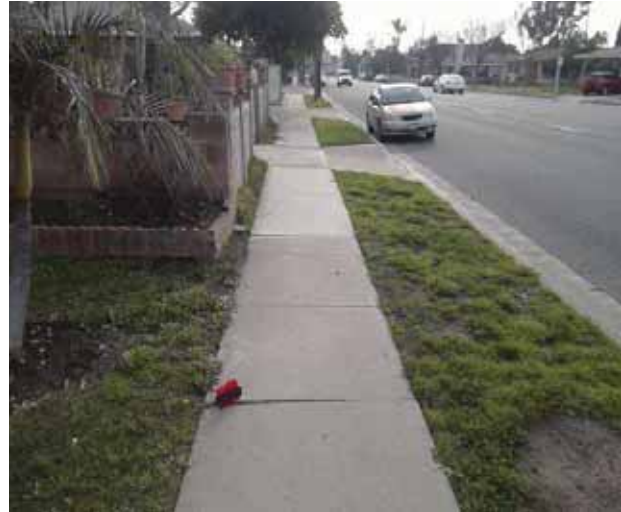
There is a change in elevation greater than recommended value.

Ensure that the change in elevation is within the recommended value.

Recommendation Up to 0.25 inches

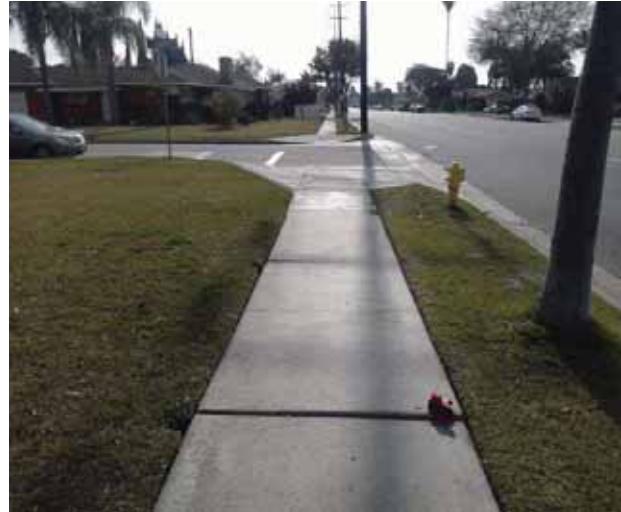
There is a change in elevation greater than recommended value.

Ensure that the change in elevation is within the recommended value.

Recommendation Up to 0.25 inches

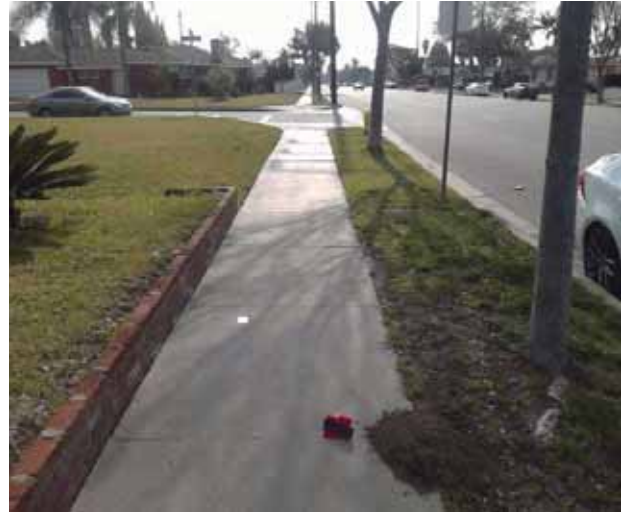
There is a change in elevation greater than recommended value.

Ensure that the change in elevation is within the recommended value.

Recommendation Up to 0.25 inches

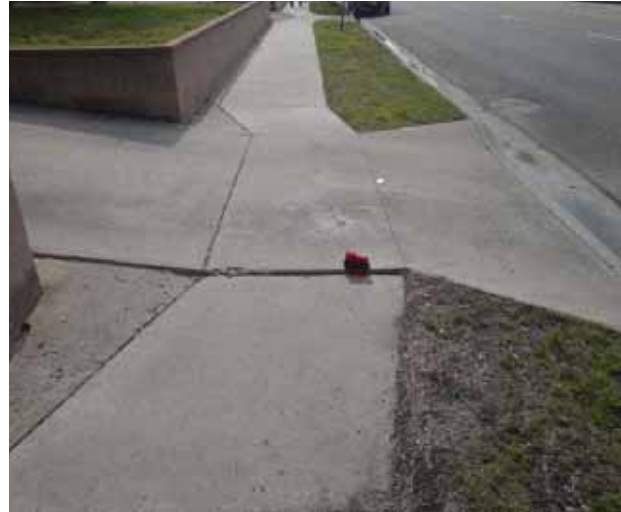
There is a change in elevation greater than recommended value.

Ensure that the change in elevation is within the recommended value.

Recommendation Up to 0.25 inches

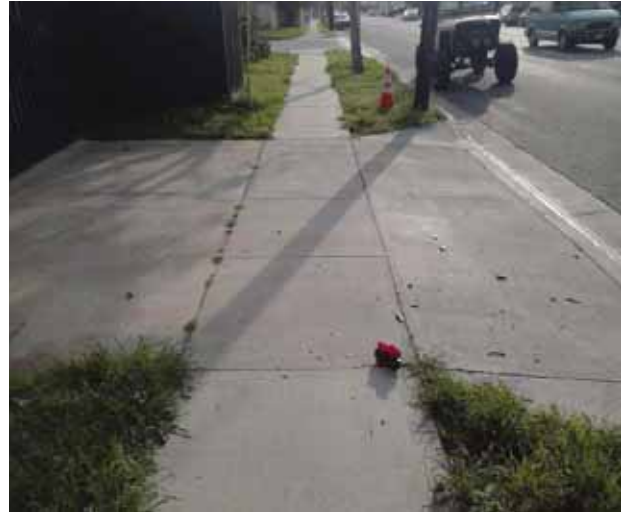
There is a change in elevation greater than recommended value.

Ensure that the change in elevation is within the recommended value.

Recommendation Up to 0.25 inches

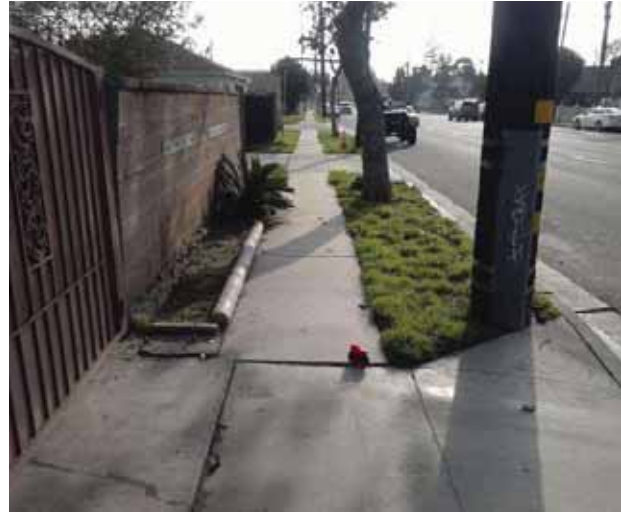
There is a change in elevation greater than recommended value.

Ensure that the change in elevation is within the recommended value.

Recommendation Up to 0.25 inches

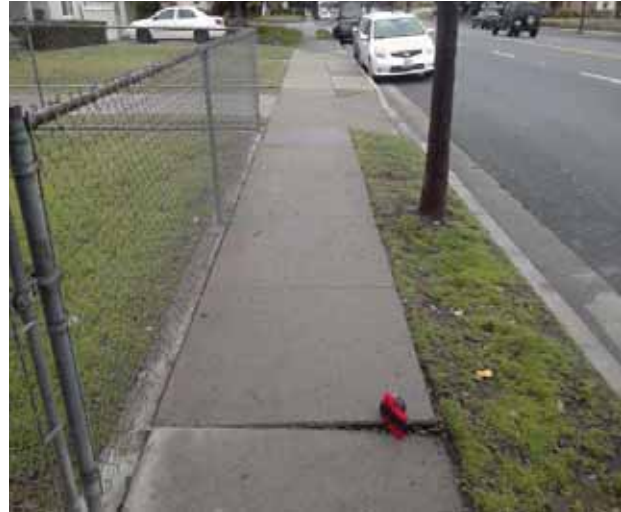
There is a change in elevation greater than recommended value.

Ensure that the change in elevation is within the recommended value.

Recommendation Up to 0.25 inches

Remove tripping hazards \$198

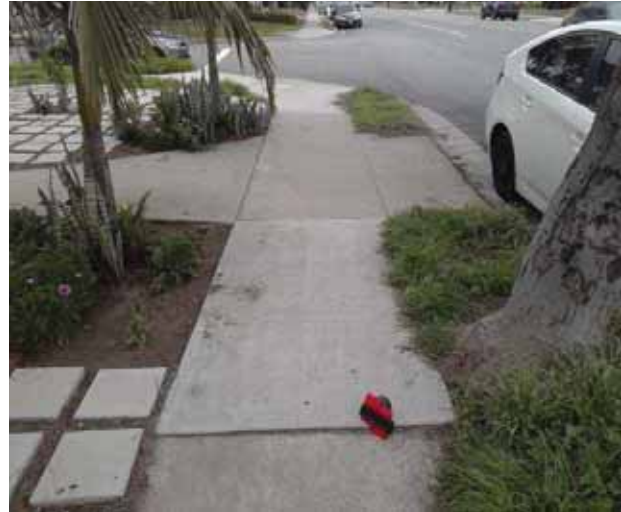
There is a change in elevation greater than recommended value.

Ensure that the change in elevation is within the recommended value.

Recommendation Up to 0.25 inches

Remove tripping hazards \$198

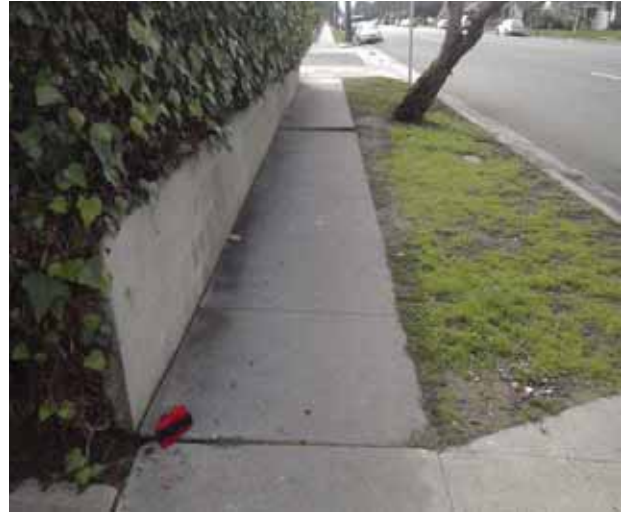
There is a change in elevation greater than recommended value.

Recommendation Up to 0.50 inches

Remove tripping hazards \$198

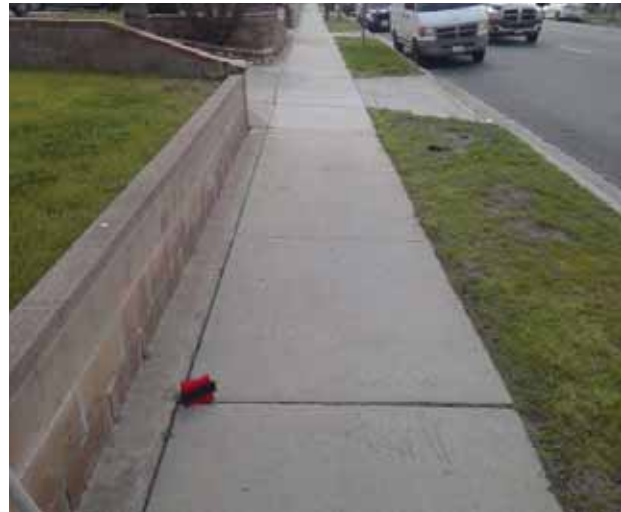
There is a change in elevation greater than recommended value.

Recommendation Up to 0.50 inches

Remove tripping hazards \$198

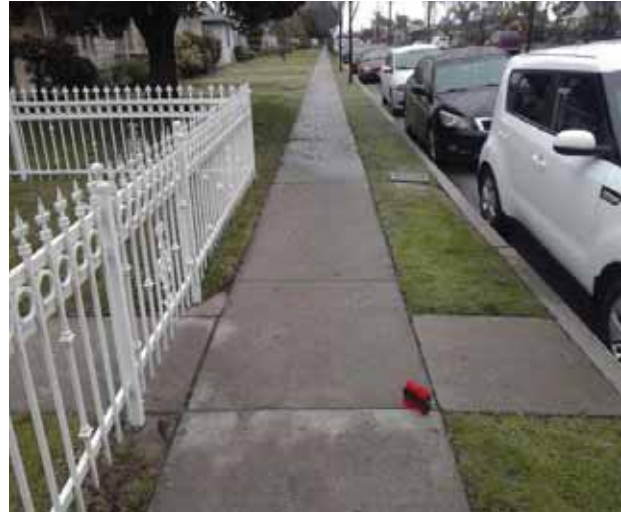
There is a change in elevation greater than recommended value.

Recommendation Up to 0.50 inches

Remove tripping hazards \$198

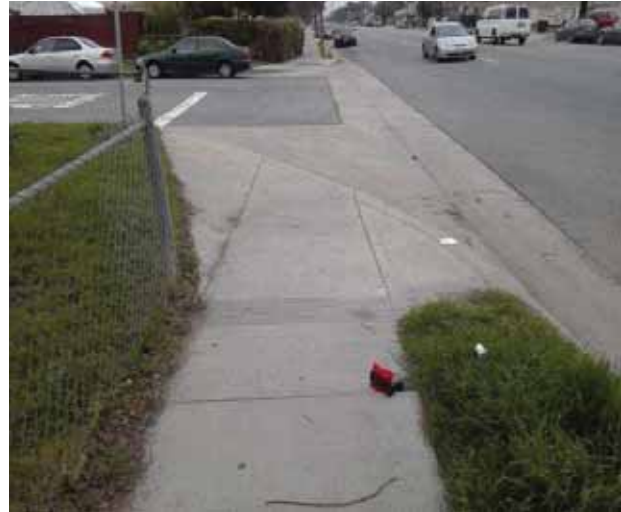
There is a change in elevation greater than recommended value.

Ensure that the change in elevation is within the recommended value.

Recommendation Up to 0.25 inches

Remove tripping hazards \$198

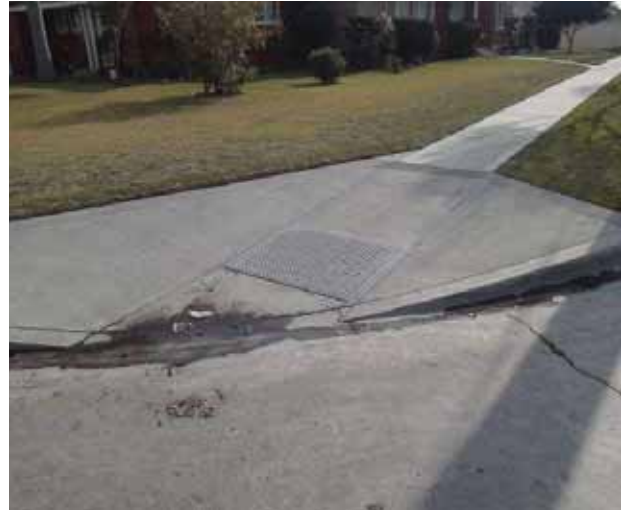
Curb Ramp , Landings and Transitions : Landing Accumulates Water - Wet Conditions

Provide compliant landing \$255

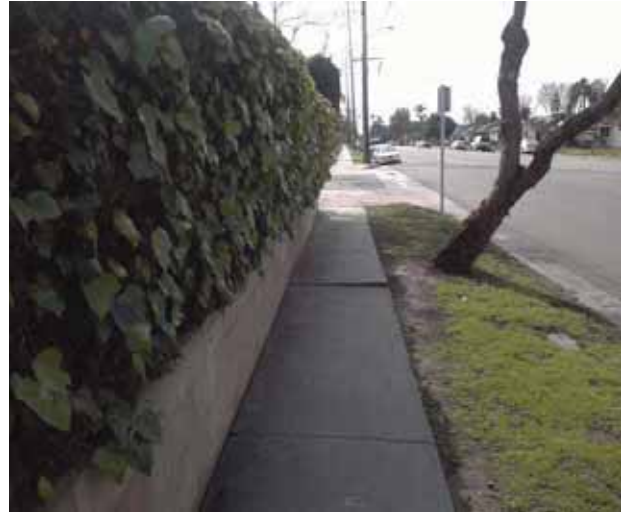
Sidewalks , Hazards & Gratings : Sidewalk Width at Obstruction

Sidewalk width at the obstruction shall have the recommended value.

Recommendation At least 48.00 inches

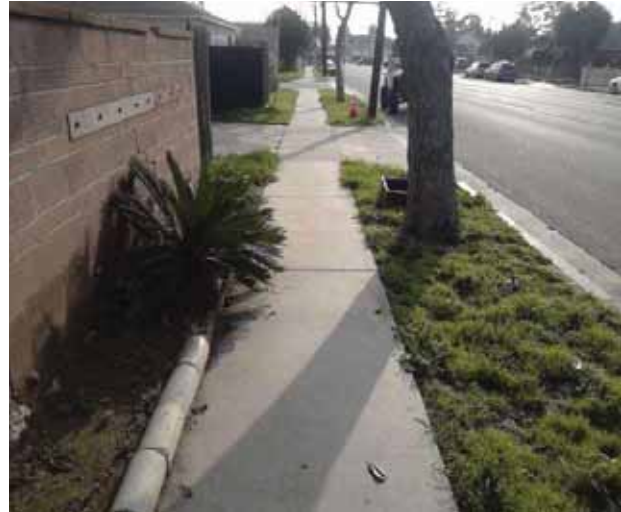
Sidewalks , Hazards & Gratings : Sidewalk Width at Obstruction

Sidewalk width at the obstruction shall have the recommended value.

Recommendation At least 48.00 inches

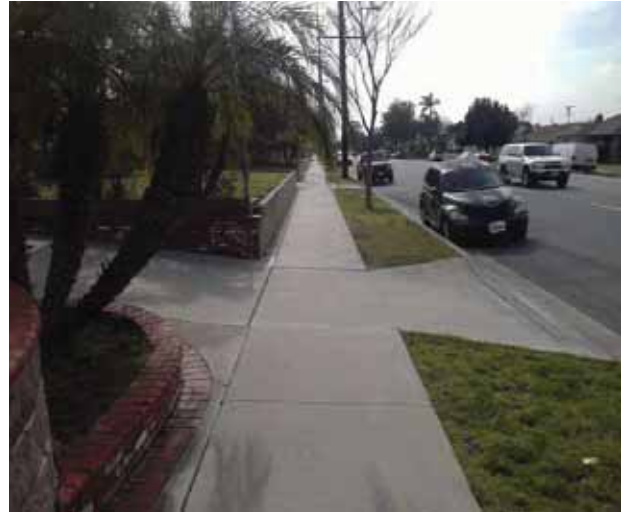
Sidewalks , Hazards & Gratings : Overhead Obstruction Height

Recommendation At least 80.00 inches

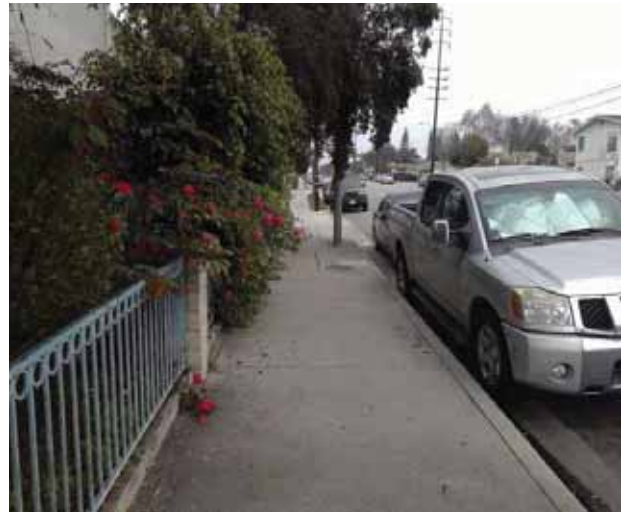
Sidewalks , Hazards & Gratings : Overhead Obstruction Height

Recommendation At least 80.00 inches

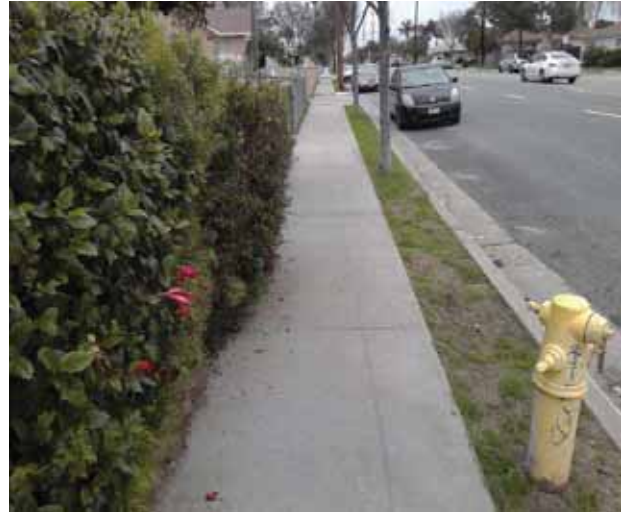
Sidewalks , Hazards & Gratings : Sidewalk Width at Obstruction

Sidewalk width at the obstruction shall have the recommended value.

Recommendation At least 48.00 inches

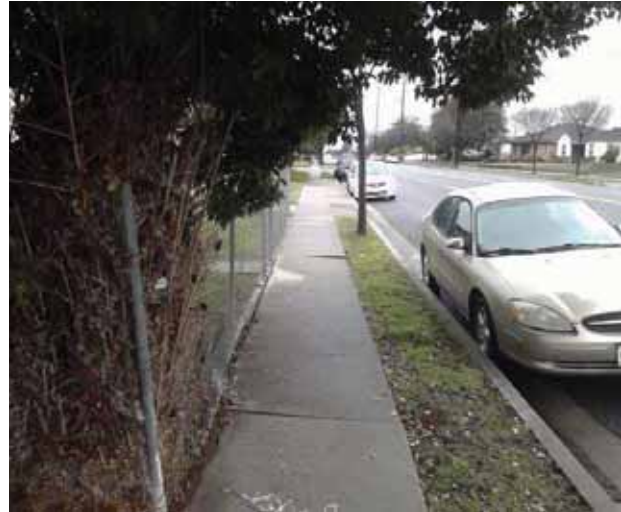
Sidewalks , Hazards & Gratings : Overhead Obstruction Height

Recommendation At least 80.00 inches

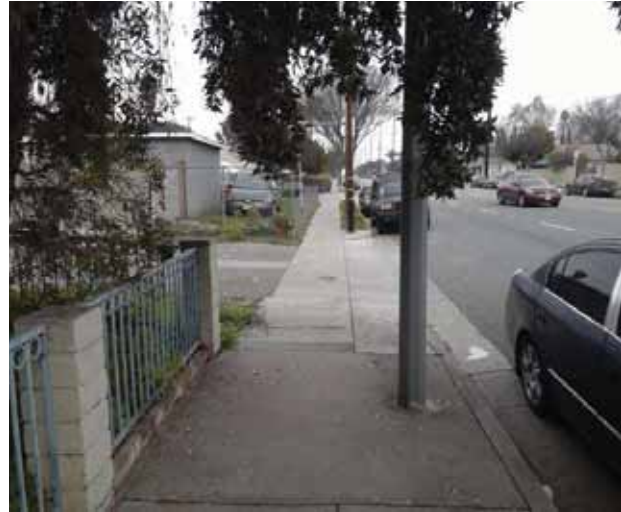
Sidewalks , Hazards & Gratings : Overhead Obstruction Height

Recommendation At least 80.00 inches

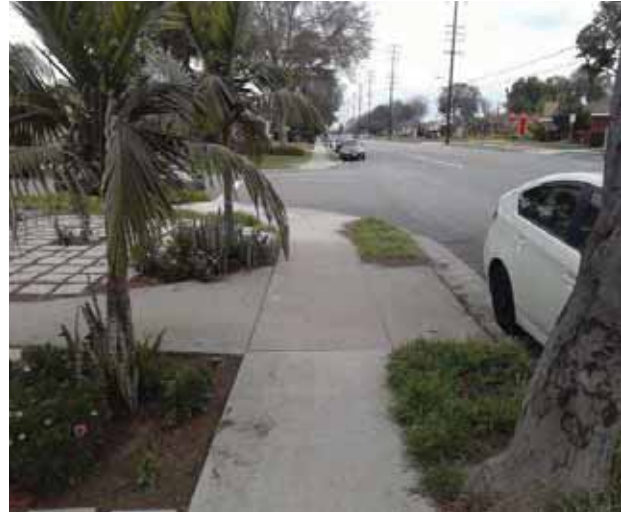
Sidewalks , Hazards & Gratings : Overhead Obstruction Height

Recommendation At least 80.00 inches

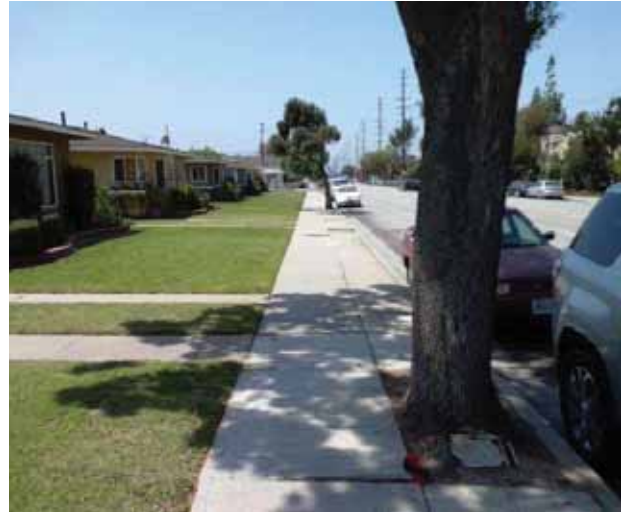
There is a change in elevation greater than recommended value.

Ensure that the change in elevation is within the recommended value.

Recommendation Up to 0.25 inches

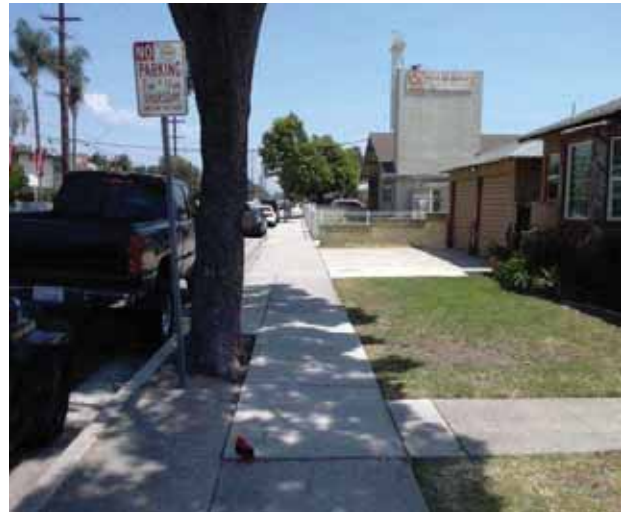
There is a change in elevation greater than recommended value.

Ensure that the change in elevation is within the recommended value.

Recommendation Up to 0.25 inches
