Accessibility Survey

City of Downey Downey Avenue & De Palma Street

Date of Inspection
1/31/2017

Prepared By
Disability Access Consultants
(800) 743-7067

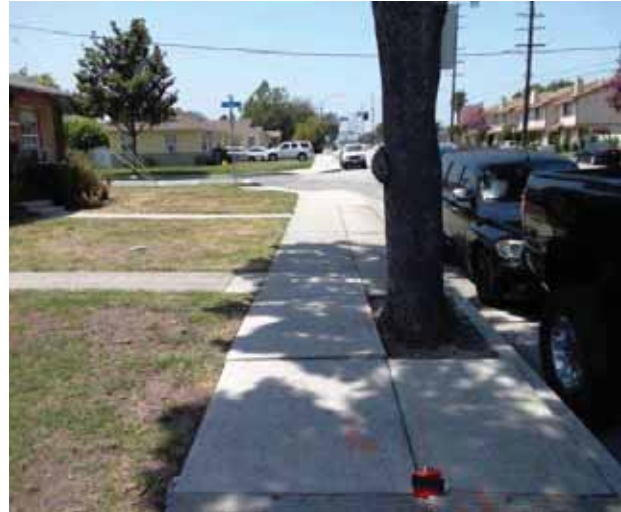
There is a change in elevation greater than recommended value.

Ensure that the change in elevation is within the recommended value.

Recommendation Up to 0.25 inches

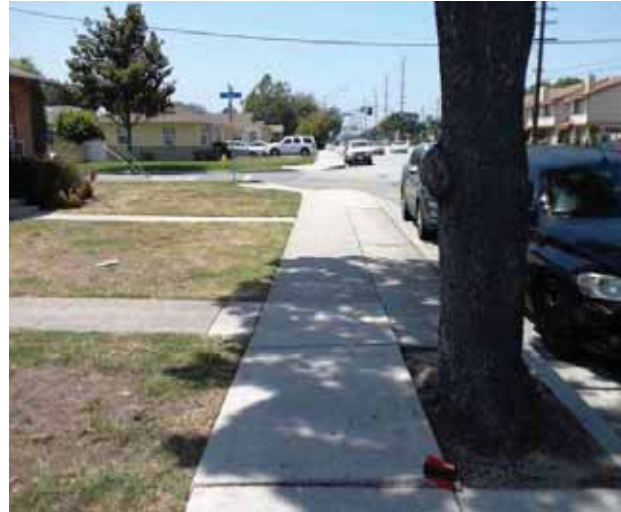
There is a change in elevation greater than recommended value.

Ensure that the change in elevation is within the recommended value.

Recommendation Up to 0.25 inches

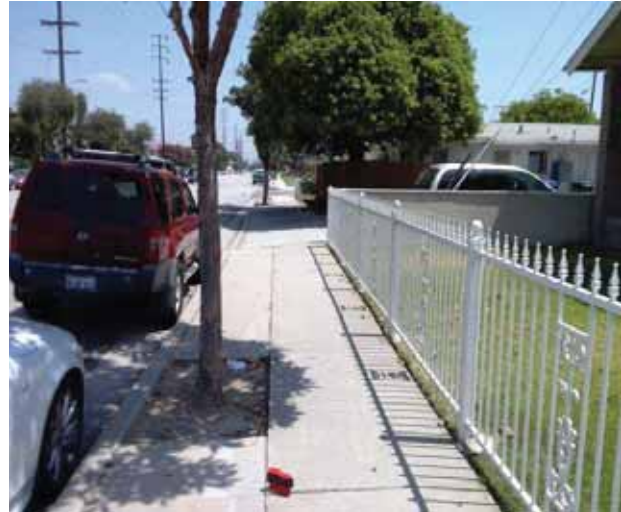
There is a change in elevation greater than recommended value.

Ensure that the change in elevation is within the recommended value.

Recommendation Up to 0.25 inches

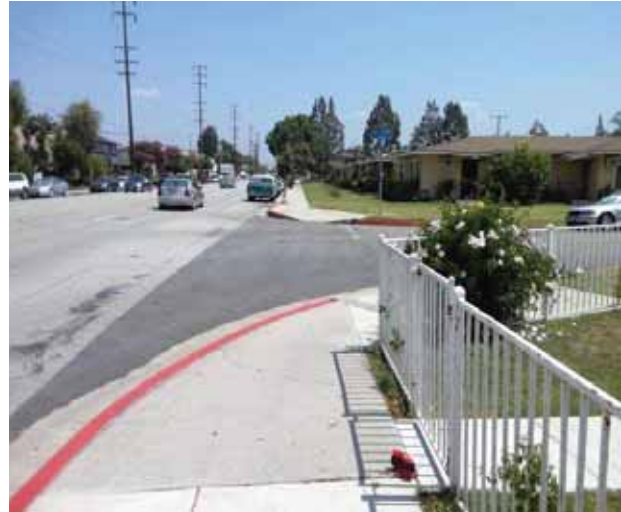
There is a change in elevation greater than recommended value.

Ensure that the change in elevation is within the recommended value.

Recommendation Up to 0.25 inches

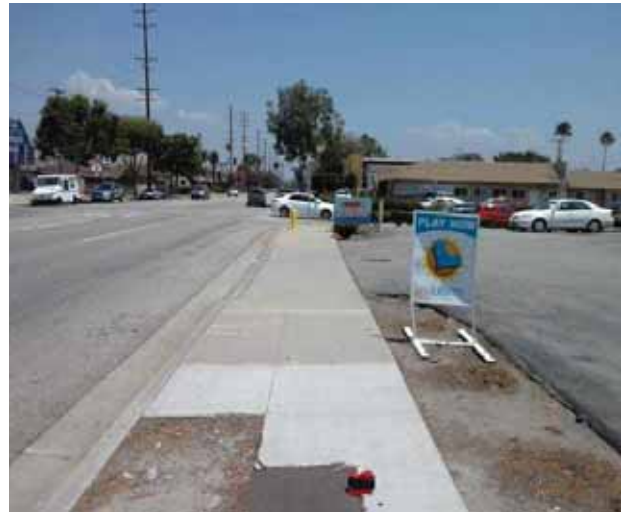
There is a change in elevation greater than recommended value.

Ensure that the change in elevation is within the recommended value.

Recommendation Up to 0.25 inches

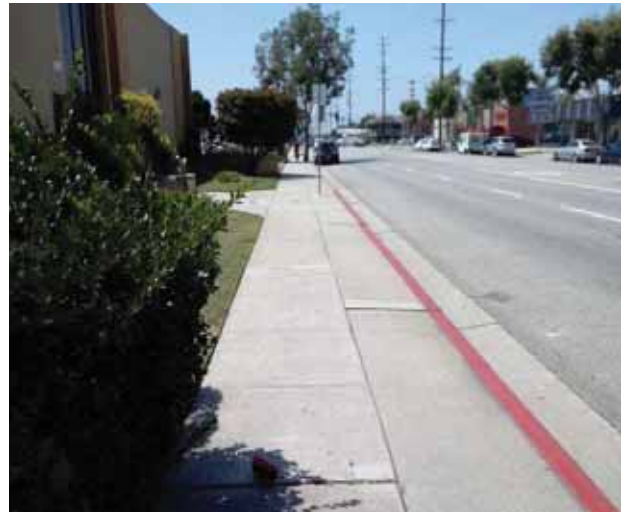
There is a change in elevation greater than recommended value.

Ensure that the change in elevation is within the recommended value.

Recommendation Up to 0.25 inches

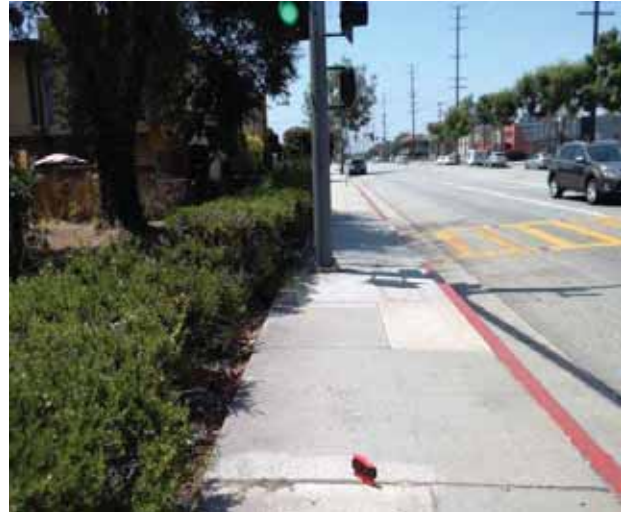
There is a change in elevation greater than recommended value.

Ensure that the change in elevation is within the recommended value.

Remove tripping hazards \$198

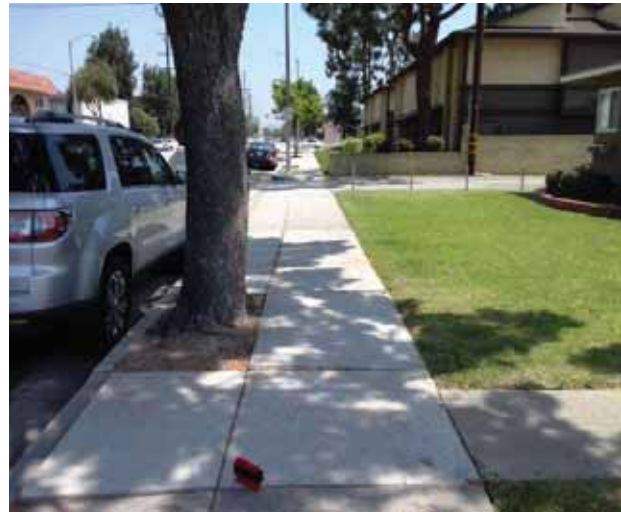
There is a change in elevation greater than recommended value.

Ensure that the change in elevation is within the recommended value.

Remove tripping hazards \$198

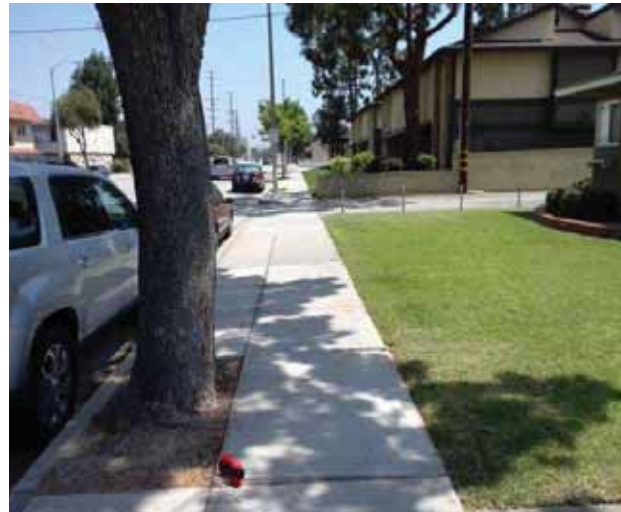
There is a change in elevation greater than recommended value.

Ensure that the change in elevation is within the recommended value.

Remove tripping hazards \$198

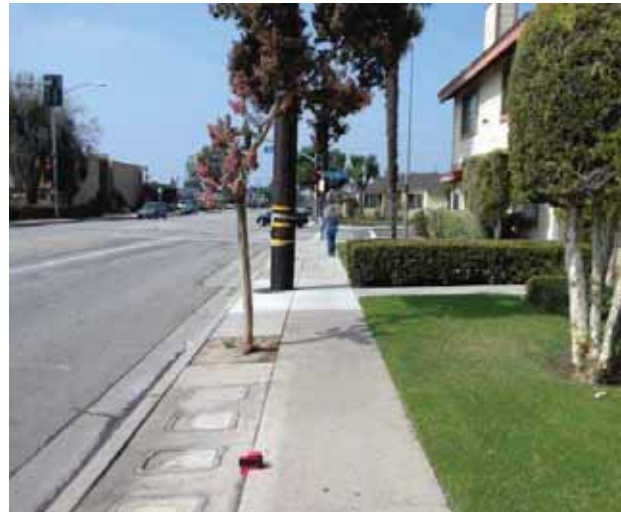
There is a change in elevation greater than recommended value.

Ensure that the change in elevation is within the recommended value.

Remove tripping hazards \$198

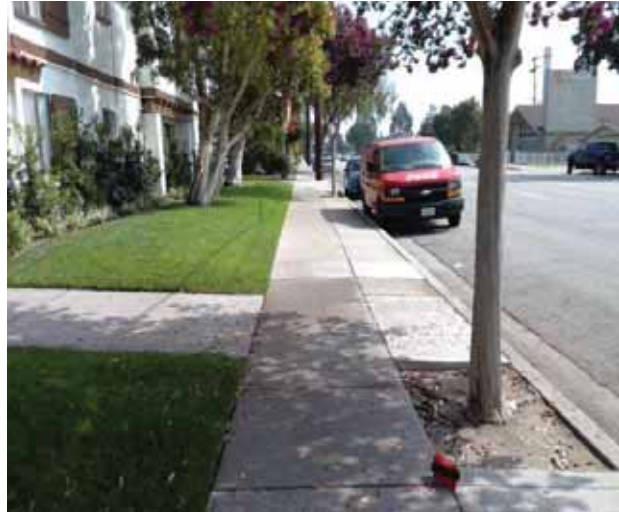
There is a change in elevation greater than recommended value.

Ensure that the change in elevation is within the recommended value.

Remove tripping hazards \$198

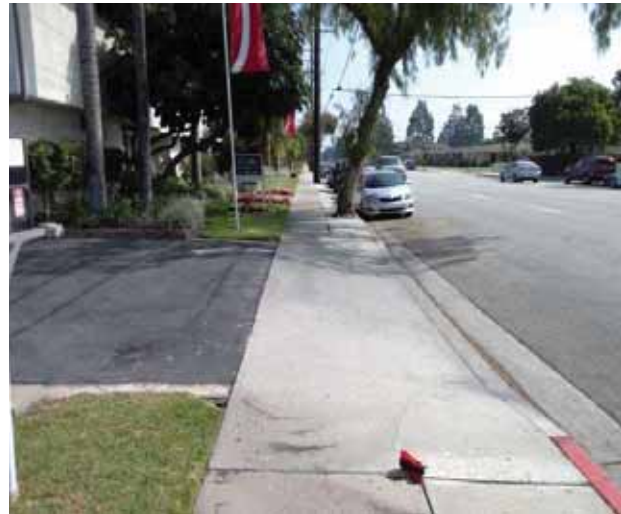
There is a change in elevation greater than recommended value.

Ensure that the change in elevation is within the recommended value.

Remove tripping hazards \$198

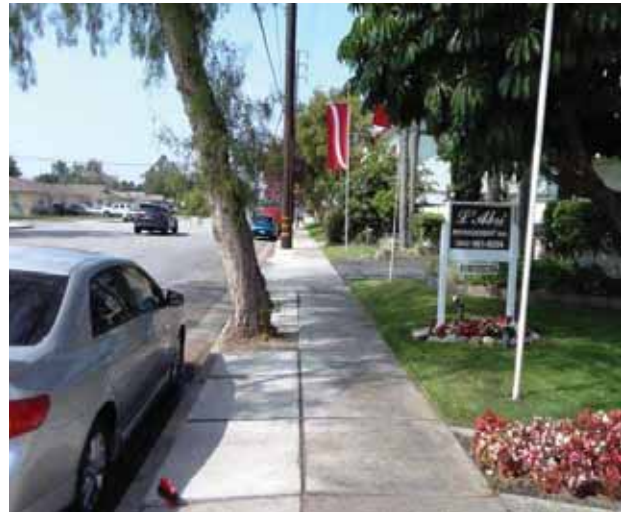
There is a change in elevation greater than recommended value.

Ensure that the change in elevation is within the recommended value.

Remove tripping hazards \$198

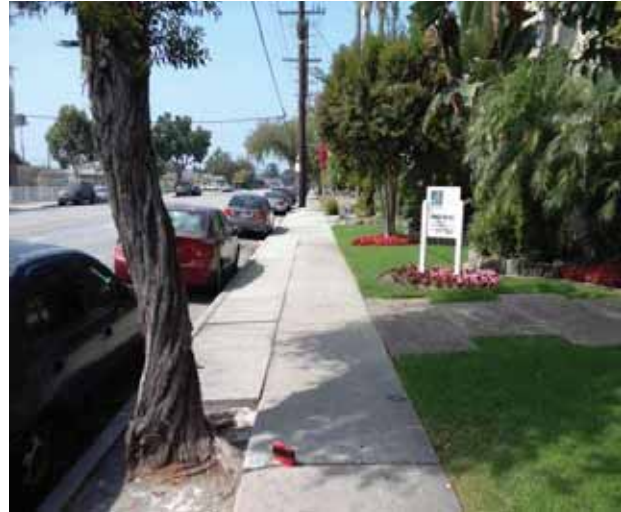
There is a change in elevation greater than recommended value.

Ensure that the change in elevation is within the recommended value.

Remove tripping hazards \$198

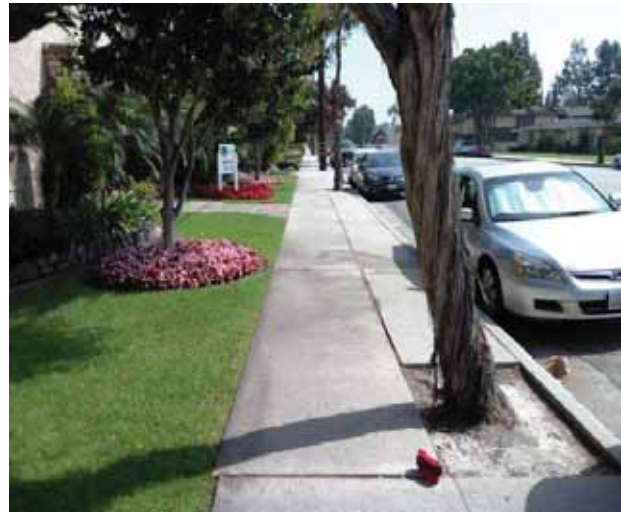
There is a change in elevation greater than recommended value.

Ensure that the change in elevation is within the recommended value.

Remove tripping hazards \$198

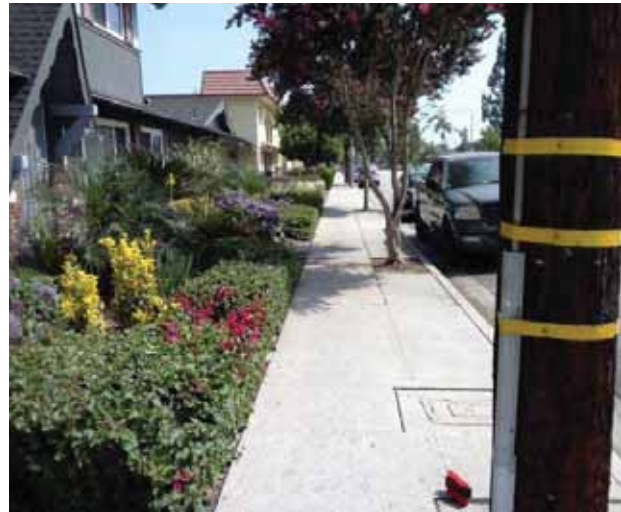
There is a change in elevation greater than recommended value.

Ensure that the change in elevation is within the recommended value.

Remove tripping hazards \$198

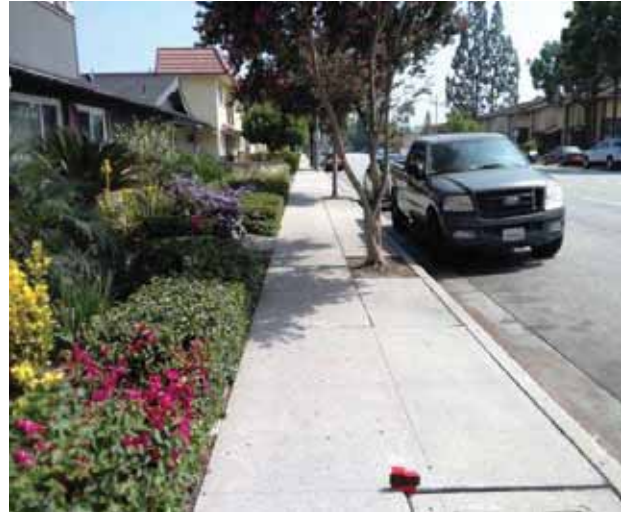
There is a change in elevation greater than recommended value.

Ensure that the change in elevation is within the recommended value.

Remove tripping hazards \$198

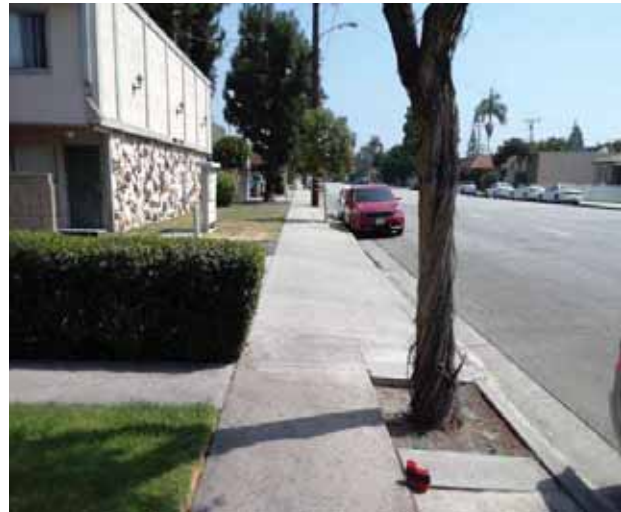
There is a change in elevation greater than recommended value.

Ensure that the change in elevation is within the recommended value.

Remove tripping hazards \$198

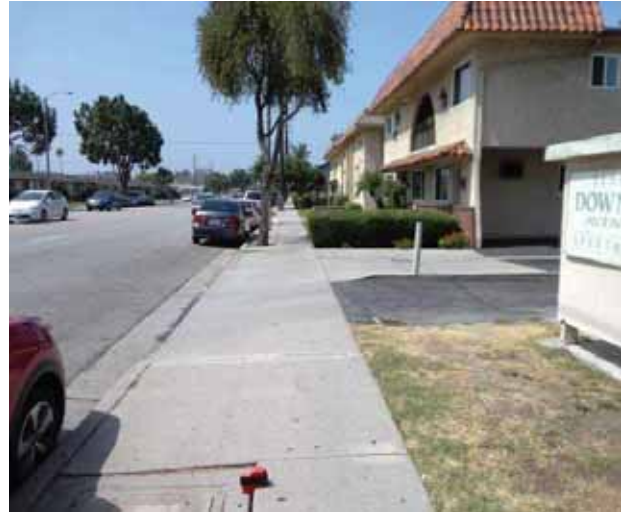
There is a change in elevation greater than recommended value.

Ensure that the change in elevation is within the recommended value.

Remove tripping hazards \$198

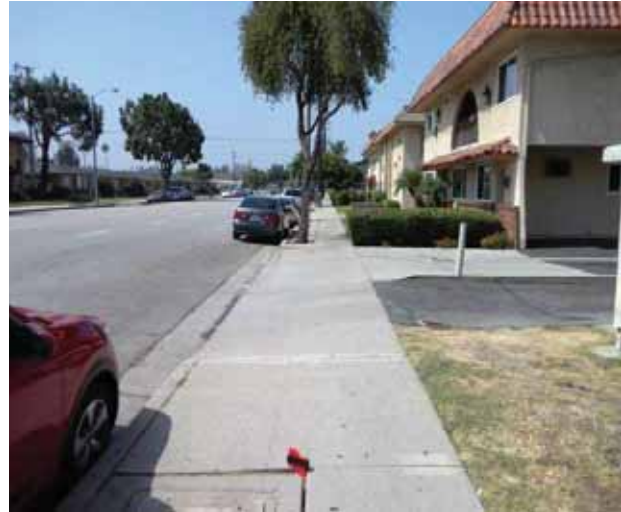
There is a change in elevation greater than recommended value.

Ensure that the change in elevation is within the recommended value.

Remove tripping hazards \$198

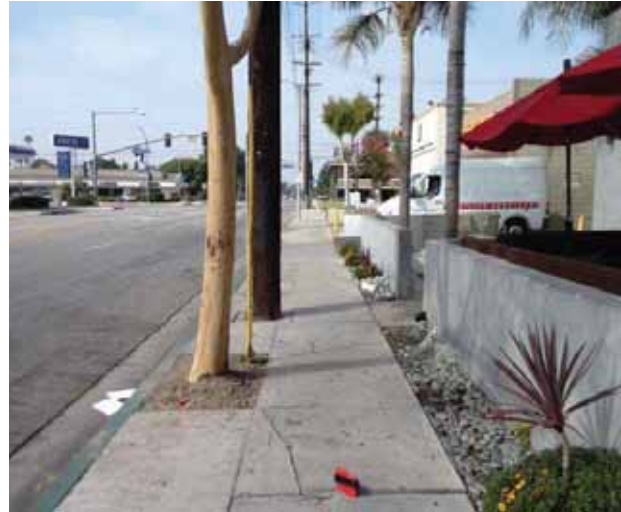
There is a change in elevation greater than recommended value.

Ensure that the change in elevation is within the recommended value.

Remove tripping hazards \$198

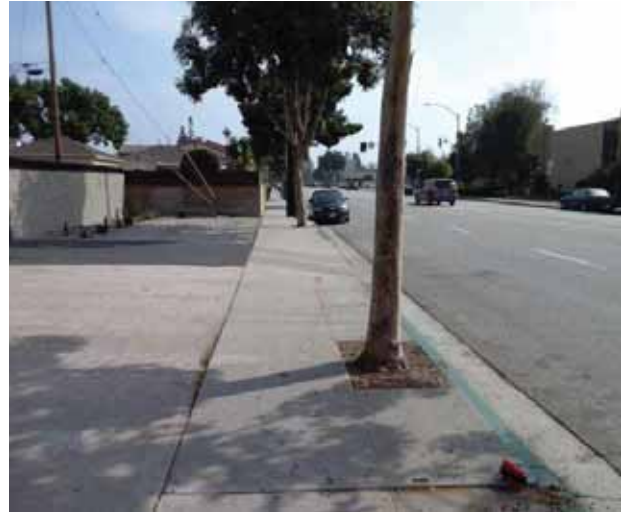
There is a change in elevation greater than recommended value.

Ensure that the change in elevation is within the recommended value.

Remove tripping hazards \$198

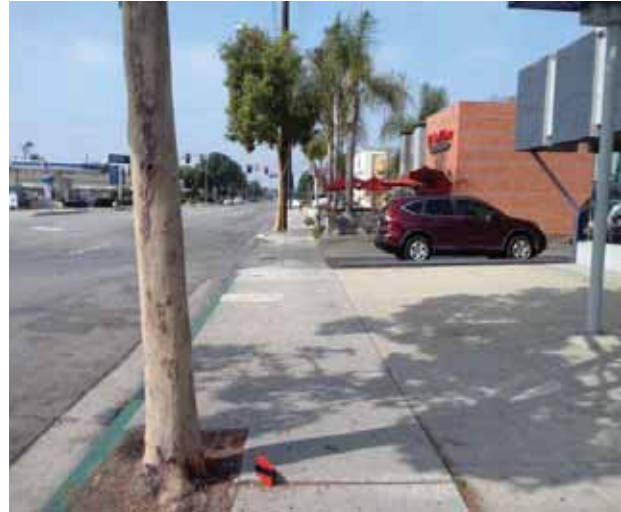
There is a change in elevation greater than recommended value.

Ensure that the change in elevation is within the recommended value.

Remove tripping hazards \$198

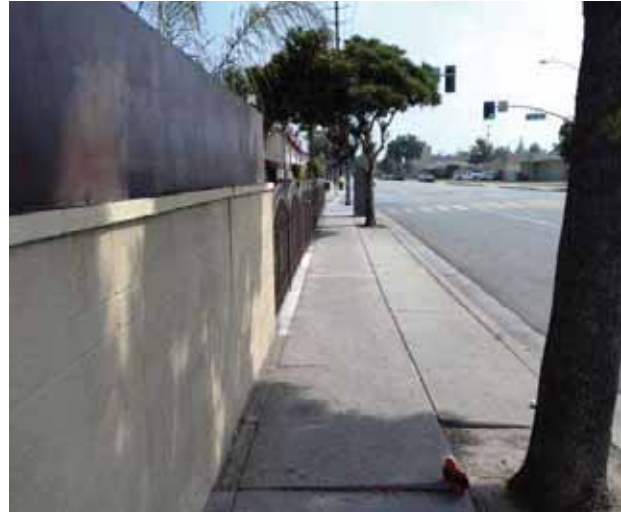
There is a change in elevation greater than recommended value.

Ensure that the change in elevation is within the recommended value.

Remove tripping hazards \$198

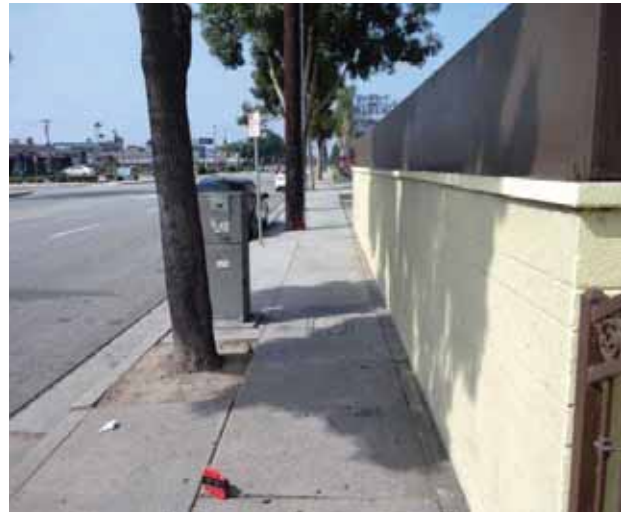
There is a change in elevation greater than recommended value.

Ensure that the change in elevation is within the recommended value.

Remove tripping hazards \$198

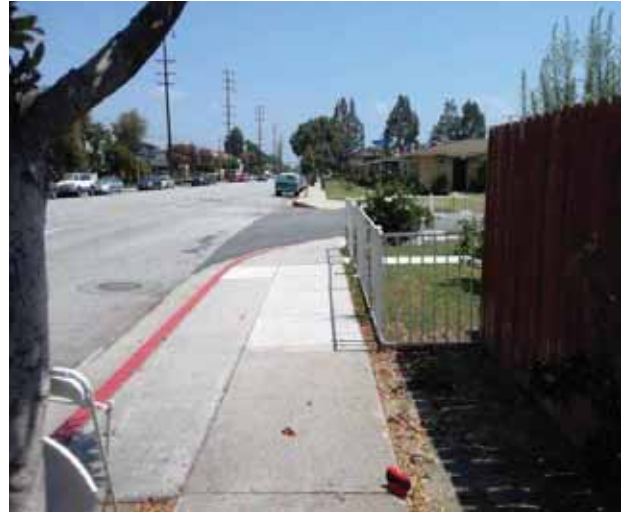
There is a change in elevation greater than recommended value.

Ensure that the change in elevation is within the recommended value.

Remove tripping hazards \$198

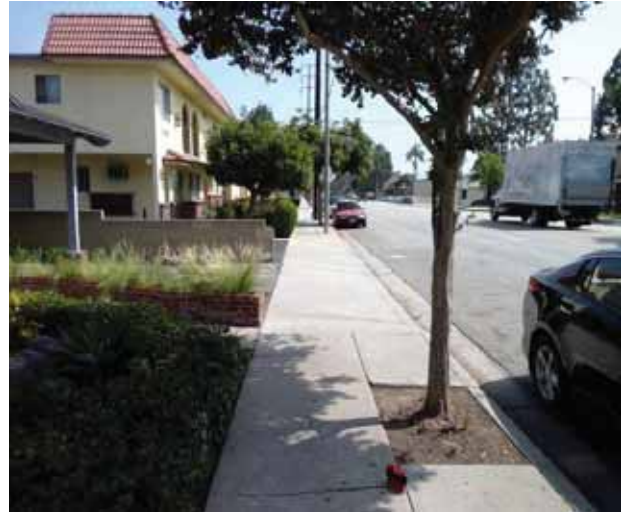
There is a change in elevation greater than recommended value.

Ensure that the change in elevation is within the recommended value.

Remove tripping hazards \$198

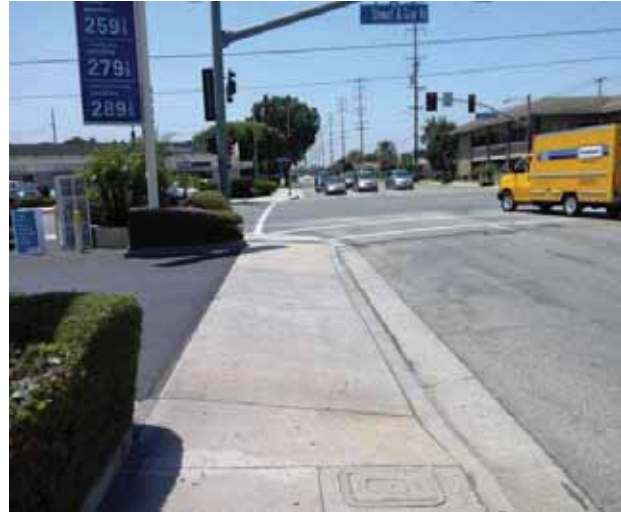
Code Reference ADA 705,CA 11B-705.1.2.5,CA 11B-247.1.2.5

Install compliant detectable warnings \$190

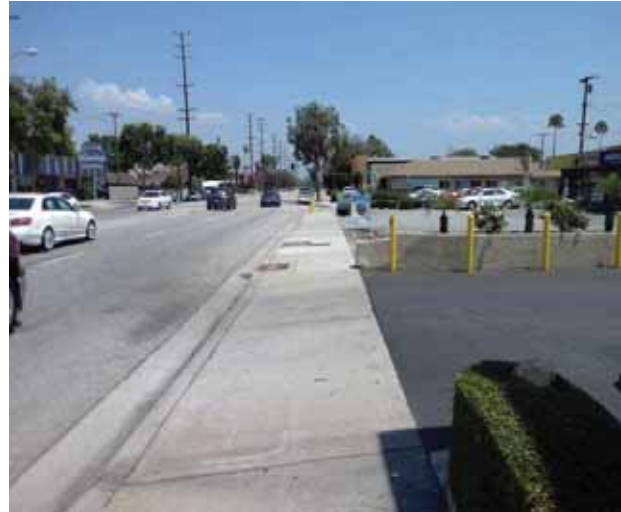
Code Reference ADA 705,CA 11B-705.1.2.5,CA 11B-247.1.2.5

Install compliant detectable warnings \$190

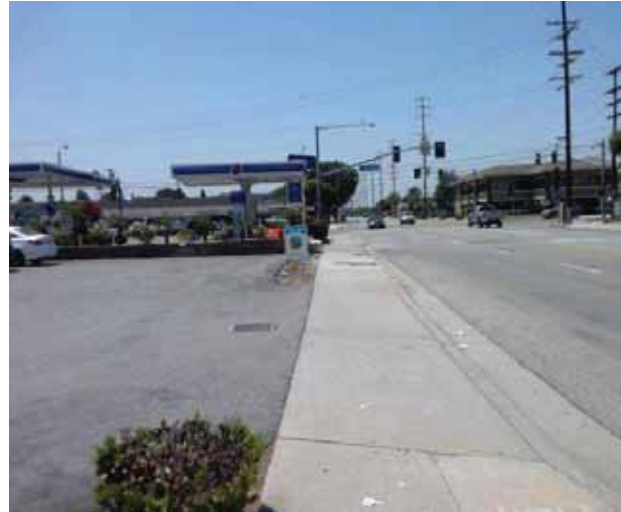
Code Reference ADA 705,CA 11B-705.1.2.5,CA 11B-247.1.2.5

Install compliant detectable warnings \$190

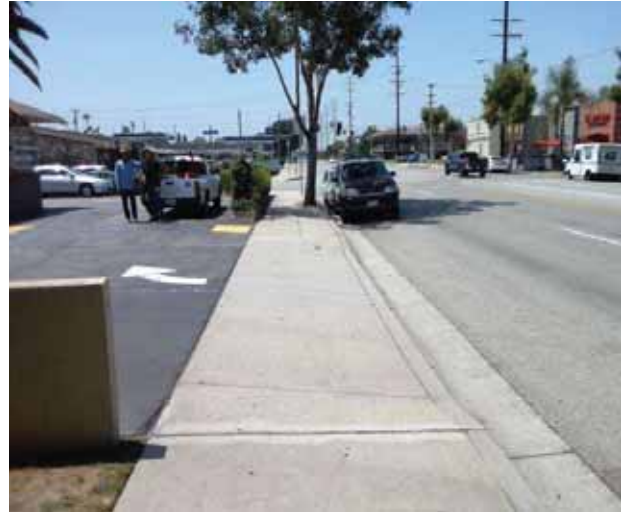
Code Reference ADA 705,CA 11B-705.1.2.5,CA 11B-247.1.2.5

Install compliant detectable warnings \$190

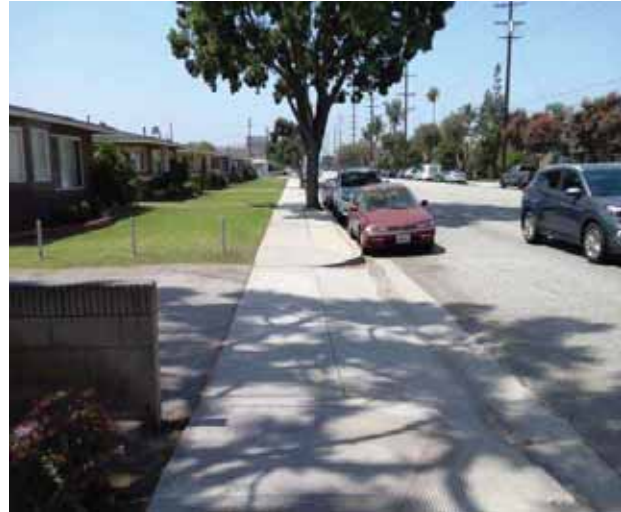
Code Reference ADA 705,CA 11B-705.1.2.5,CA 11B-247.1.2.5

Install compliant detectable warnings \$190

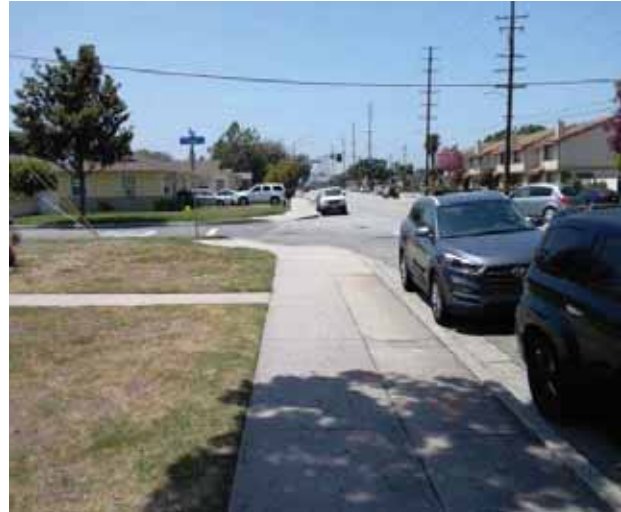
Recommendation Up to 2.08 percent

Repave the sidewalk surface with the recommended cross slope.

Repave surface \$1,092

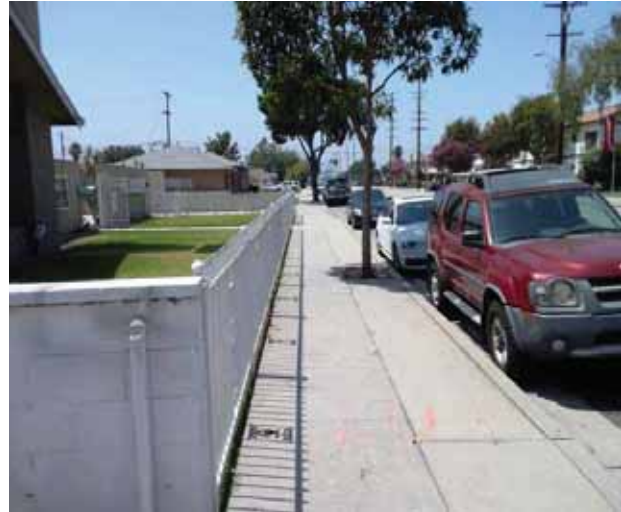
Recommendation Up to 2.08 percent

Repave the sidewalk surface with the recommended cross slope.

Repave surface \$1,092

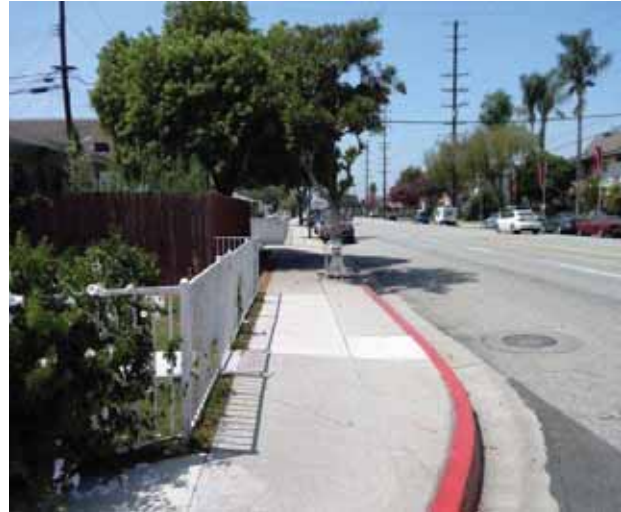
Recommendation Up to 2.08 percent

Repave the sidewalk surface with the recommended cross slope.

Repave surface \$1,092

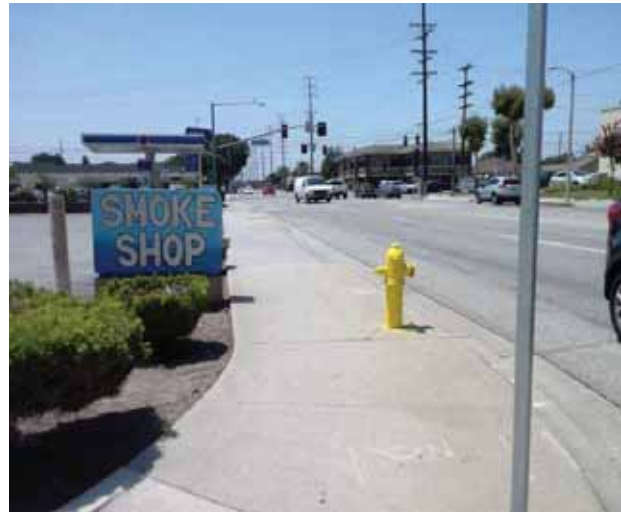
Recommendation Up to 2.08 percent

Repave the sidewalk surface with the recommended cross slope.

Repave surface \$1,092

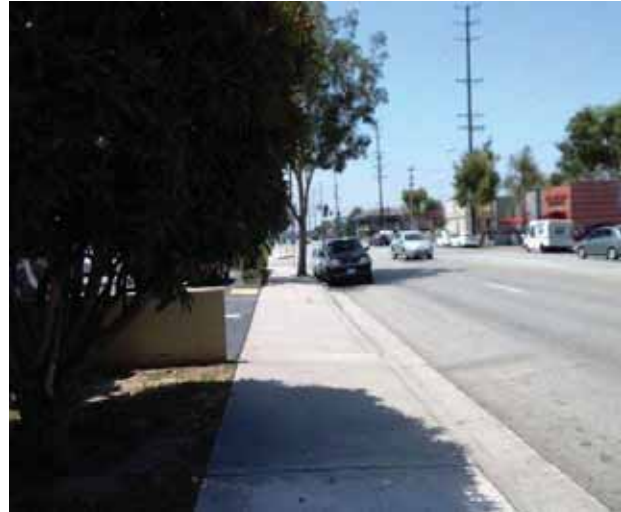
Recommendation Up to 2.08 percent

Repave the sidewalk surface with the recommended cross slope.

Repave surface \$1,092

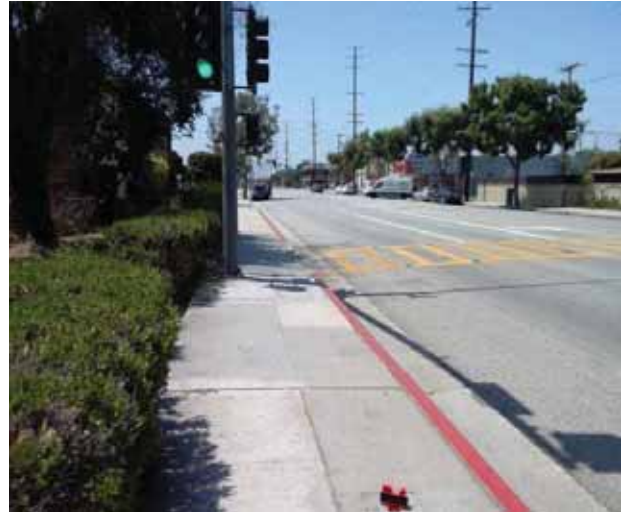
Recommendation Up to 2.08 percent

Repave the sidewalk surface with the recommended cross slope.

Repave surface \$1,092

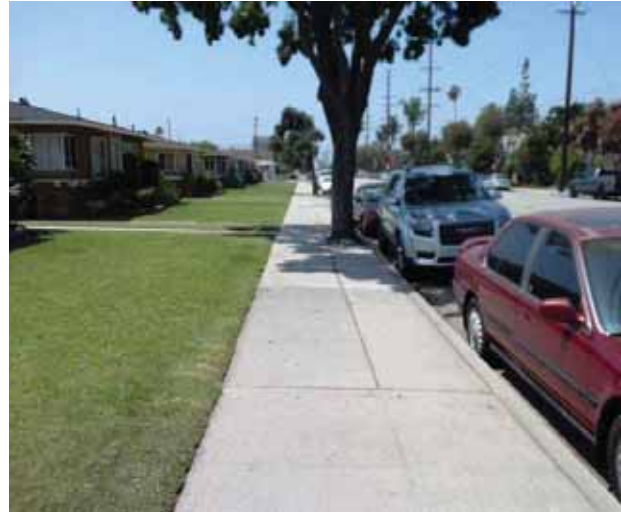
Recommendation Up to 2.08 percent

Repave the sidewalk surface with the recommended cross slope.

Repave surface \$1,092

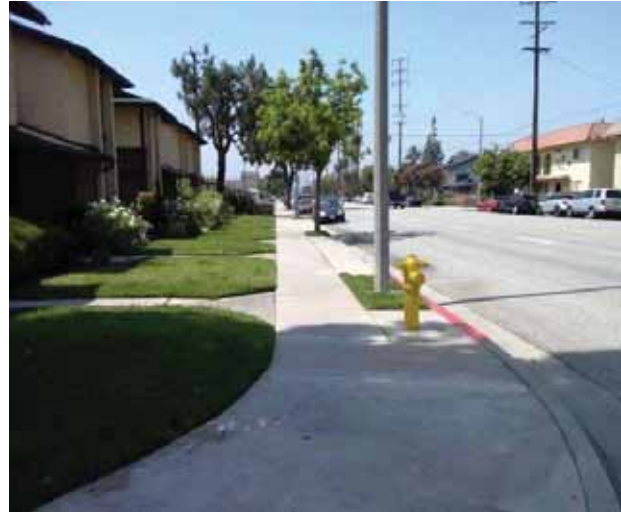
Recommendation Up to 2.08 percent

Repave the sidewalk surface with the recommended cross slope.

Repave surface \$1,092

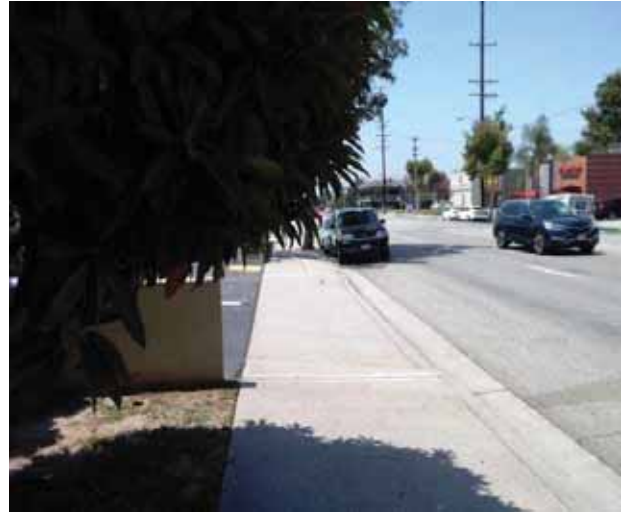
Sidewalks , Hazards & Gratings : Overhead Obstruction Height

Recommendation At least 80.00 inches

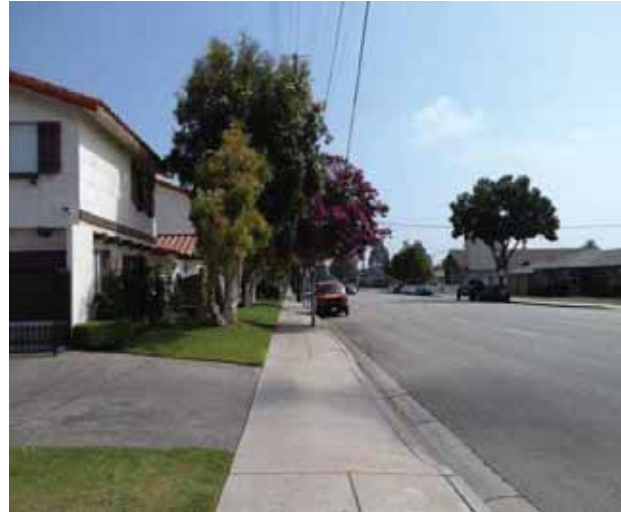
Code Reference ADA 705,CA 11B-705.1.2.5,CA 11B-247.1.2.5

Install compliant detectable warnings \$190

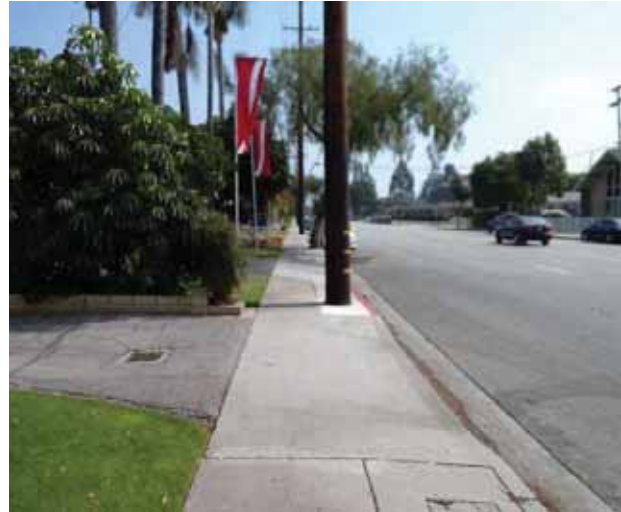
Code Reference ADA 705,CA 11B-705.1.2.5,CA 11B-247.1.2.5

Install compliant detectable warnings \$190

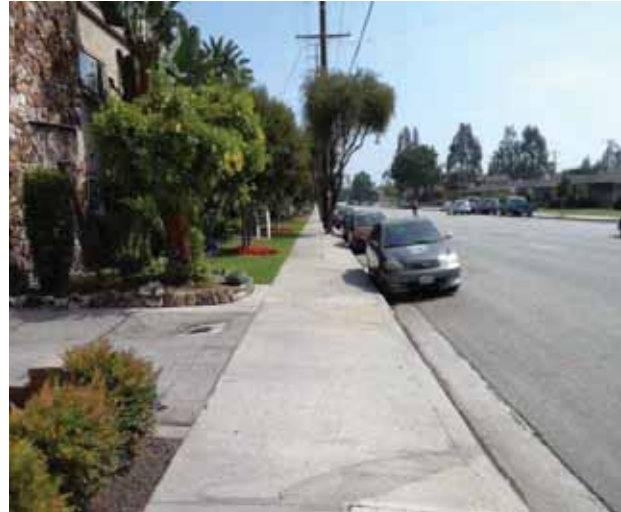
Code Reference ADA 705,CA 11B-705.1.2.5,CA 11B-247.1.2.5

Install compliant detectable warnings \$190

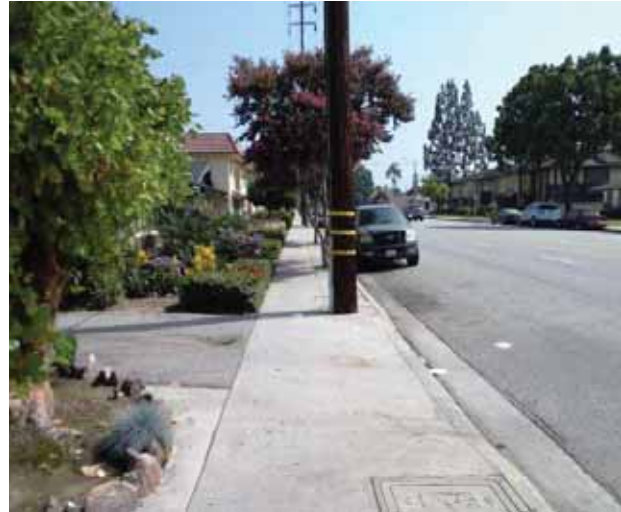
Recommendation Up to 2.08 percent

Repave surface \$1,092

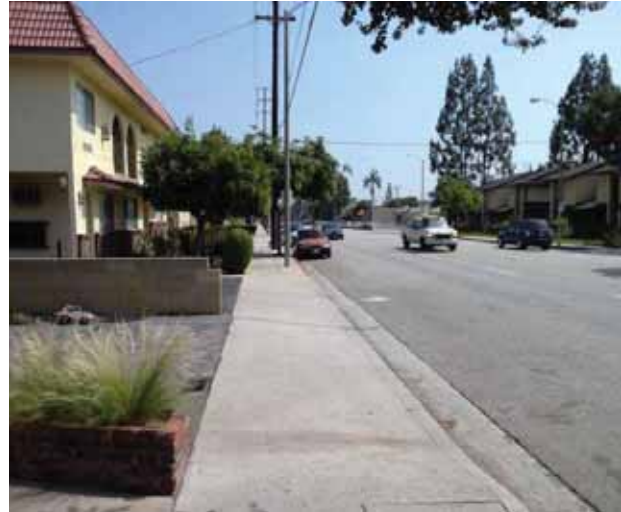
Code Reference ADA 705,CA 11B-705.1.2.5,CA 11B-247.1.2.5

Install compliant detectable warnings \$190

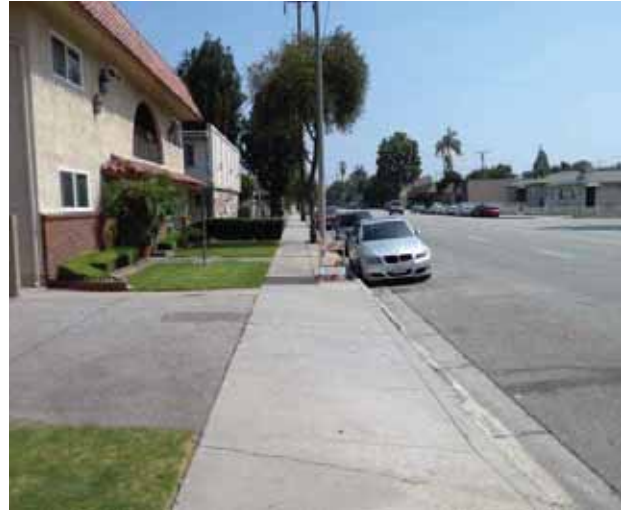
Code Reference ADA 705,CA 11B-705.1.2.5,CA 11B-247.1.2.5

Install compliant detectable warnings \$190

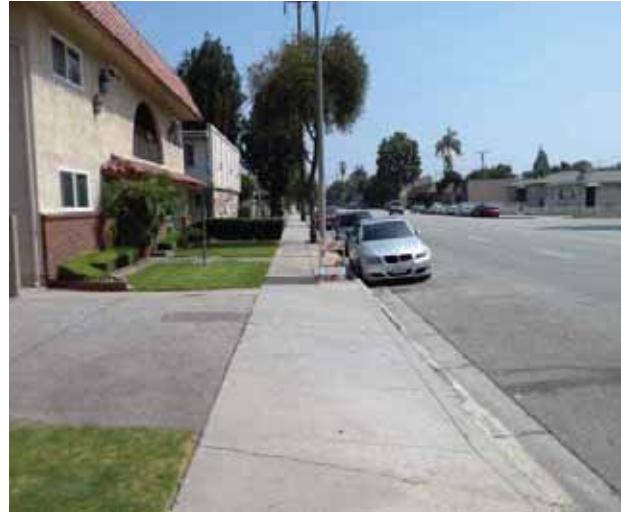
Recommendation Up to 2.08 percent

Repave surface \$1,092

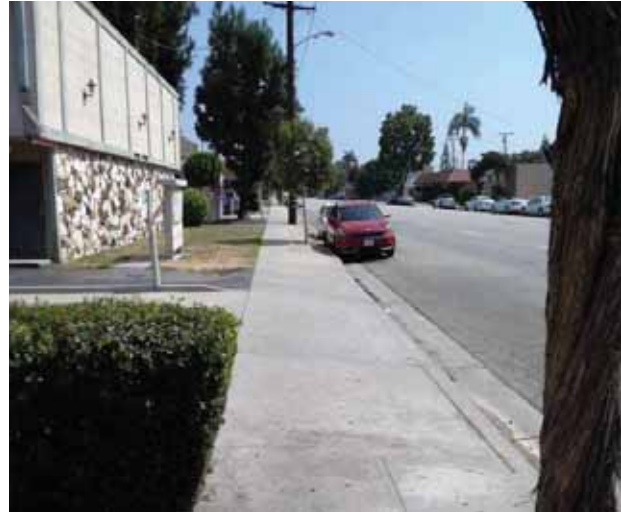
Code Reference ADA 705,CA 11B-705.1.2.5,CA 11B-247.1.2.5

Install compliant detectable warnings \$190

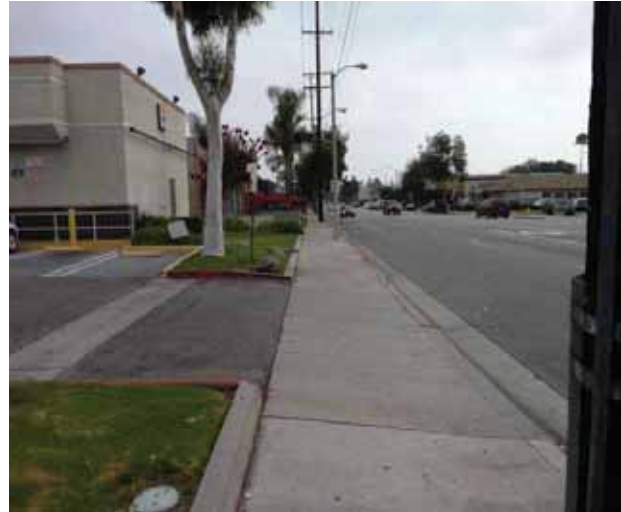
Code Reference ADA 705,CA 11B-705.1.2.5,CA 11B-247.1.2.5

Install compliant detectable warnings \$190

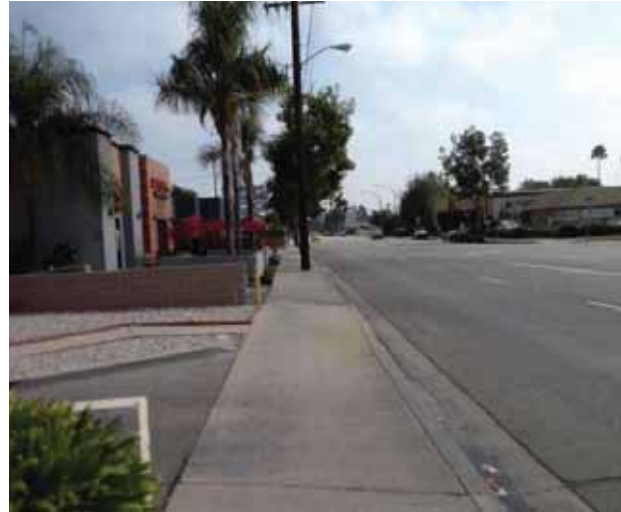
Code Reference ADA 705,CA 11B-705.1.2.5,CA 11B-247.1.2.5

Install compliant detectable warnings \$190

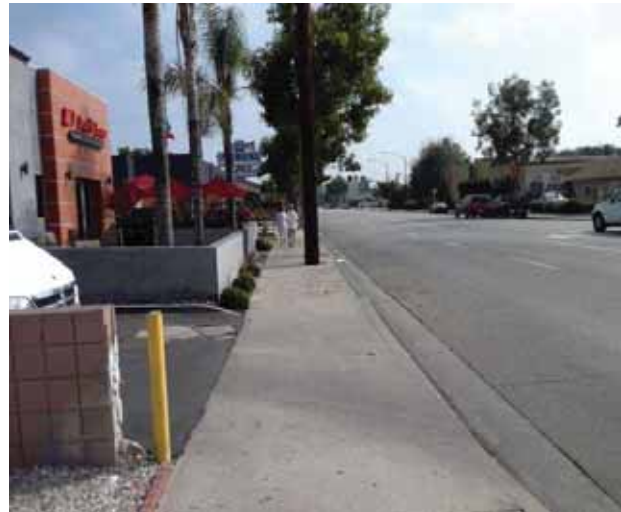
Code Reference ADA 705,CA 11B-705.1.2.5,CA 11B-247.1.2.5

Install compliant detectable warnings \$190

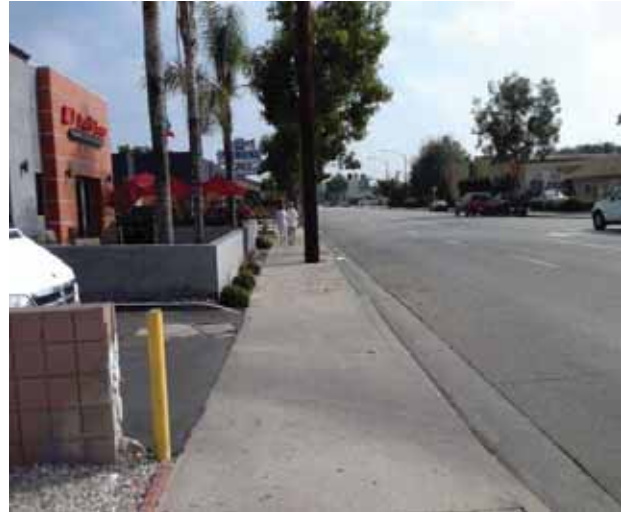
Recommendation Up to 2.08 percent

Repave surface \$1,092

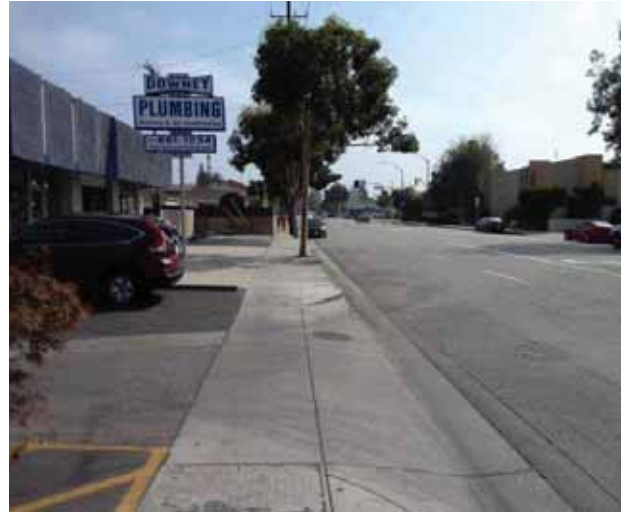
Code Reference ADA 705,CA 11B-705.1.2.5,CA 11B-247.1.2.5

Install compliant detectable warnings \$190

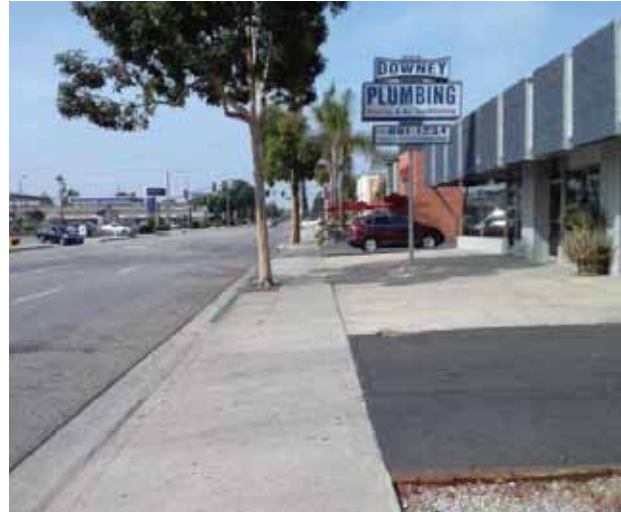
Code Reference ADA 705,CA 11B-705.1.2.5,CA 11B-247.1.2.5

Install compliant detectable warnings \$190

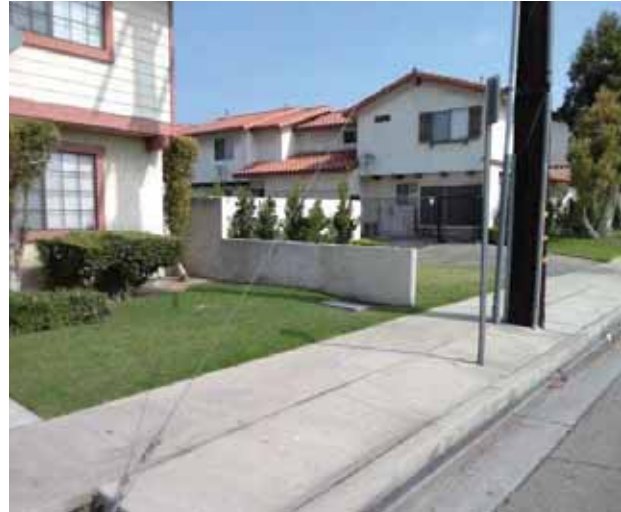
Sidewalks , Hazards & Gratings : Overhead Obstruction Height

Recommendation At least 80.00 inches

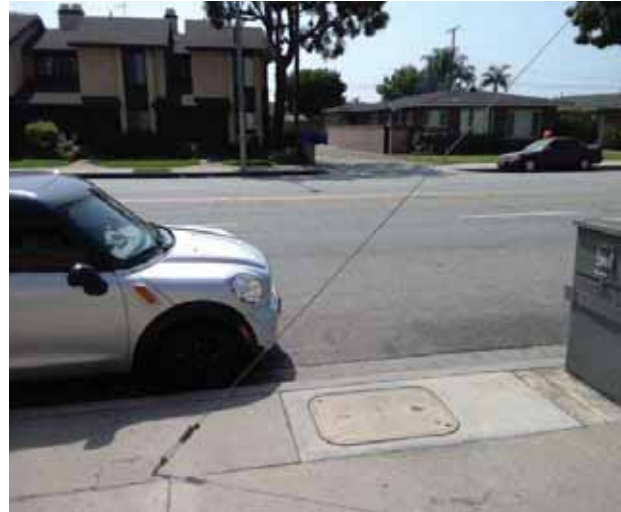
Sidewalks , Hazards & Gratings : Overhead Obstruction Height

Recommendation At least 80.00 inches

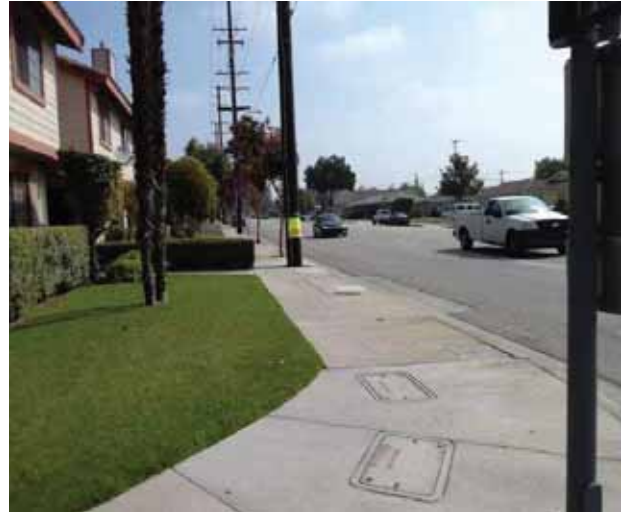
Recommendation Up to 2.08 percent

Repave the sidewalk surface with the recommended cross slope.

Repave surface \$1,092

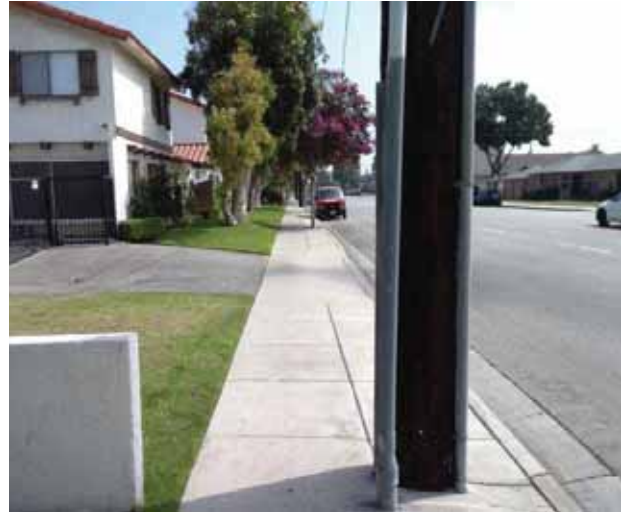
Recommendation Up to 2.08 percent

Repave the sidewalk surface with the recommended cross slope.

Repave surface \$1,092

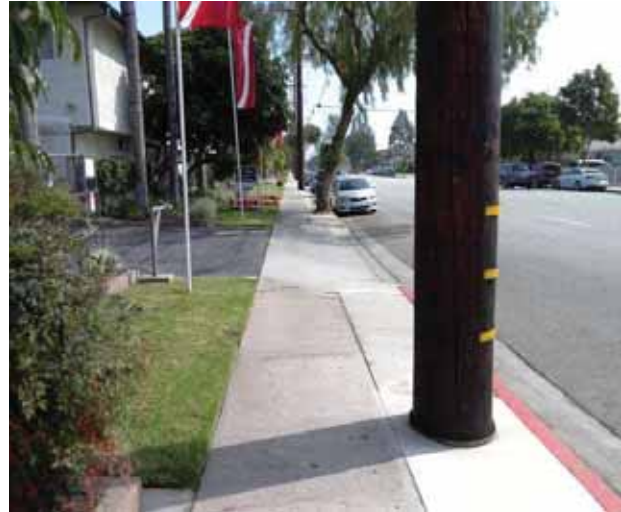
Recommendation Up to 2.08 percent

Repave the sidewalk surface with the recommended cross slope.

Repave surface \$1,092

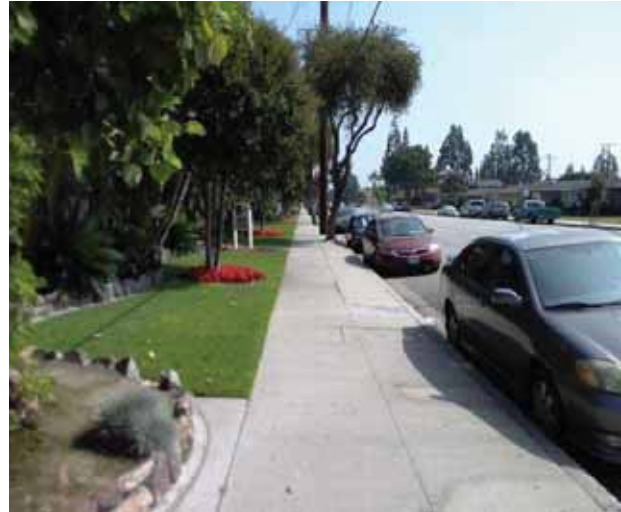
Recommendation Up to 2.08 percent

Repave the sidewalk surface with the recommended cross slope.

Repave surface \$1,092

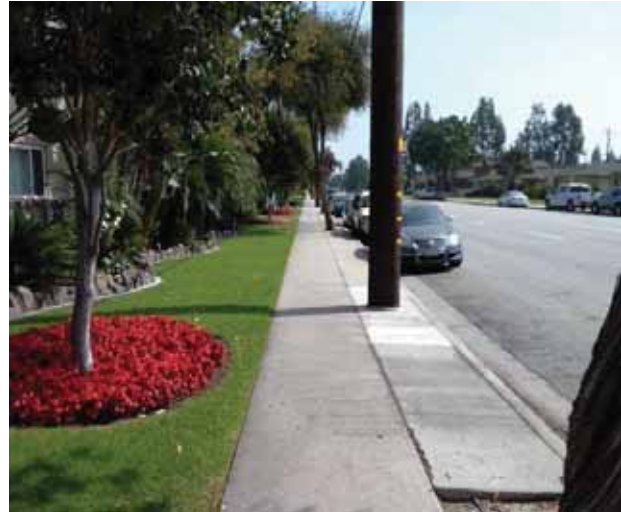
Recommendation Up to 2.08 percent

Repave the sidewalk surface with the recommended cross slope.

Repave surface \$1,092

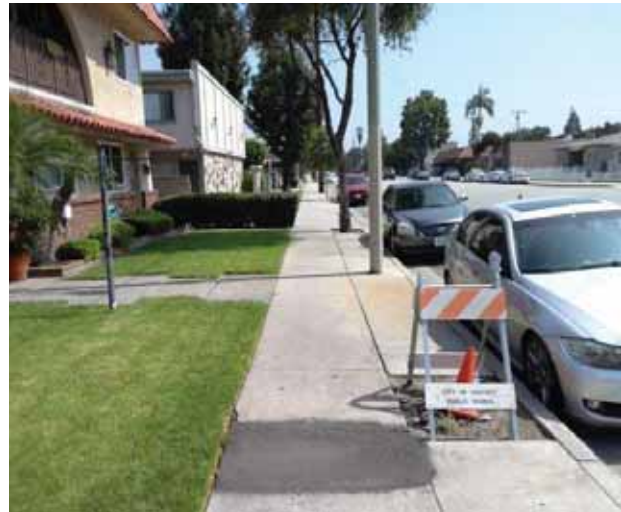
Recommendation Up to 2.08 percent

Repave the sidewalk surface with the recommended cross slope.

Repave surface \$1,092

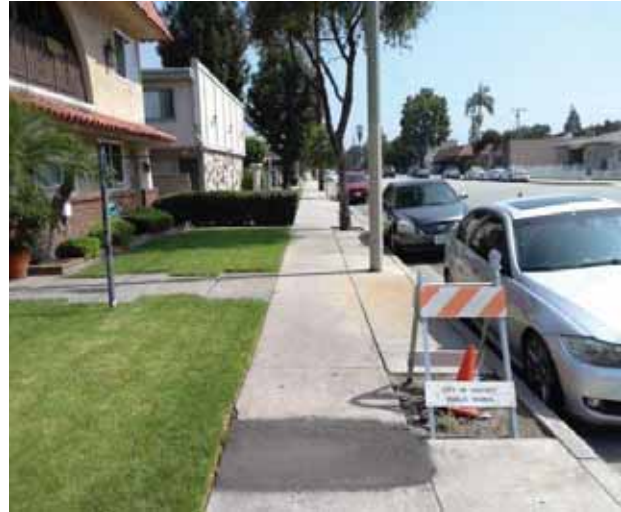
Recommendation Up to 5.00 percent

Repave the sidewalk surface with the recommended running slope.

Repave surface \$1,184

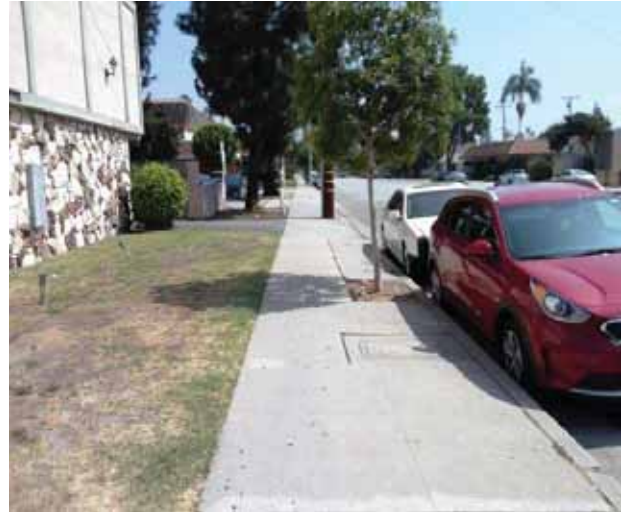
Recommendation Up to 2.08 percent

Repave the sidewalk surface with the recommended cross slope.

Repave surface \$1,092
