Accessibility Survey

City of Downey Downey Avenue & De Palma Street

Date of Inspection
1/31/2017

Prepared By
Disability Access Consultants
(800) 743-7067

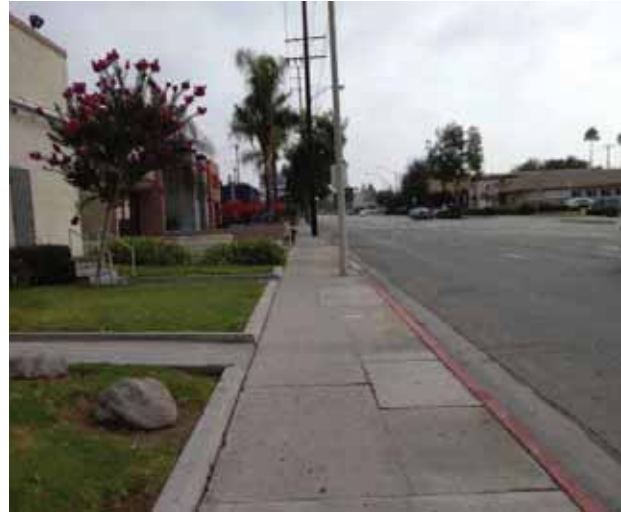
Recommendation Up to 2.08 percent

Repave the sidewalk surface with the recommended cross slope.

Repave surface \$1,092

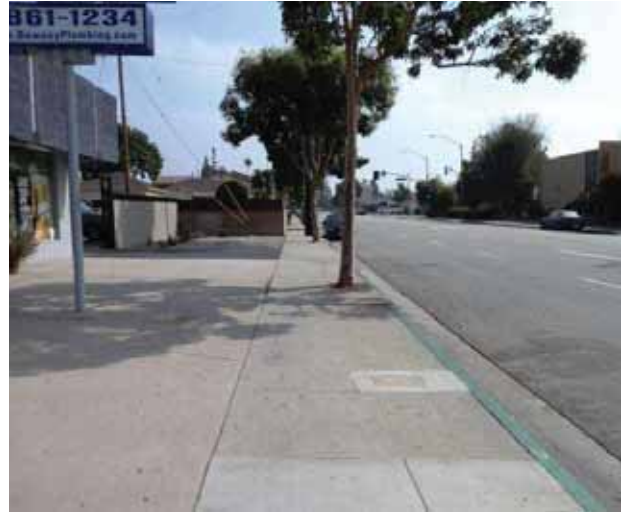
Recommendation Up to 2.08 percent

Repave the sidewalk surface with the recommended cross slope.

Repave surface \$1,092

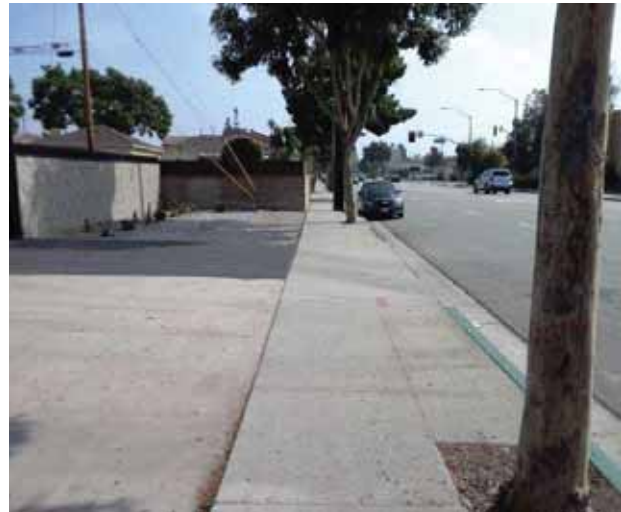
Recommendation Up to 2.08 percent

Repave the sidewalk surface with the recommended cross slope.

Repave surface \$1,092

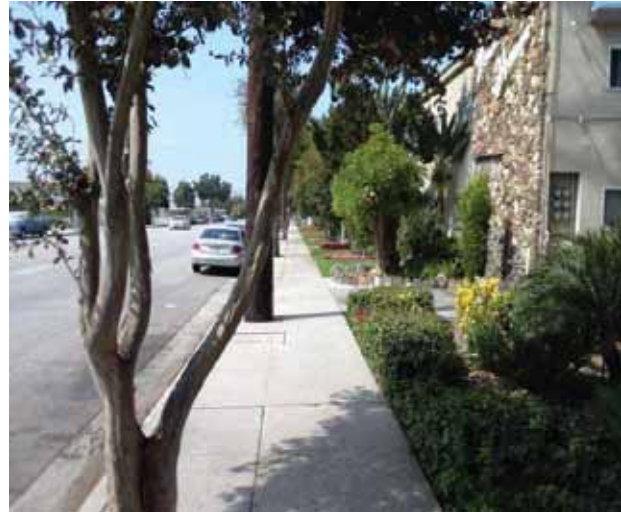
Sidewalks , Hazards & Gratings : Overhead Obstruction Height

Recommendation At least 80.00 inches

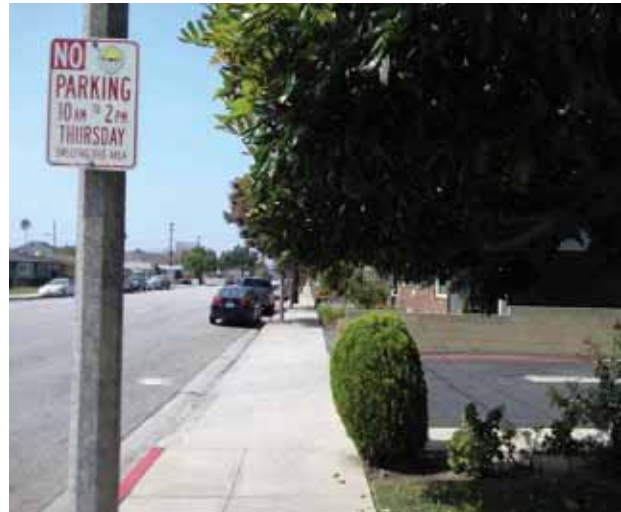
Sidewalks , Hazards & Gratings : Overhead Obstruction Height

Recommendation At least 80.00 inches

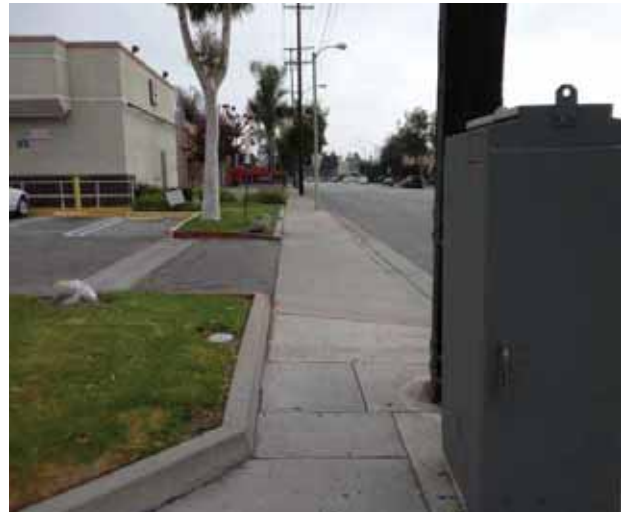
Sidewalks , Hazards & Gratings : Sidewalk Width at Obstruction

Recommendation At least 48.00 inches

Sidewalk width at the obstruction shall have the recommended value.

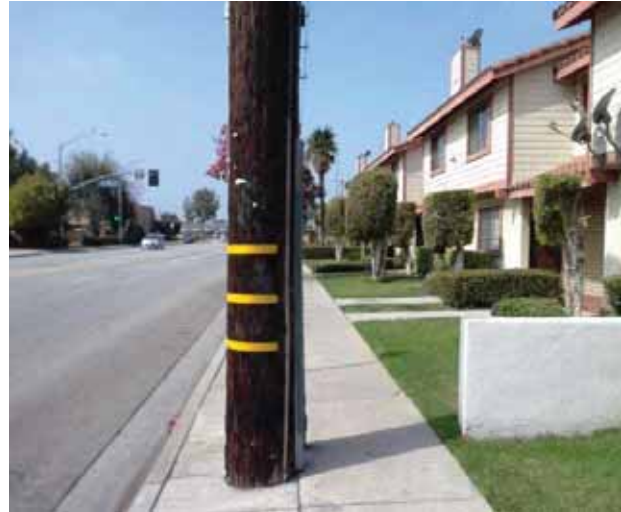
Sidewalks , Hazards & Gratings : Sidewalk Width at Obstruction

Recommendation At least 48.00 inches

Sidewalk width at the obstruction shall have the recommended value.

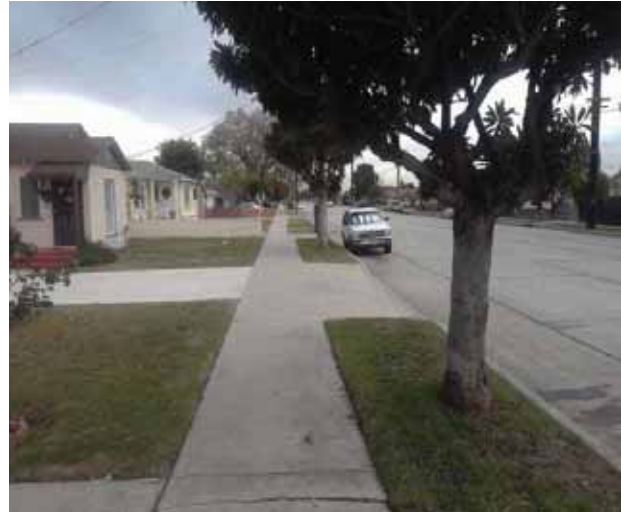
There is a change in elevation greater than recommended value.

Ensure that the change in elevation is within the recommended value.

Remove tripping hazards \$198

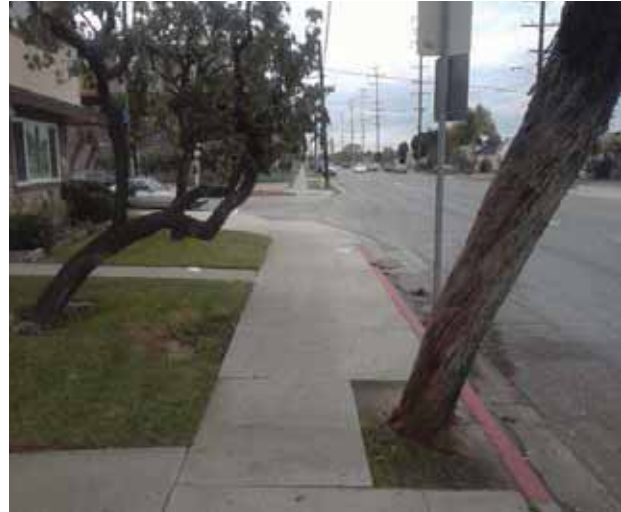
There is a change in elevation greater than recommended value.

Ensure that the change in elevation is within the recommended value.

Remove tripping hazards \$198

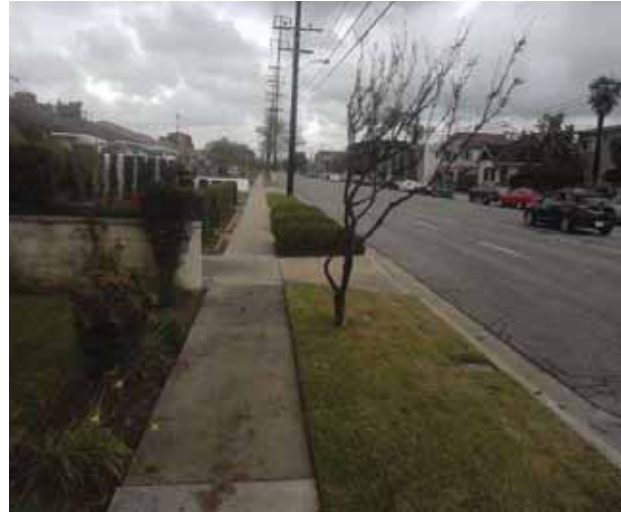
There is a change in elevation greater than recommended value.

Ensure that the change in elevation is within the recommended value.

Remove tripping hazards \$198

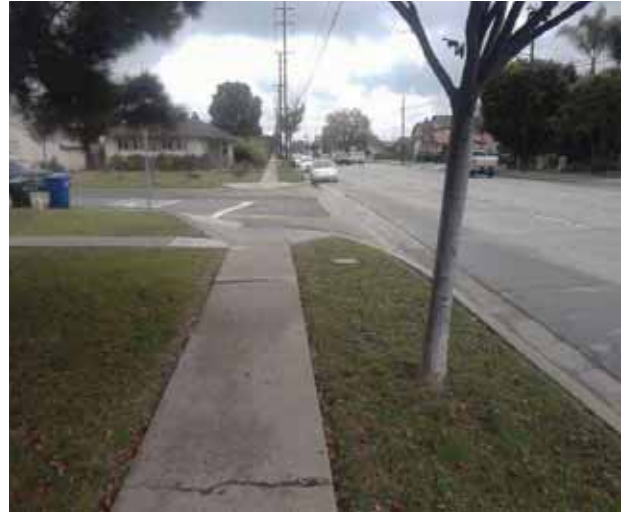
There is a change in elevation greater than recommended value.

Ensure that the change in elevation is within the recommended value.

Remove tripping hazards \$198

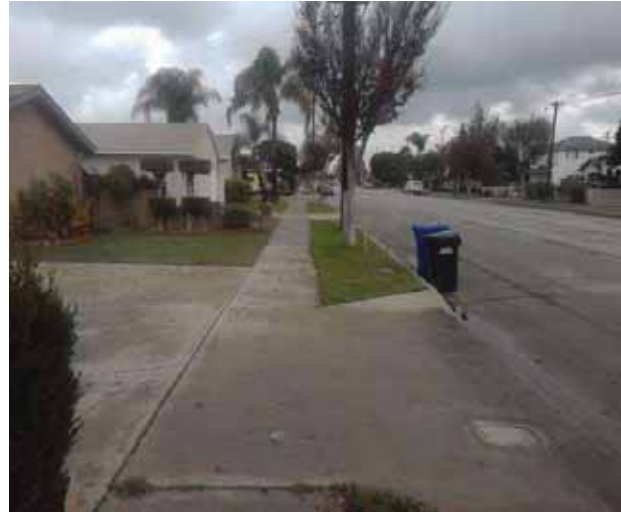
There is a change in elevation greater than recommended value.

Ensure that the change in elevation is within the recommended value.

Remove tripping hazards \$198

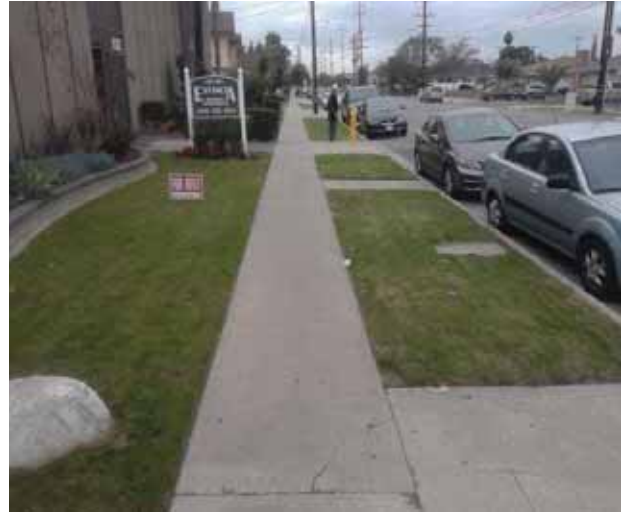
There is a change in elevation greater than recommended value.

Ensure that the change in elevation is within the recommended value.

Remove tripping hazards \$198

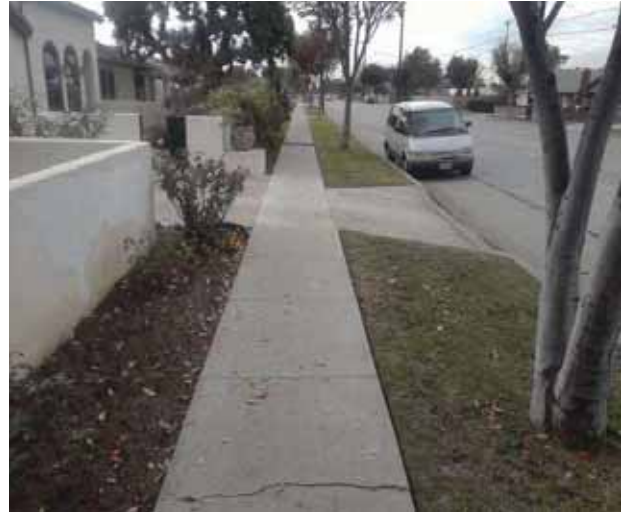
There is a change in elevation greater than recommended value.

Ensure that the change in elevation is within the recommended value.

Remove tripping hazards \$198

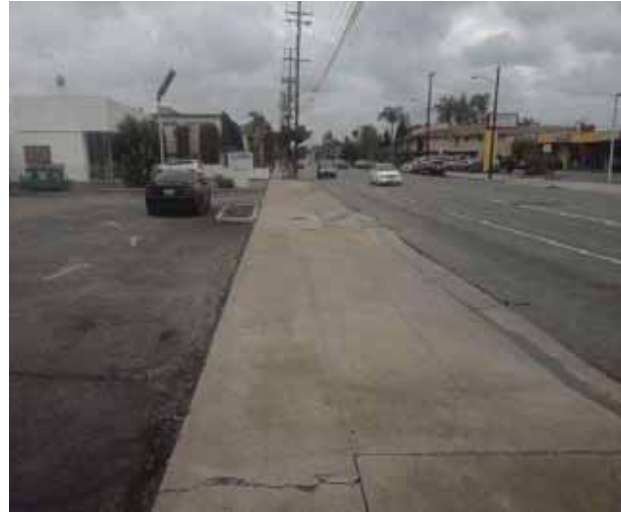
There is a change in elevation greater than recommended value.

Ensure that the change in elevation is within the recommended value.

Remove tripping hazards \$198

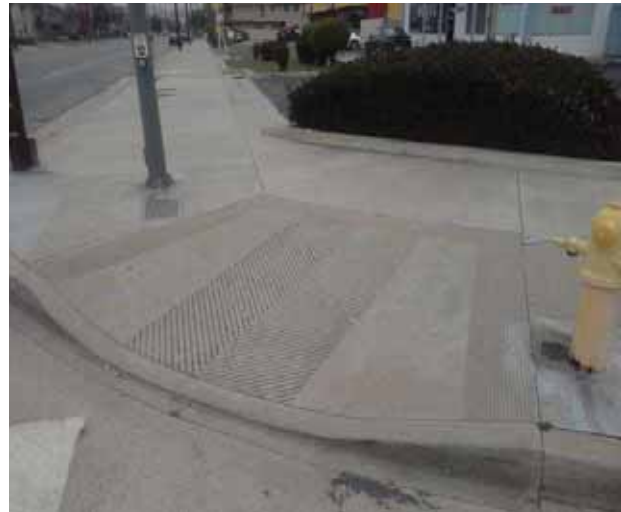
Recommendation Up to 8.33 percent

Install curb ramp \$1,300

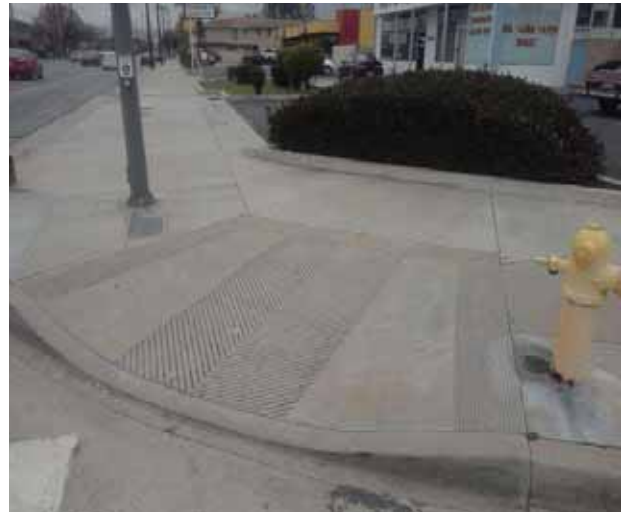
Recommendation Up to 2.08 percent

Provide compliant landing \$1,260

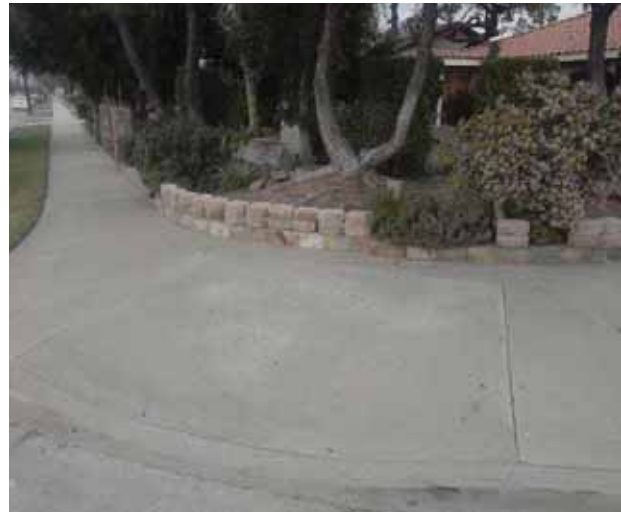
Recommendation At least 48.00 inches

Provide compliant landing \$240

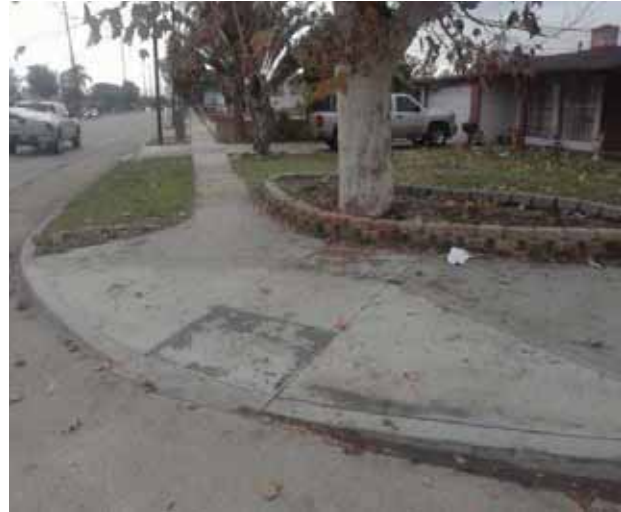
Recommendation Up to 2.08 percent

Install curb ramp \$1,300

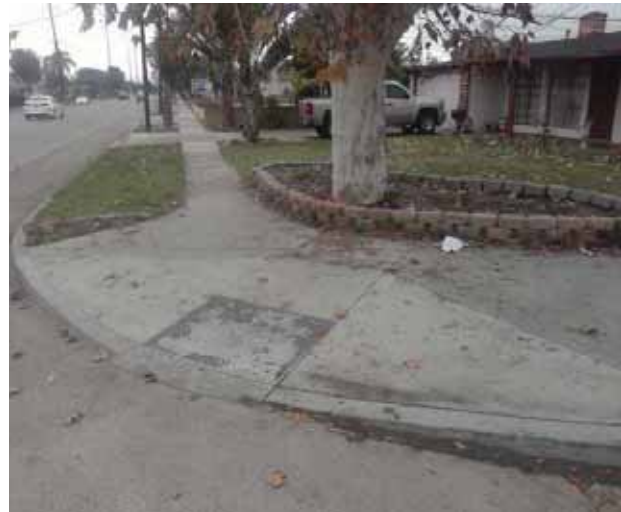
Recommendation Up to 2.08 percent

Provide compliant landing \$1,260

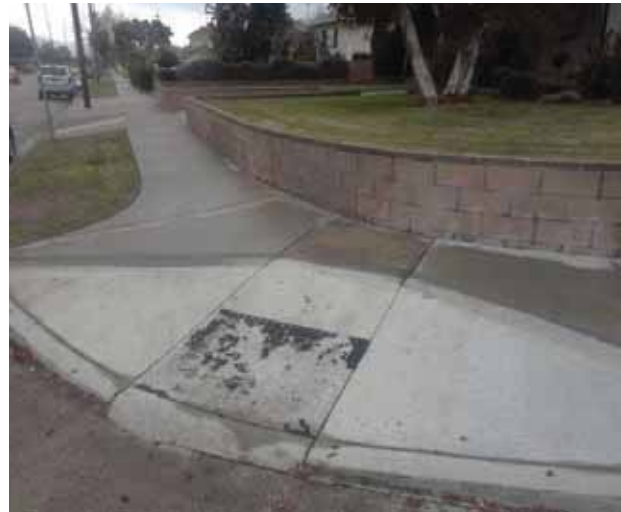
Recommendation Up to 2.08 percent

Provide compliant landing \$1,260

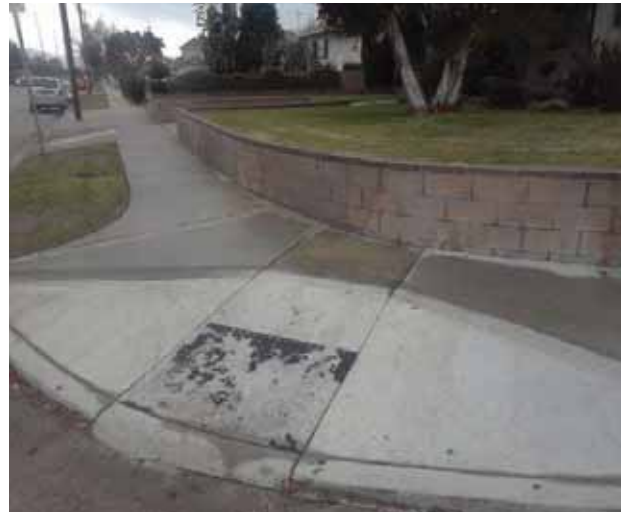
Recommendation Up to 8.33 percent

Install curb ramp \$1,300

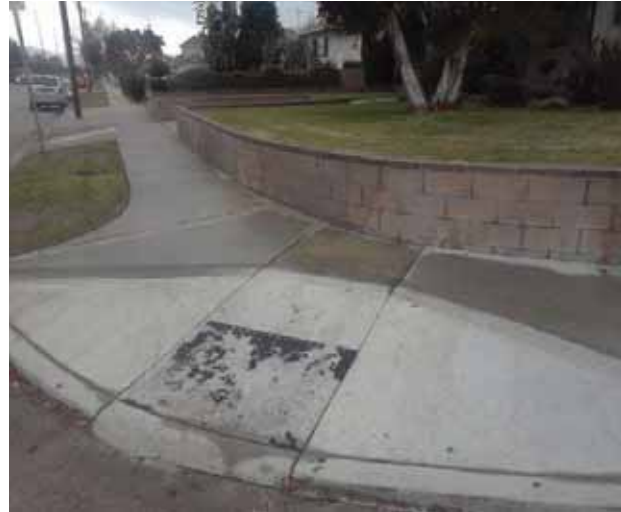
Recommendation Up to 2.08 percent

Install curb ramp \$1,300

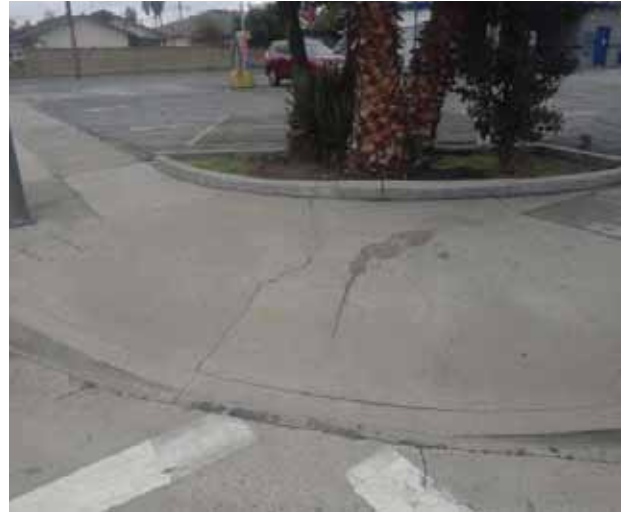
Recommendation At least 48.00 inches

Provide compliant landing \$240

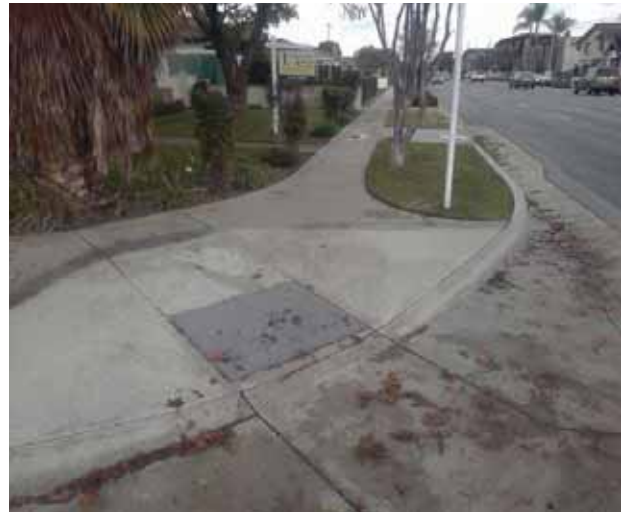
Recommendation Up to 8.33 percent

Install curb ramp \$1,300

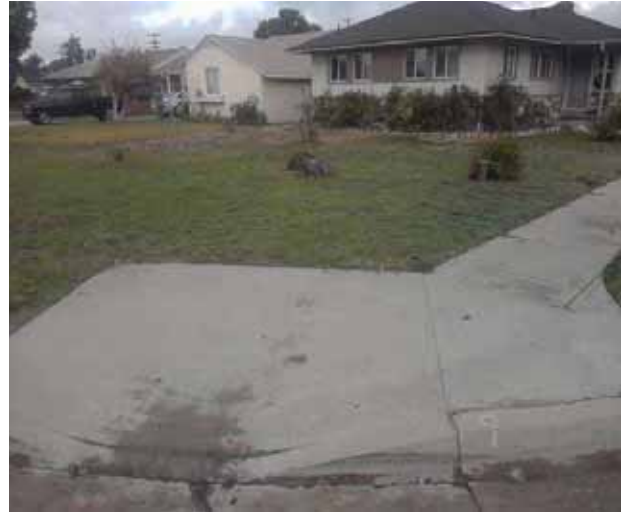
Recommendation Up to 2.08 percent

Install curb ramp \$1,300

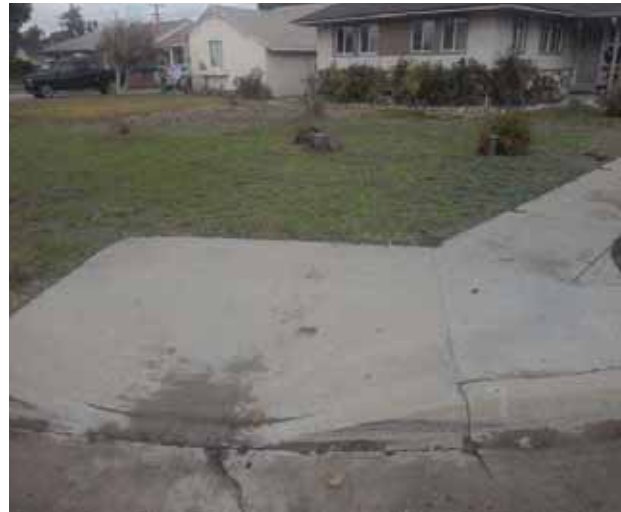
Recommendation Up to 2.08 percent

Provide compliant landing \$1,260

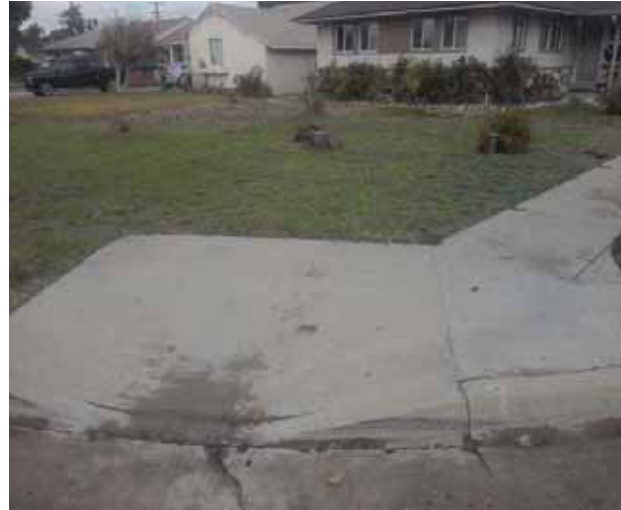
Recommendation At least 48.00 inches

Provide compliant landing \$240

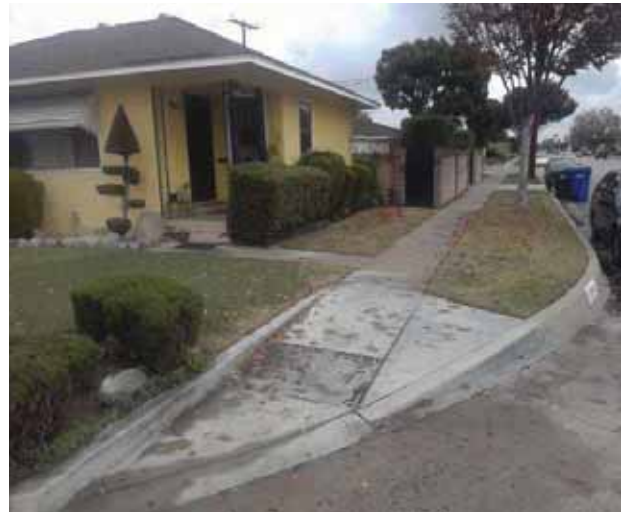
Recommendation Up to 2.08 percent

Install curb ramp \$1,300

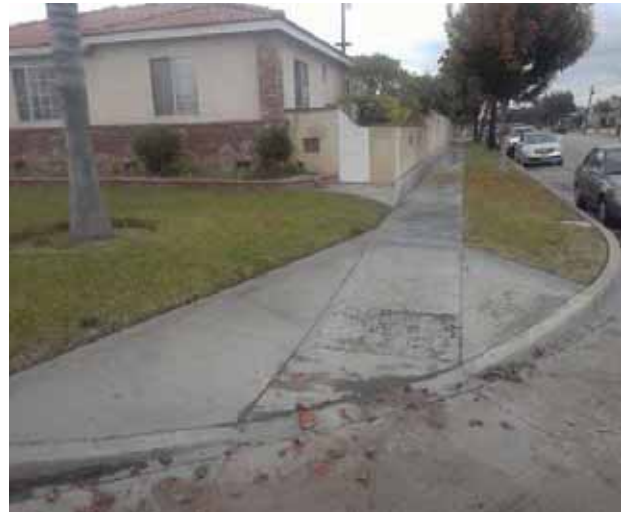
Recommendation Up to 2.08 percent

Install curb ramp \$1,300

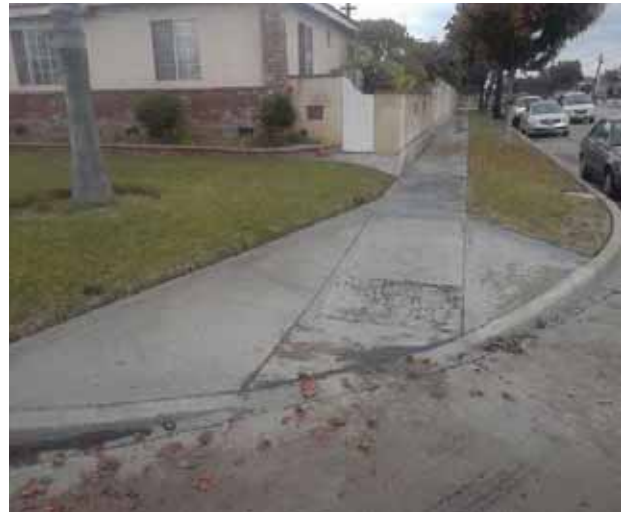
Recommendation Up to 5.00 percent

Repave landing \$1,260

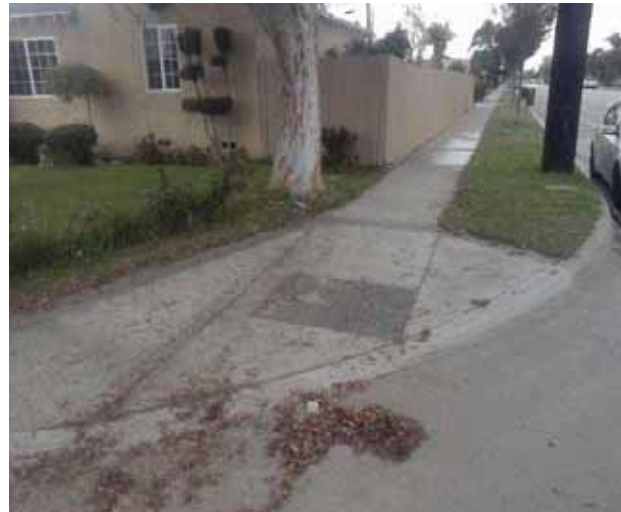
Recommendation Up to 2.08 percent

Install curb ramp \$1,300

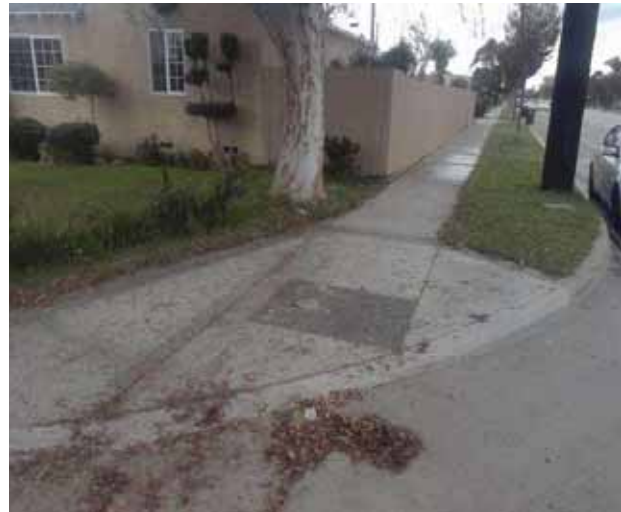
Recommendation Up to 2.08 percent

Provide compliant landing \$1,260

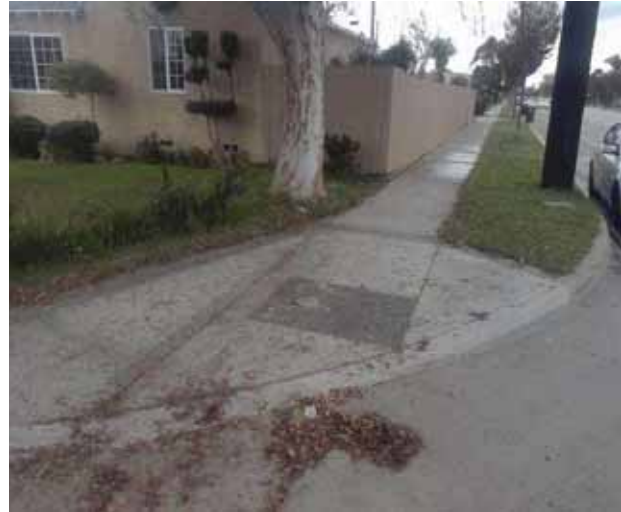
Recommendation At least 48.00 inches

Provide compliant landing \$240

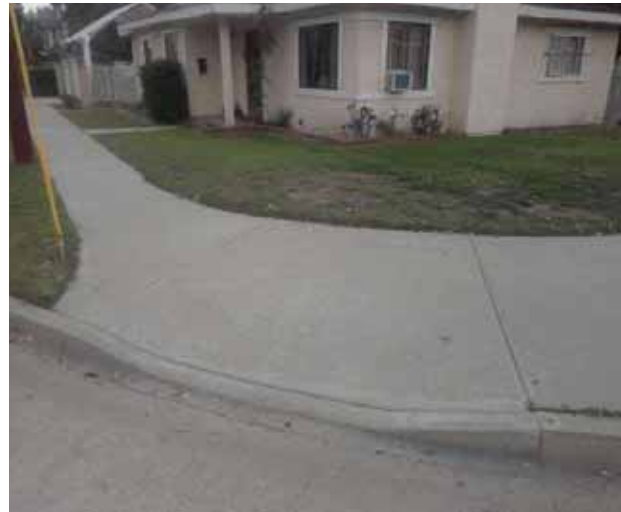
Recommendation Up to 2.08 percent

Provide compliant landing \$240

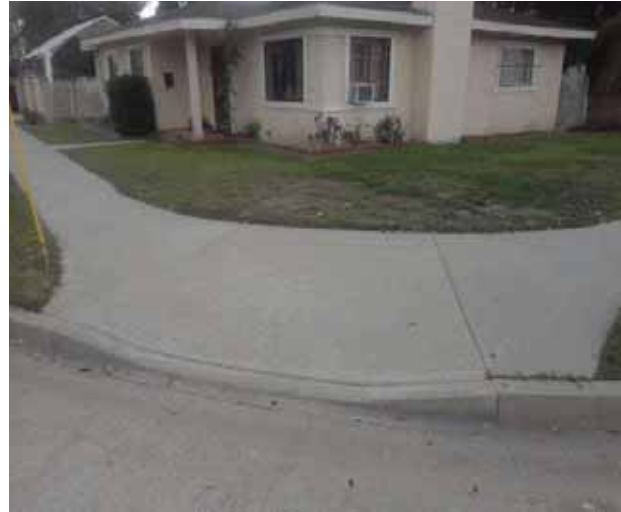
Recommendation Up to 10.00 percent

Install flared sides \$1,300

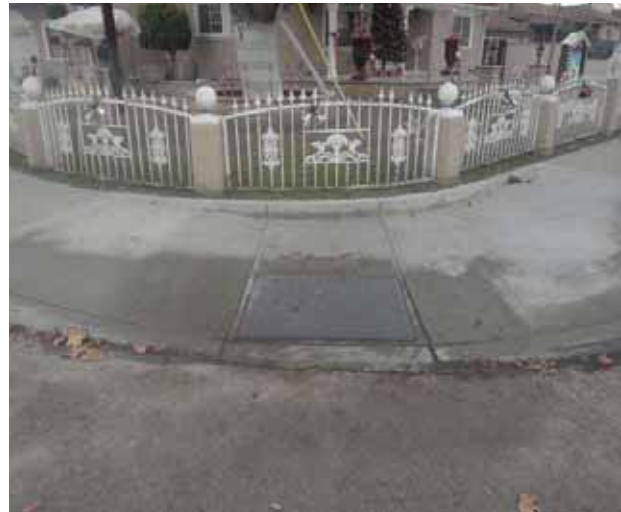
Recommendation Up to 2.08 percent

Provide compliant landing \$1,260

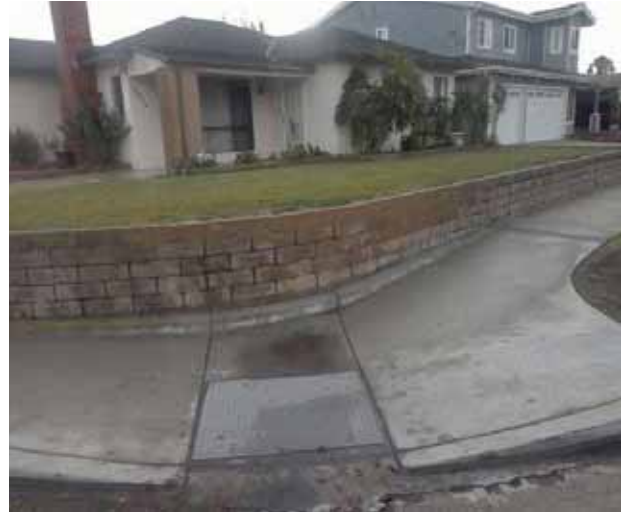
Recommendation Up to 8.33 percent

Install curb ramp \$1,300

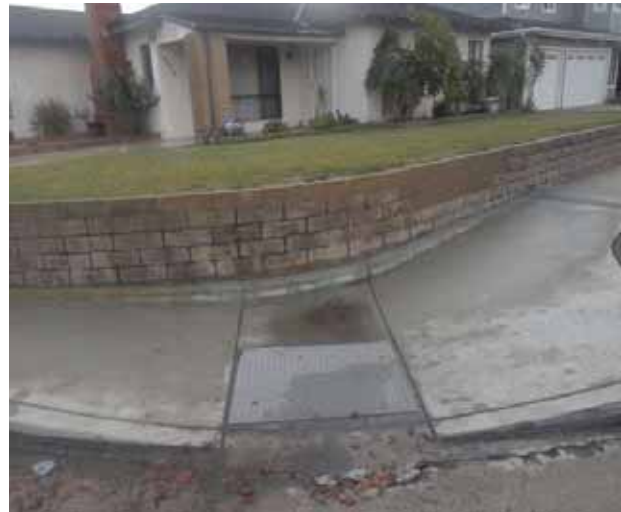
Recommendation Up to 2.08 percent

Provide compliant landing \$240

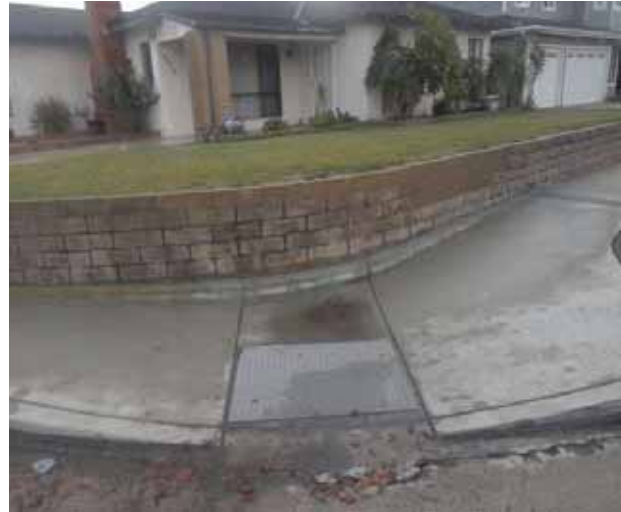
Recommendation At least 48.00 inches

Provide compliant landing \$240

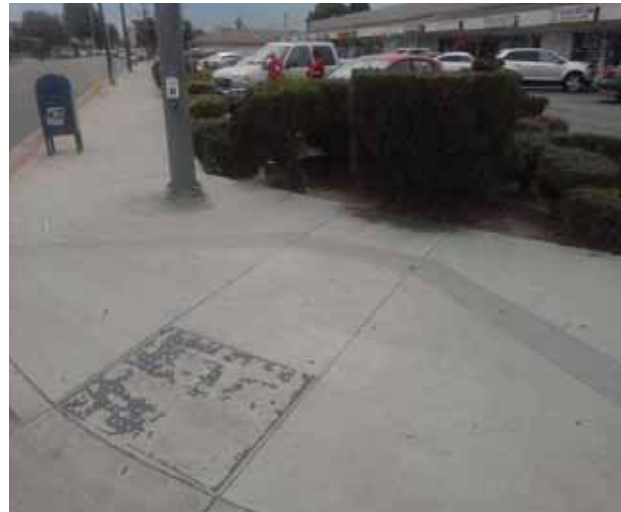
Recommendation Up to 5.00 percent

Repave landing \$1,260

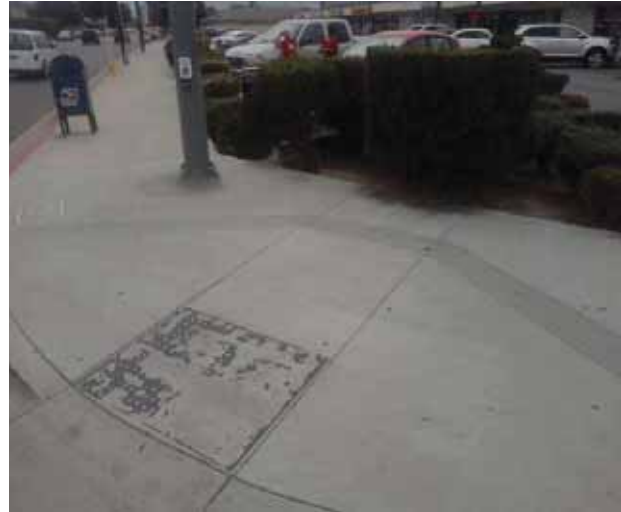
Recommendation Up to 8.33 percent

Install curb ramp \$1,300

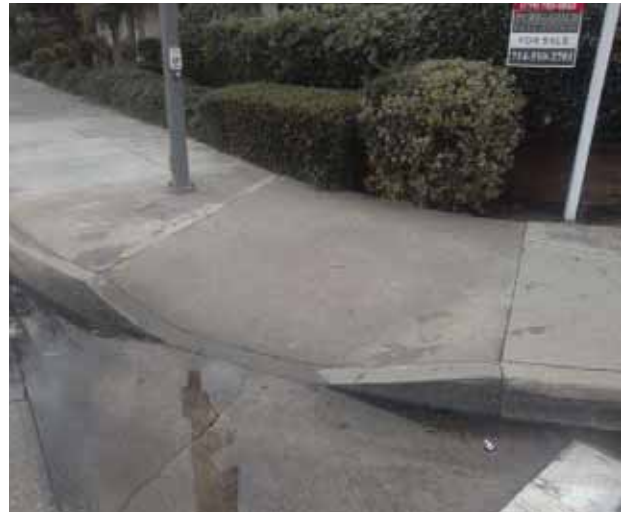
Recommendation Up to 8.33 percent

Install curb ramp \$1,300

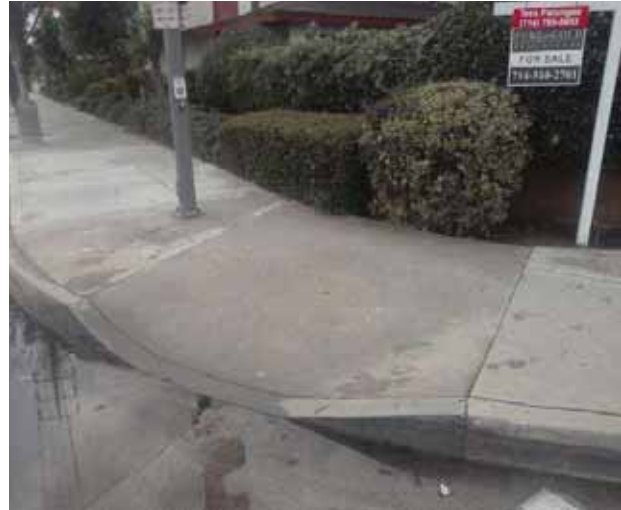
Recommendation At least 48.00 inches

Provide compliant landing \$240

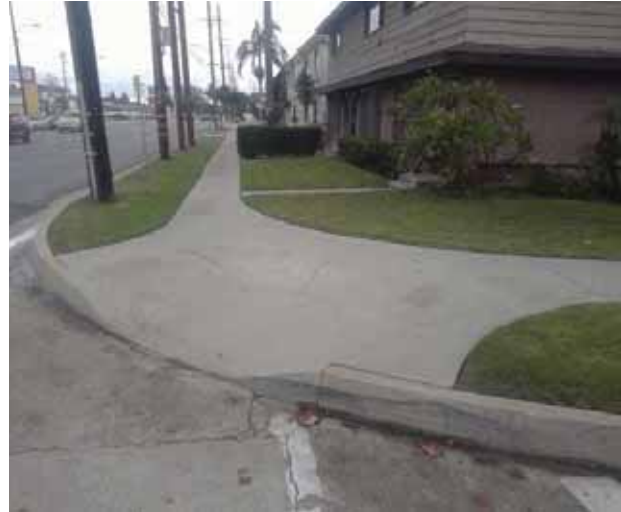
Recommendation Up to 10.00 percent

Install flared sides \$1,300

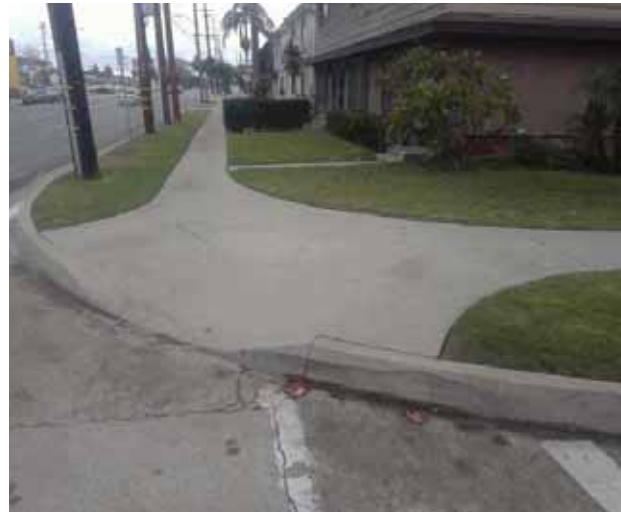
Recommendation Up to 2.08 percent

Provide compliant landing \$240

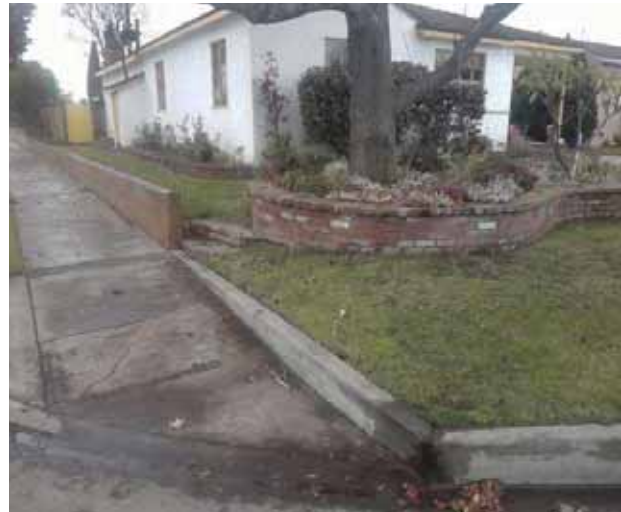
Recommendation Up to 2.08 percent

Install curb ramp \$1,300

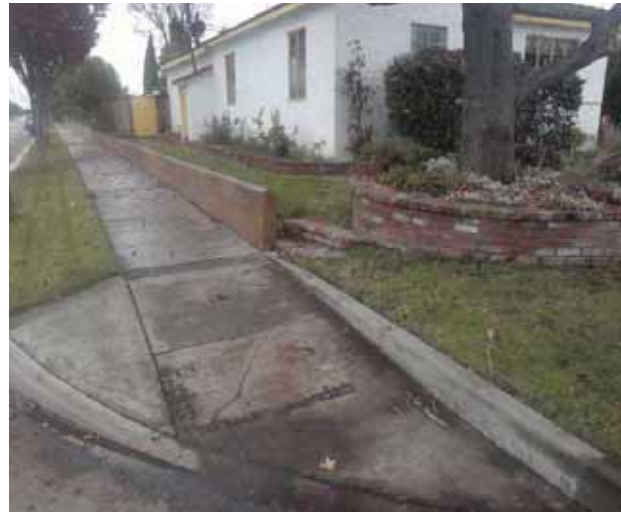
Recommendation Up to 5.00 percent

Repave landing \$1,260

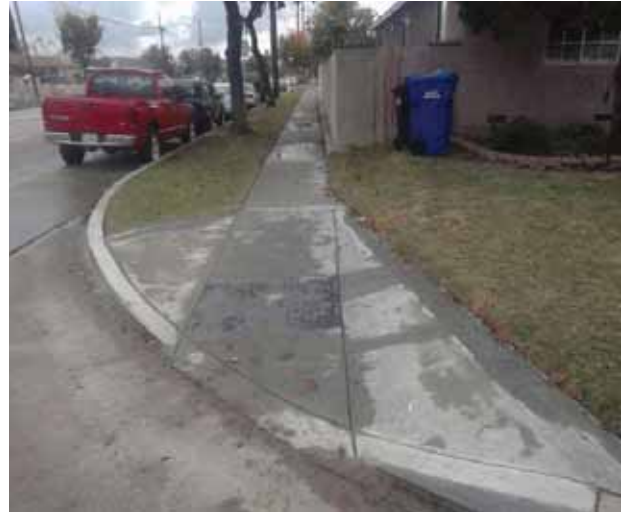
Recommendation Up to 10.00 percent

Install flared sides \$1,300

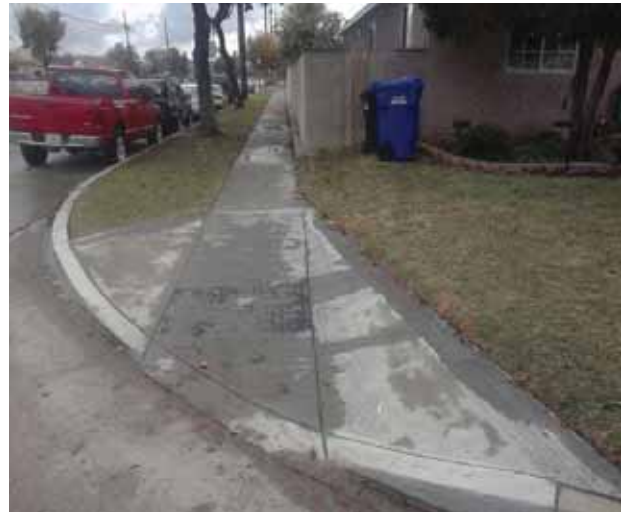
Recommendation Up to 5.00 percent

Repave landing \$1,260

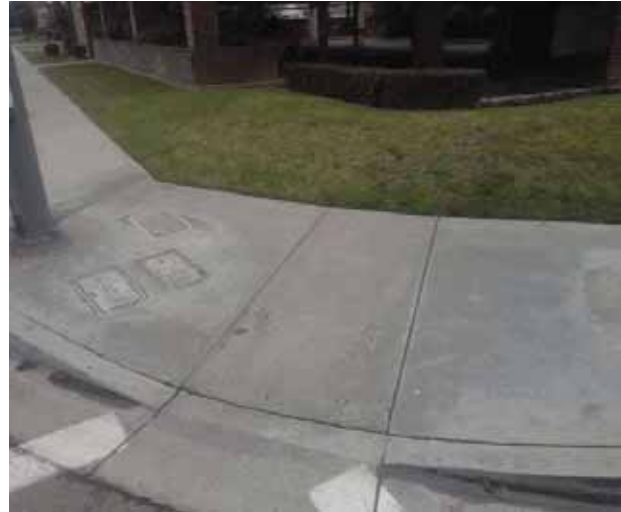
Recommendation Up to 2.08 percent

Provide compliant landing \$240

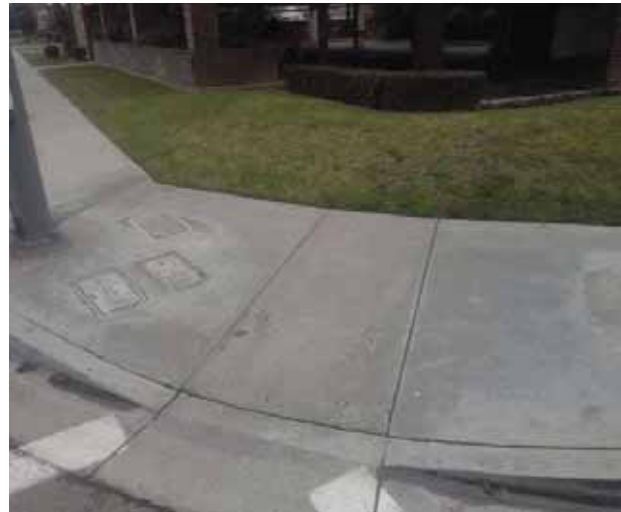
Recommendation Up to 2.08 percent

Provide compliant landing \$1,260

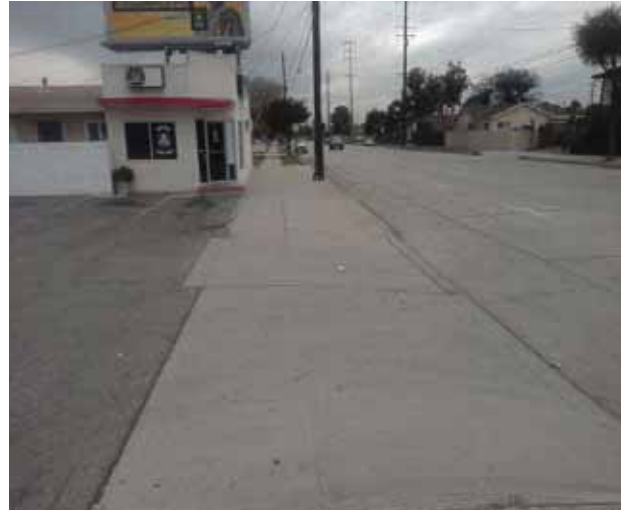
Recommendation Up to 2.08 percent

Repave surface \$1,092

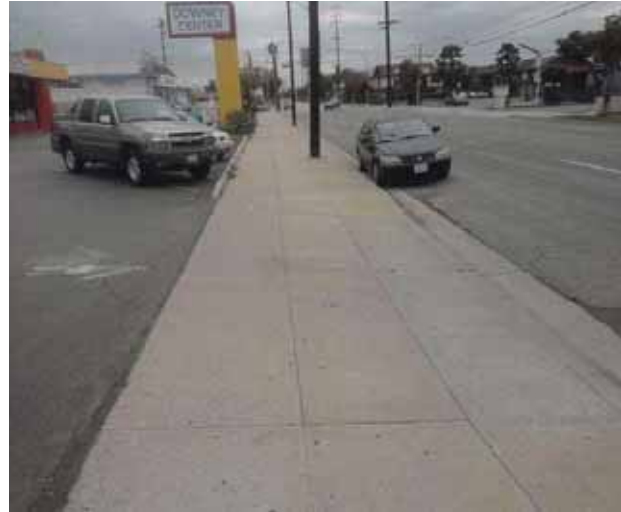
Recommendation Up to 2.08 percent

Repave surface \$1,092

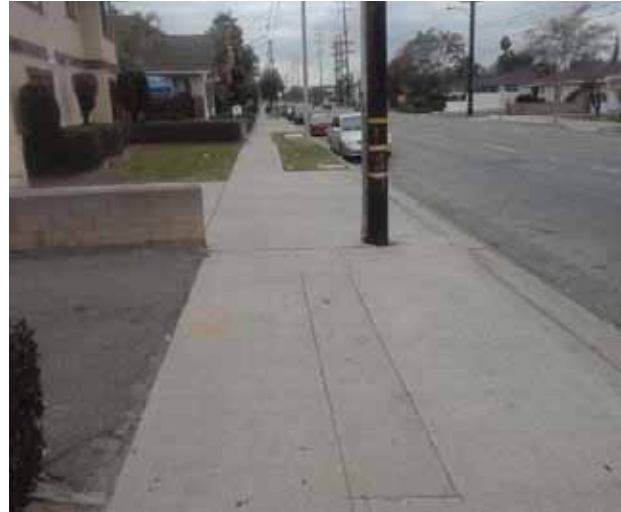
Recommendation Up to 2.08 percent

Repave surface \$1,092

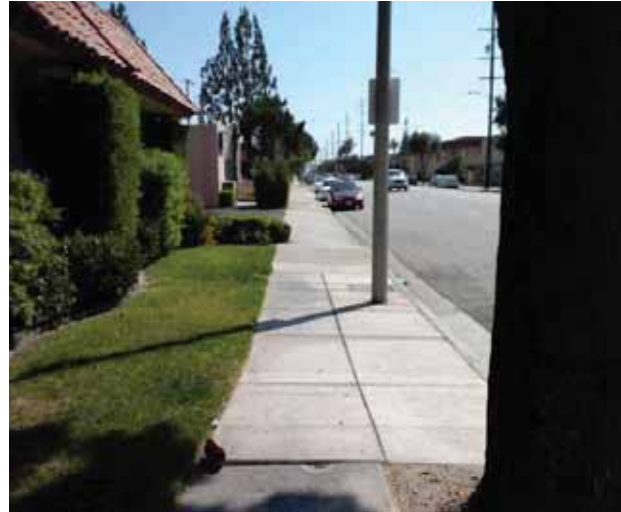
There is a change in elevation greater than recommended value.

Ensure that the change in elevation is within the recommended value.

Recommendation Up to 0.25 inches

Remove tripping hazards \$198

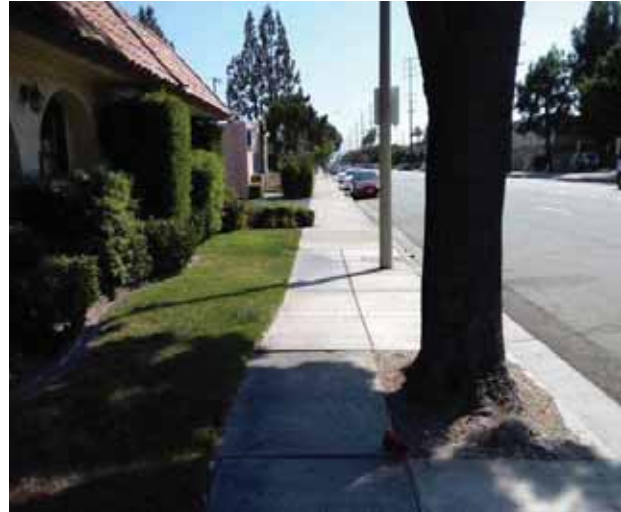
There is a change in elevation greater than recommended value.

Ensure that the change in elevation is within the recommended value.

Recommendation Up to 0.25 inches

Remove tripping hazards \$198

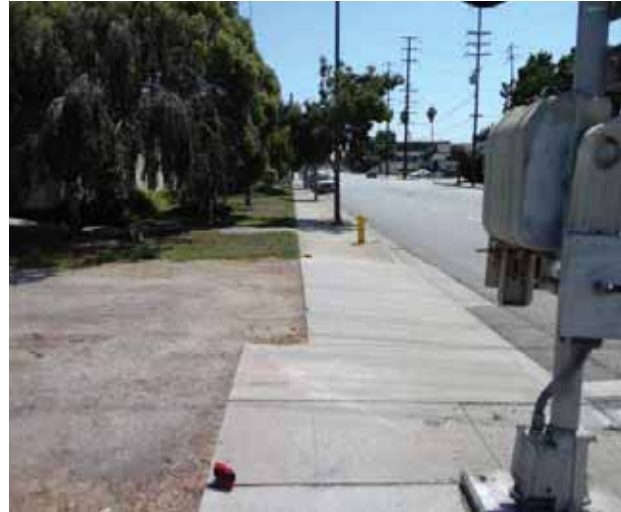
There is a change in elevation greater than recommended value.

Ensure that the change in elevation is within the recommended value.

Recommendation Up to 0.25 inches

Remove tripping hazards \$198

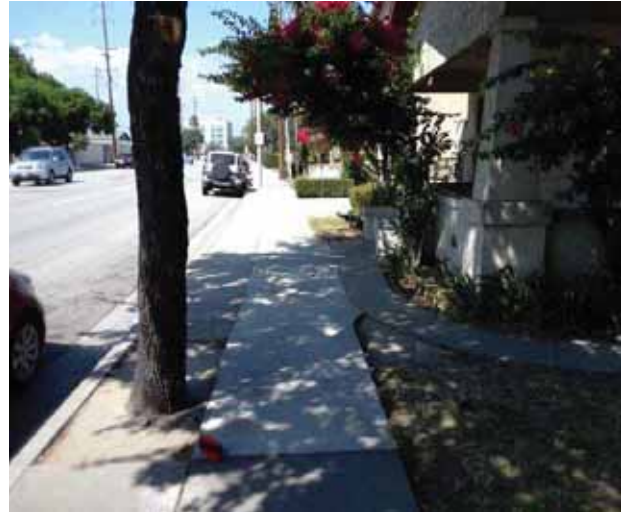
There is a change in elevation greater than recommended value.

Ensure that the change in elevation is within the recommended value.

Recommendation Up to 0.25 inches

Remove tripping hazards \$198

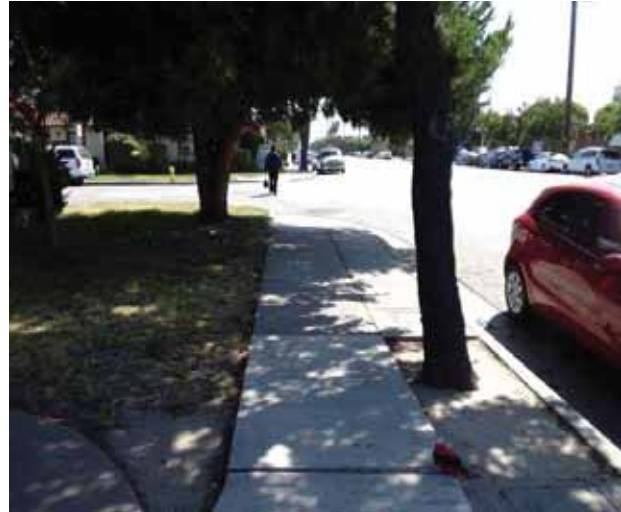
There is a change in elevation greater than recommended value.

Ensure that the change in elevation is within the recommended value.

Recommendation Up to 0.25 inches

Remove tripping hazards \$198

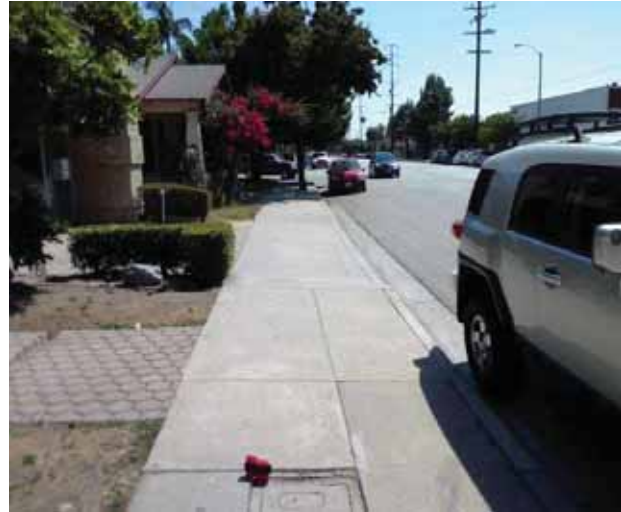
There is a change in elevation greater than recommended value.

Ensure that the change in elevation is within the recommended value.

Recommendation Up to 0.25 inches

Remove tripping hazards \$198

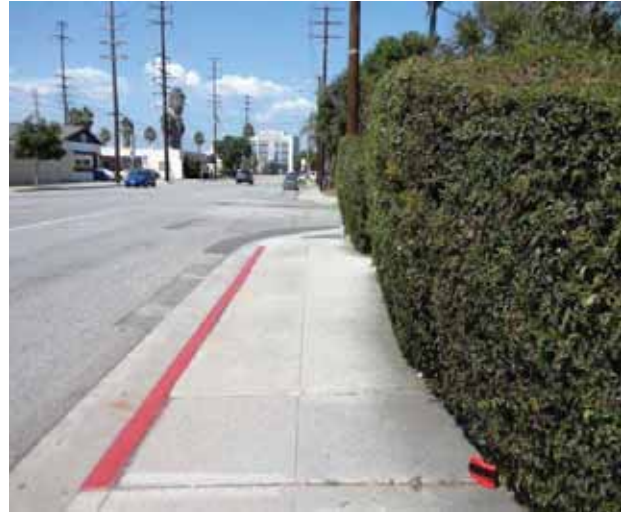
There is a change in elevation greater than recommended value.

Ensure that the change in elevation is within the recommended value.

Recommendation Up to 0.25 inches

Remove tripping hazards \$198

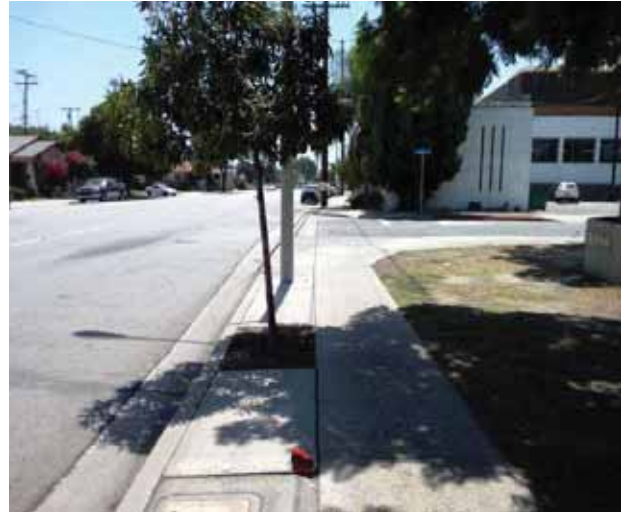
There is a change in elevation greater than recommended value.

Ensure that the change in elevation is within the recommended value.

Recommendation Up to 0.25 inches

Remove tripping hazards \$198

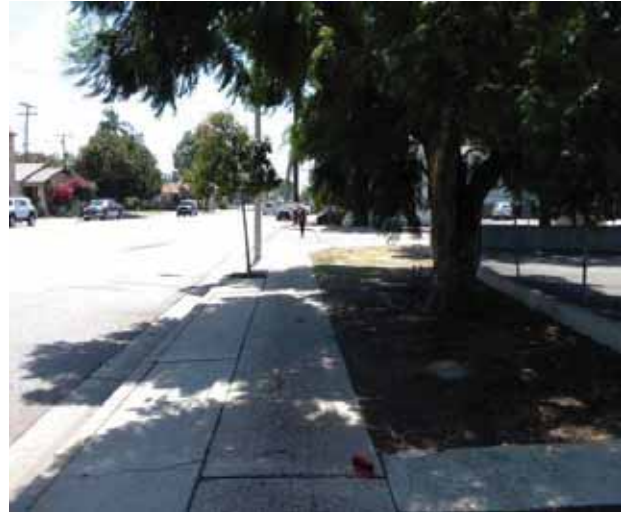
There is a change in elevation greater than recommended value.

Ensure that the change in elevation is within the recommended value.

Recommendation Up to 0.25 inches

Remove tripping hazards \$198

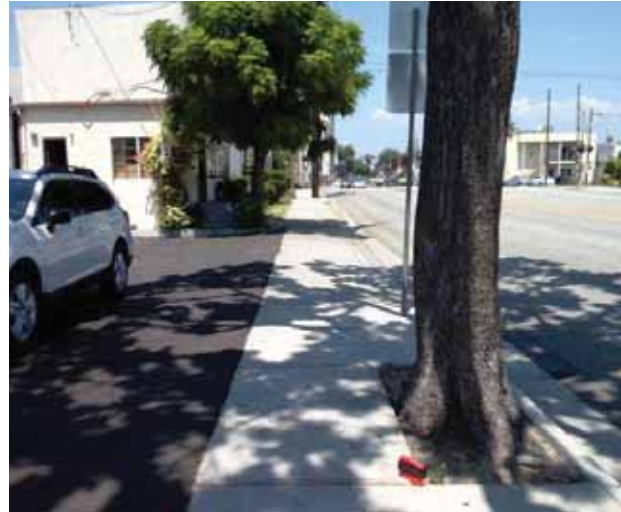
There is a change in elevation greater than recommended value.

Ensure that the change in elevation is within the recommended value.

Recommendation Up to 0.25 inches

Remove tripping hazards \$198

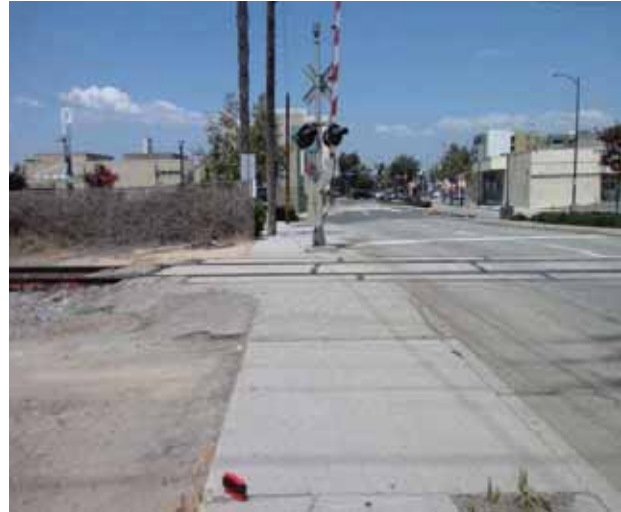
There is a change in elevation greater than recommended value.

Recommendation Up to 0.25 inches

Code Reference ADA 206, 302

Ensure that the change in elevation is within the recommended value.

Remove tripping hazards \$198
