Accessibility Survey

City of Downey Downey Avenue & De Palma Street

Date of Inspection
1/31/2017

Prepared By
Disability Access Consultants
(800) 743-7067

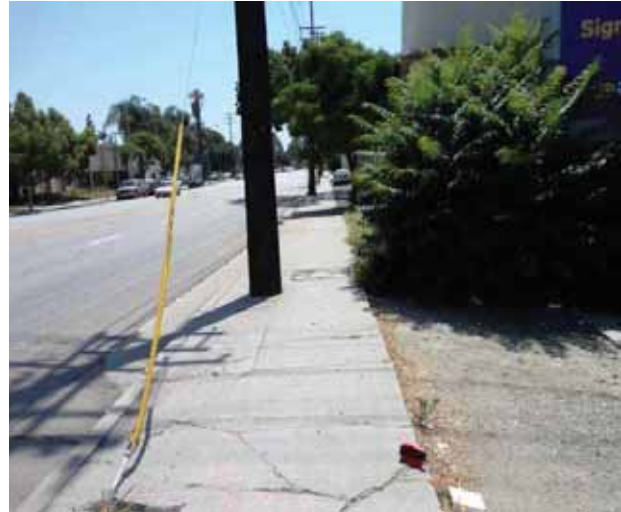
There is a change in elevation greater than recommended value.

Recommendation Up to 0.25 inches

Code Reference ADA 206, 302

Ensure that the change in elevation is within the recommended value.

Remove tripping hazards \$198

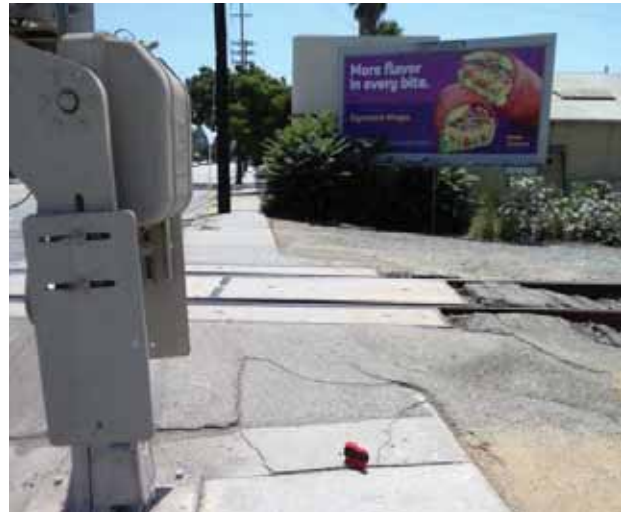
There is a change in elevation greater than recommended value.

Recommendation Up to 0.25 inches

Code Reference ADA 206, 302

Ensure that the change in elevation is within the recommended value.

Remove tripping hazards \$198

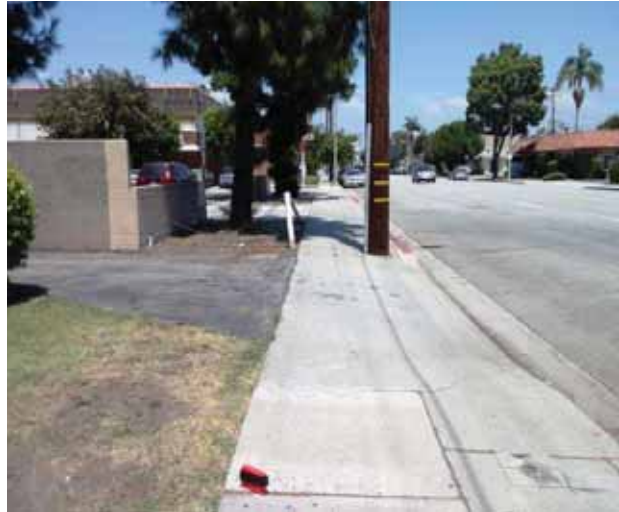
There is a change in elevation greater than recommended value.

Recommendation Up to 0.25 inches

Code Reference ADA 206, 302

Ensure that the change in elevation is within the recommended value.

Remove tripping hazards \$198

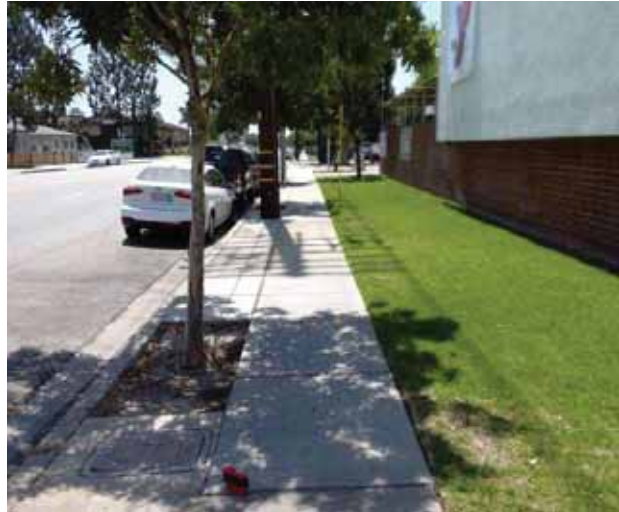
There is a change in elevation greater than recommended value.

Recommendation Up to 0.25 inches

Code Reference ADA 206, 302

Ensure that the change in elevation is within the recommended value.

Remove tripping hazards \$198

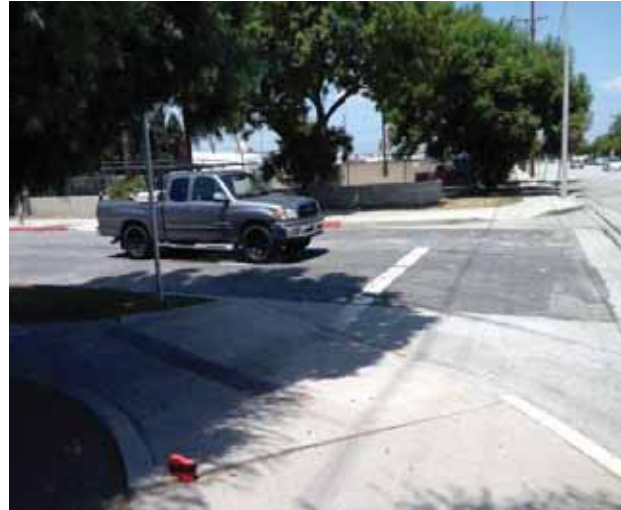
There is a change in elevation greater than recommended value.

Recommendation Up to 0.25 inches

Code Reference ADA 206, 302

Ensure that the change in elevation is within the recommended value.

Remove tripping hazards \$198

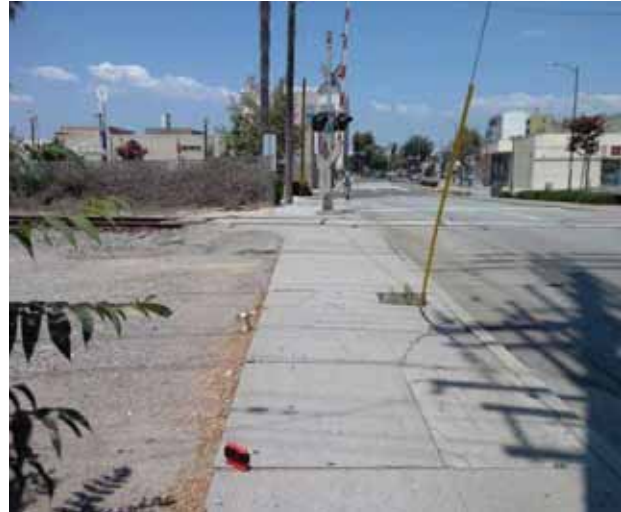
There is a change in elevation greater than recommended value.

Recommendation Up to 0.25 inches

Code Reference ADA 206, 302

Ensure that the change in elevation is within the recommended value.

Remove tripping hazards \$198

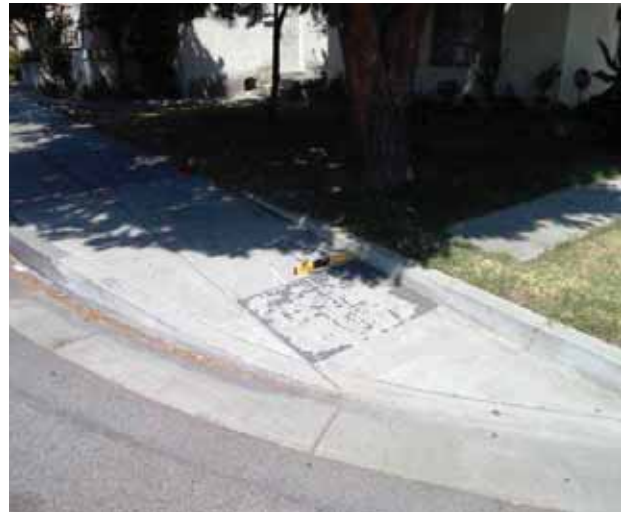
Code Reference CA 11B-406.5.12

Provide detectable warning to surface \$248

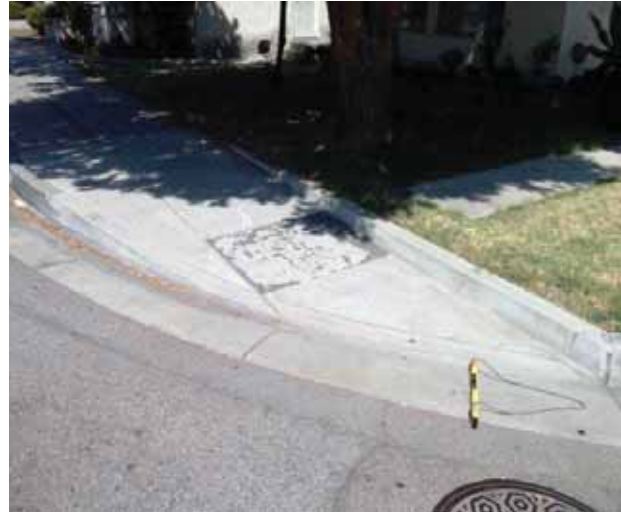
Recommendation Up to 5.00 percent

Code Reference ADA 406, 406.2, CA 11B-406.5.8

Repave landing \$1,260

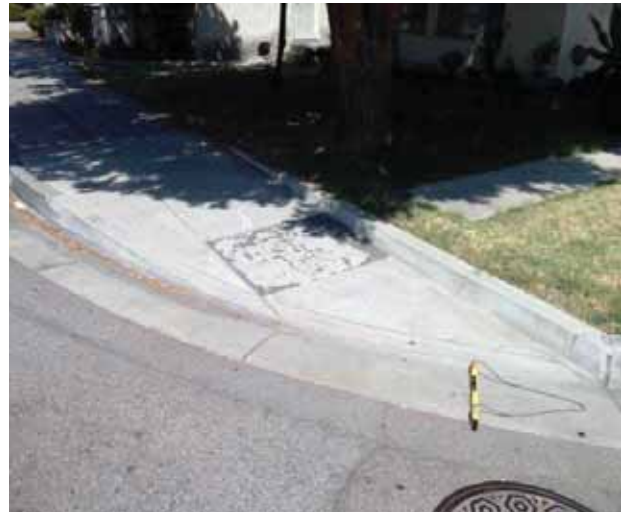
Recommendation Up to 2.08 percent

Code Reference ADA 402, 406.4, 403.3, 406.1, CA 11B-406.5.3

Provide compliant landing \$1,260

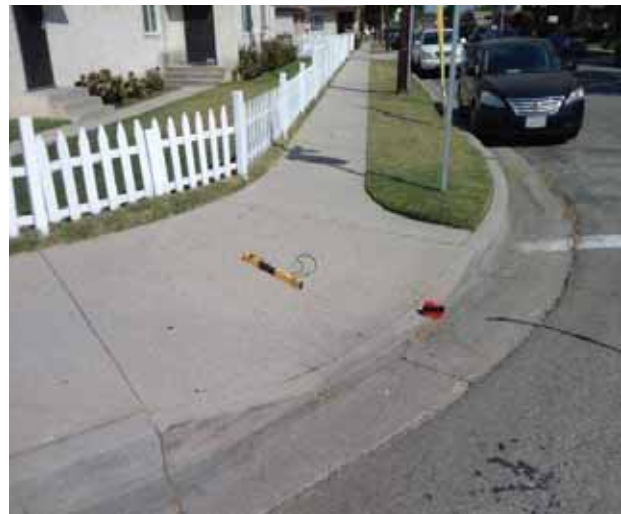
Code Reference CA 11B-406.5.12

Provide detectable warning to surface \$248

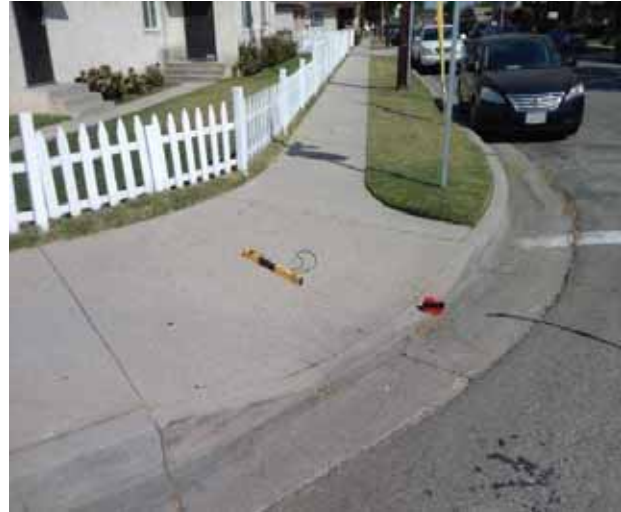
Recommendation Up to 8.33 percent

Code Reference ADA 406, 406.1, 405.2, CA 11B-406

Install curb ramp \$1,300

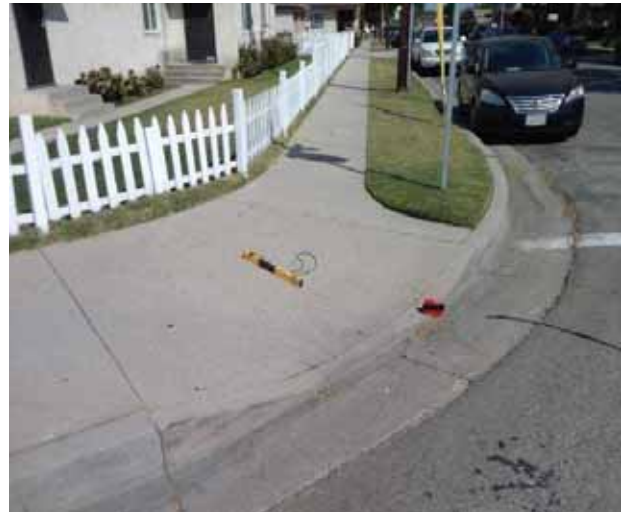
Recommendation Up to 10.00 percent

Code Reference ADA 406, 406.3, CA 11B-406.2.2

Install flared sides \$1,300

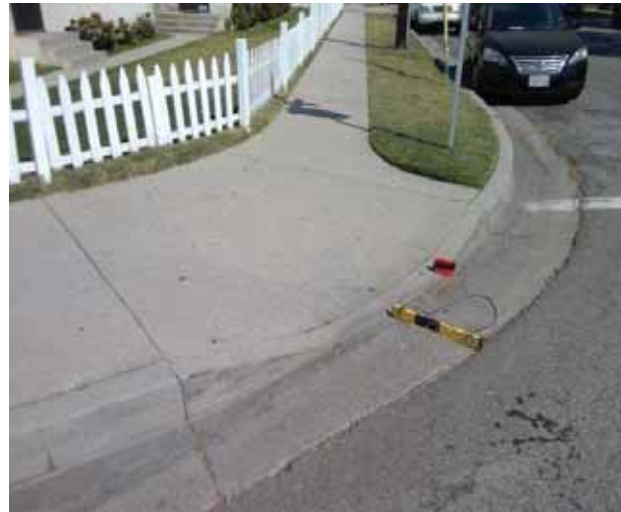
Recommendation Up to 5.00 percent

Code Reference ADA 406, 406.2, CA 11B-406.5.8

Repave landing \$1,260

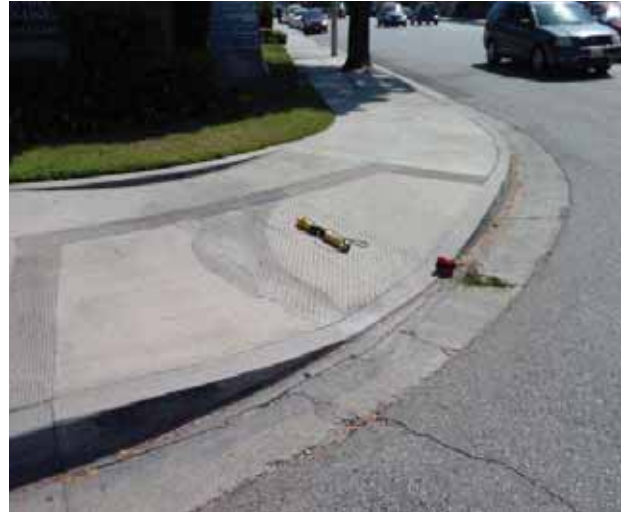
Code Reference CA 11B-406.5.12

Provide detectable warning to surface \$248

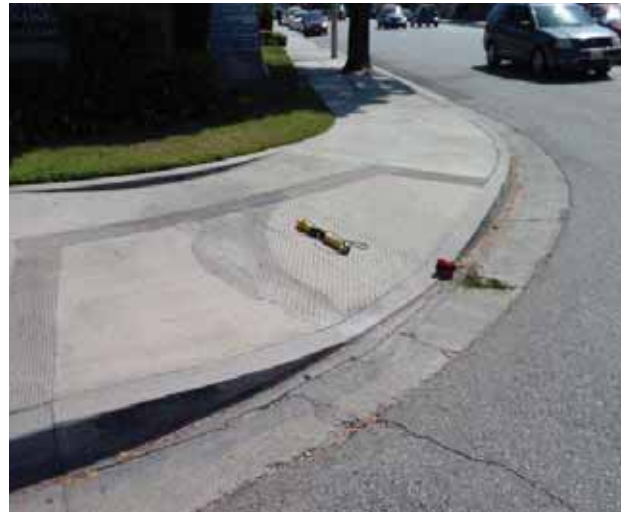
Recommendation At least 48.00 inches

Code Reference ADA 406, 406.1, 405.5, CA 11B-406.5.2

Install curb ramp \$1,300

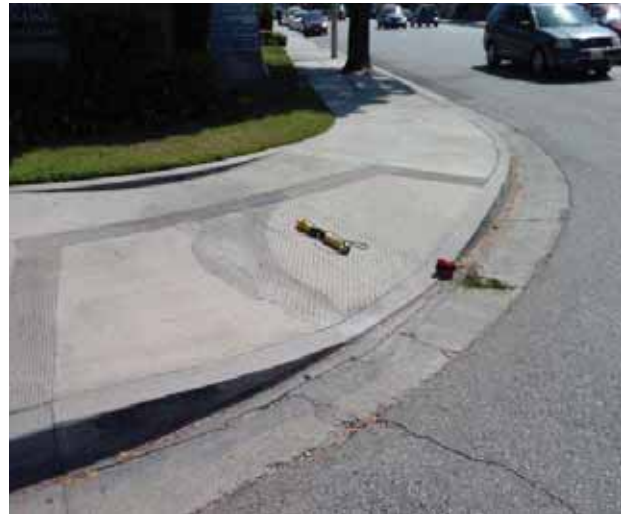
Recommendation Up to 2.08 percent

Code Reference ADA 402, 406.1, 405.3, CA 11B-406.5.7

Install curb ramp \$1,300

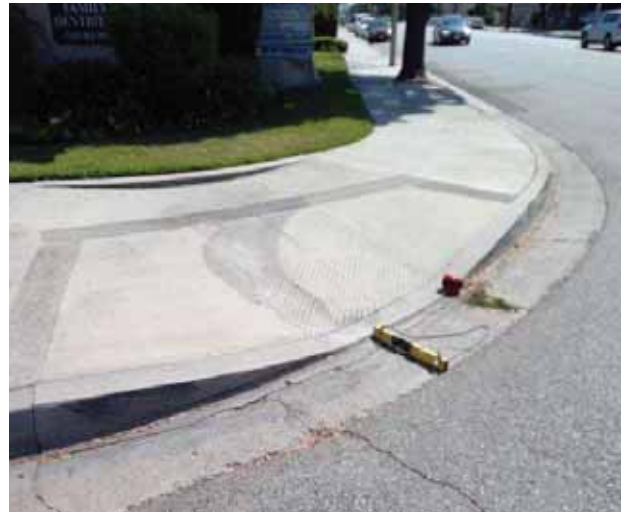
Recommendation Up to 5.00 percent

Code Reference ADA 406, 406.2, CA 11B-406.5.8

Repave landing \$1,260

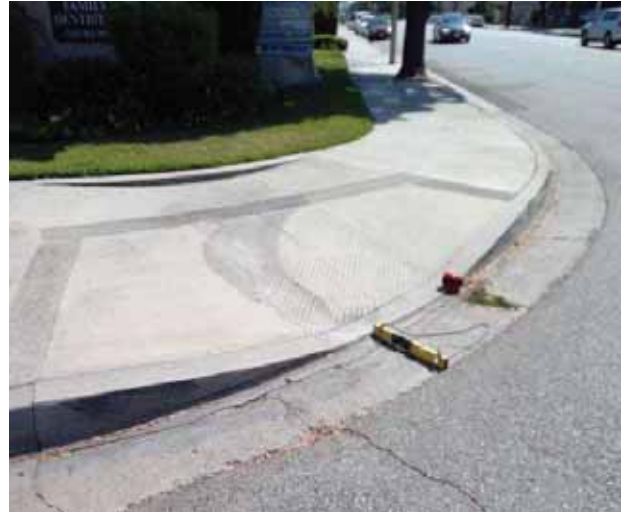
Recommendation At least 48.00 inches

Code Reference ADA 406, 406.4, CA 11B-406.5.3

Provide compliant landing \$240

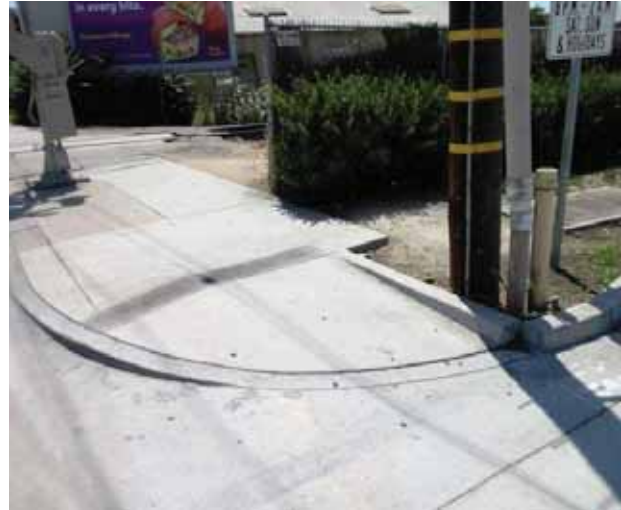
Code Reference CA 11B-406.5.12

Provide detectable warning to surface \$248

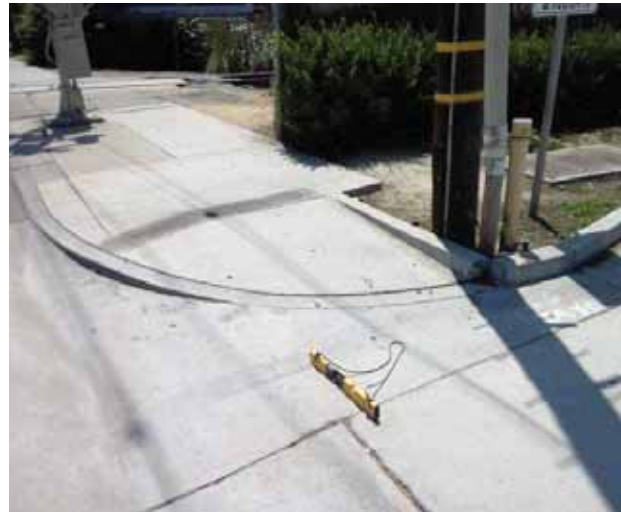
Recommendation Up to 5.00 percent

Code Reference ADA 406, 406.2, CA 11B-406.5.8

Repave landing \$1,260

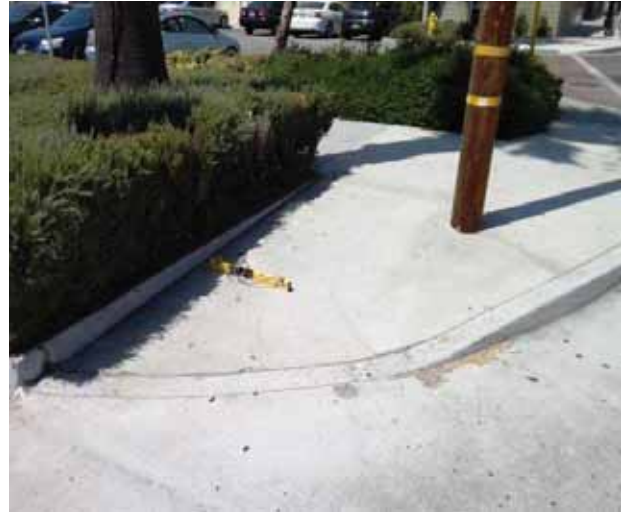
Code Reference CA 11B-406.5.12

Provide detectable warning to surface \$248

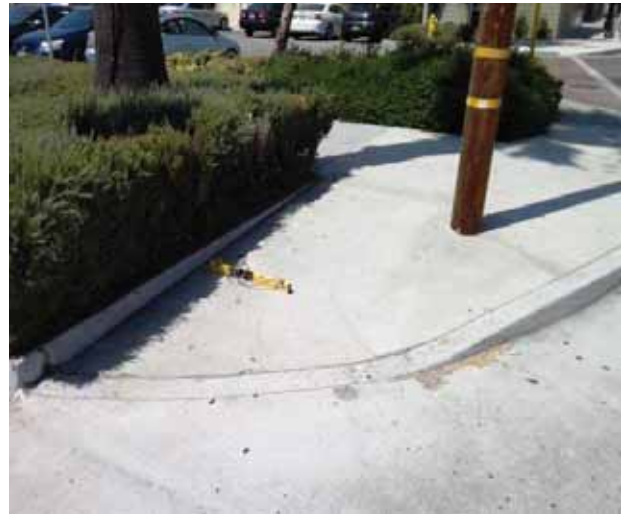
Recommendation Up to 2.08 percent

Code Reference ADA 402, 406.1, 405.3, CA 11B-406.5.7

Install curb ramp \$1,300

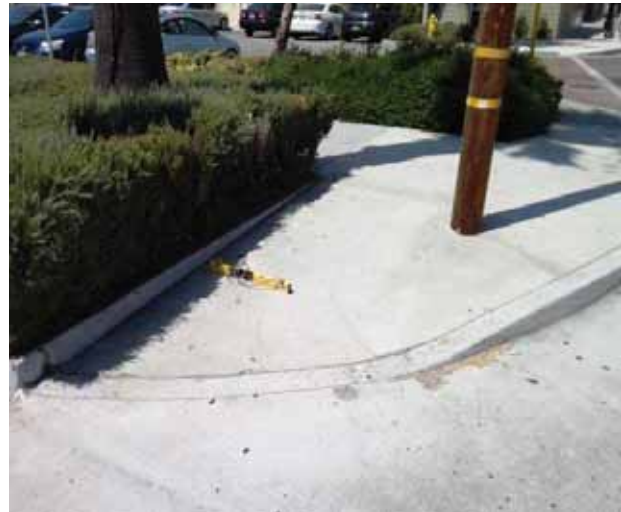
Code Reference ADA 303.3, CA 11B-303.3

Install curb ramp \$1,440

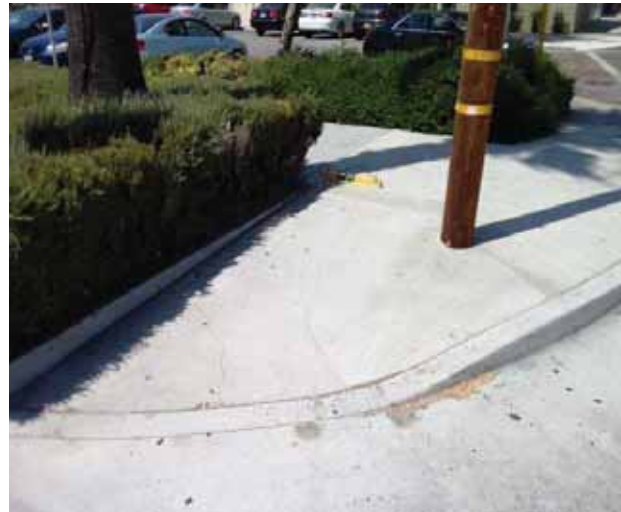
Recommendation Up to 2.08 percent

Code Reference ADA 402, 406.4, 403.3, 406.1, CA 11B-406.5.3

Provide compliant landing \$1,260

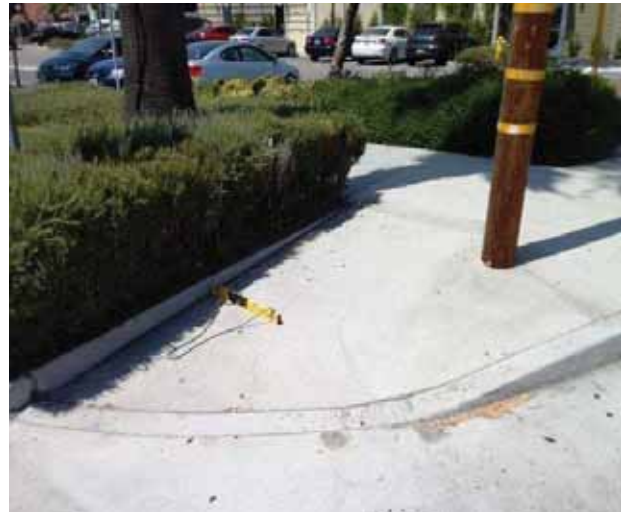
Recommendation Up to 8.33 percent

Code Reference ADA 406, 406.1, 405.2, CA 11B-406

Install curb ramp \$1,300

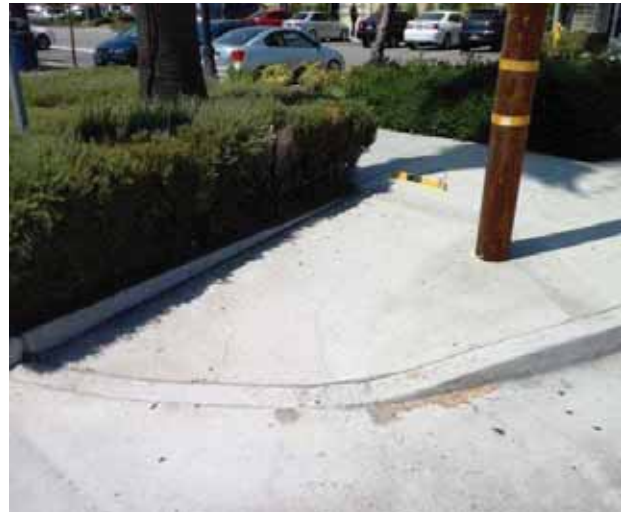
Recommendation Up to 2.08 percent

Code Reference ADA 402, 406.4, 403.3, 406.1, CA 11B-406.5.3

Provide compliant landing \$1,260

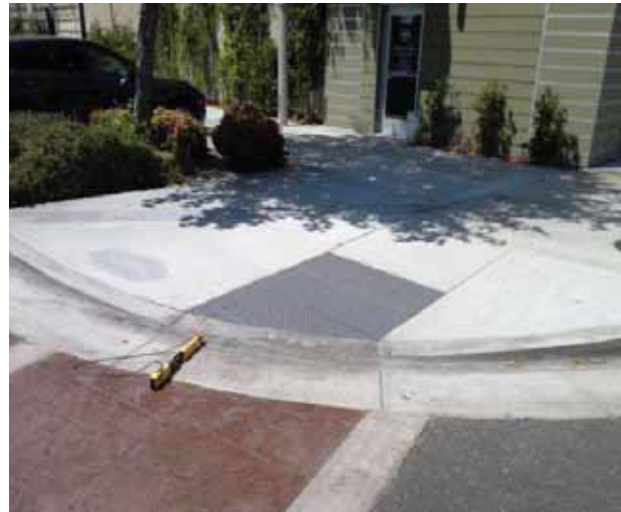
Recommendation Up to 5.00 percent

Code Reference ADA 406, 406.2, CA 11B-406.5.8

Repave landing \$1,260

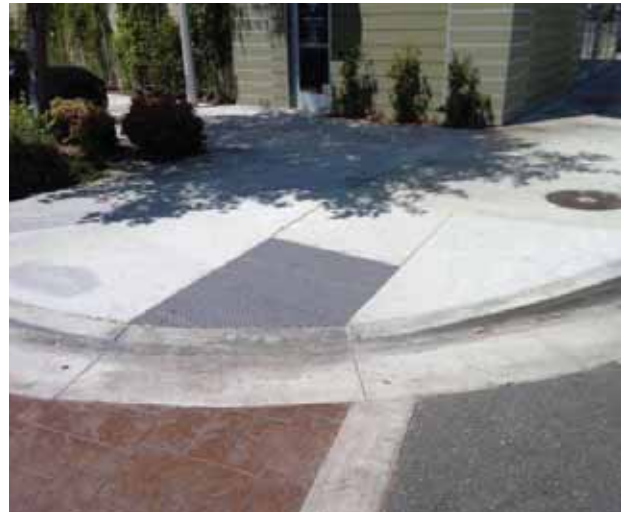
Code Reference CA 11B-406.5.12

Provide detectable warning to surface \$248

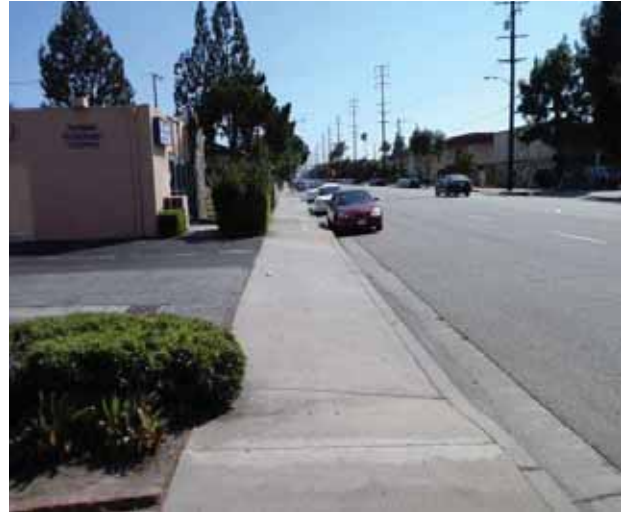
Code Reference ADA 705,CA 11B-705.1.2.5,CA 11B-247.1.2.5

Install compliant detectable warnings \$190

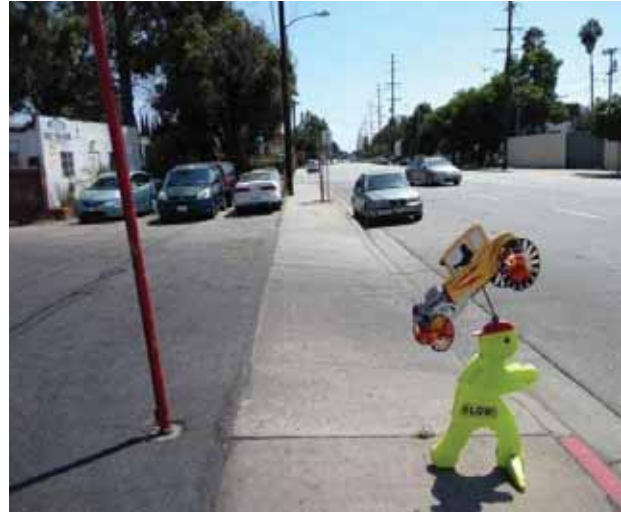
Code Reference ADA 705,CA 11B-705.1.2.5,CA 11B-247.1.2.5

Install compliant detectable warnings \$190

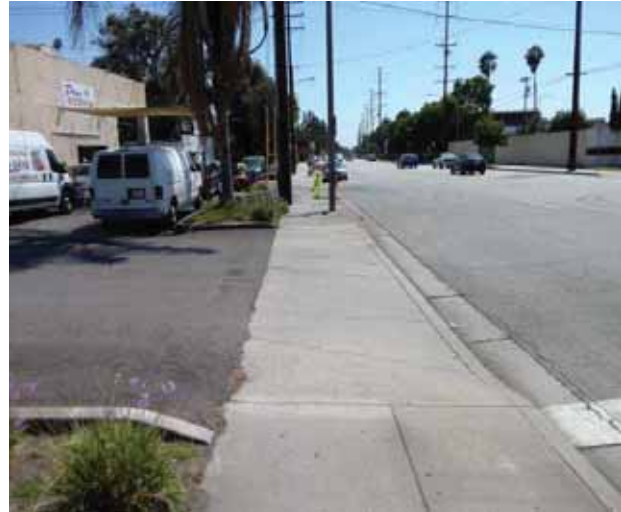
Code Reference ADA 705,CA 11B-705.1.2.5,CA 11B-247.1.2.5

Install compliant detectable warnings \$190

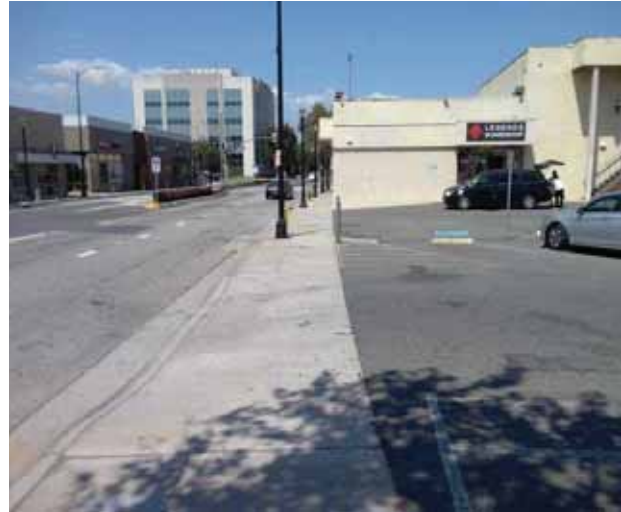
Code Reference ADA 705,CA 11B-705.1.2.5,CA 11B-247.1.2.5

Install compliant detectable warnings \$190

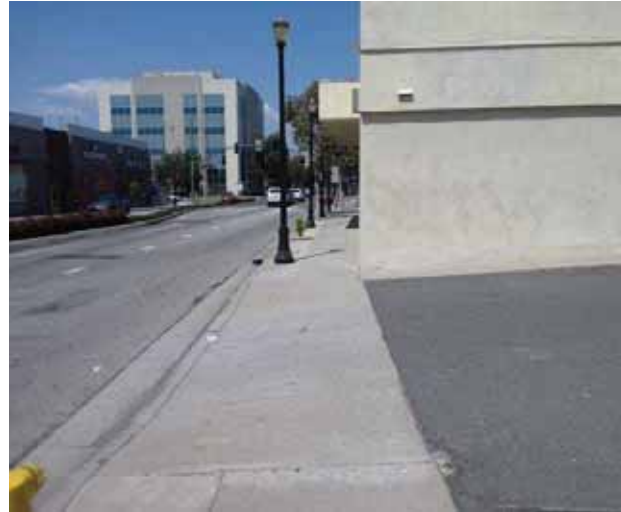
Code Reference ADA 705,CA 11B-705.1.2.5,CA 11B-247.1.2.5

Install compliant detectable warnings \$190

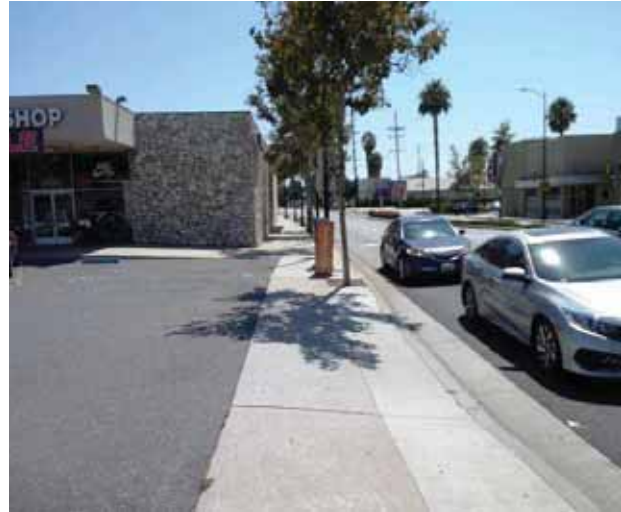
Code Reference ADA 705,CA 11B-705.1.2.5,CA 11B-247.1.2.5

Install compliant detectable warnings \$190

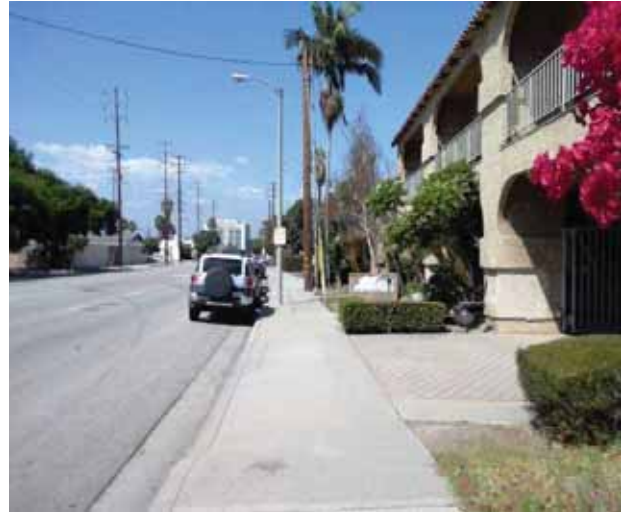
Code Reference ADA 705,CA 11B-705.1.2.5,CA 11B-247.1.2.5

Install compliant detectable warnings \$190

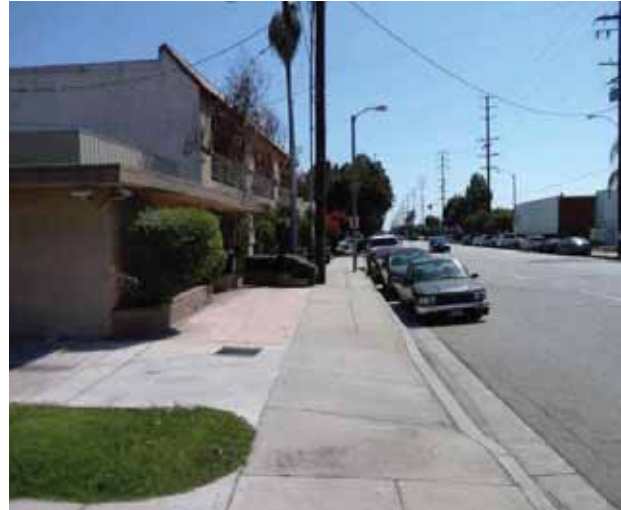
Code Reference ADA 705,CA 11B-705.1.2.5,CA 11B-247.1.2.5

Install compliant detectable warnings \$190

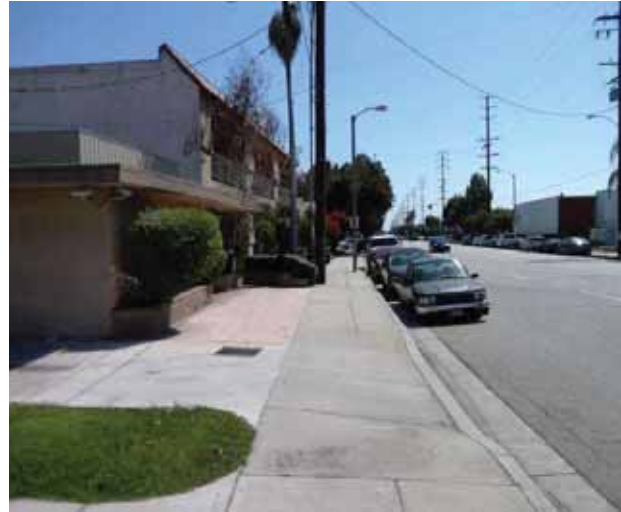
Recommendation Up to 2.08 percent

Code Reference ADA 206, 302, CA 11B-403.3

Repave surface \$1,092

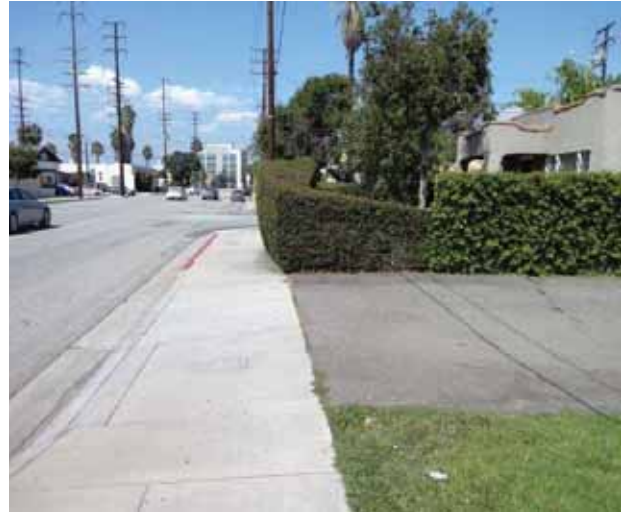
Code Reference ADA 705,CA 11B-705.1.2.5,CA 11B-247.1.2.5

Install compliant detectable warnings \$190

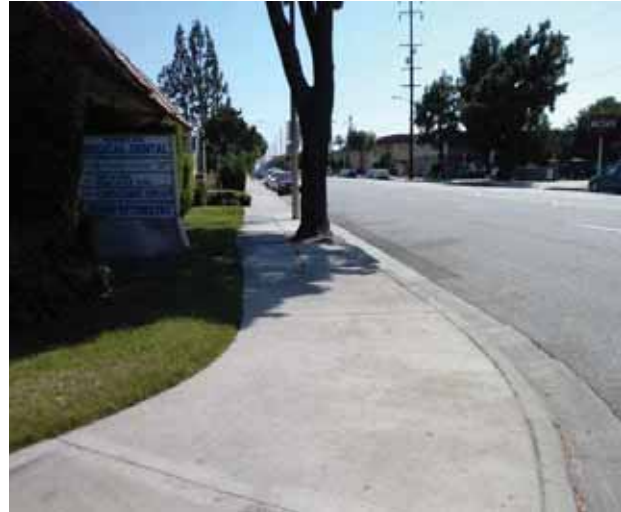
Recommendation At least 48.00 inches

Code Reference ADA 206, 302, CA 11B-403.5.1

Widen the sidewalk to the recommended value.

\$1,260

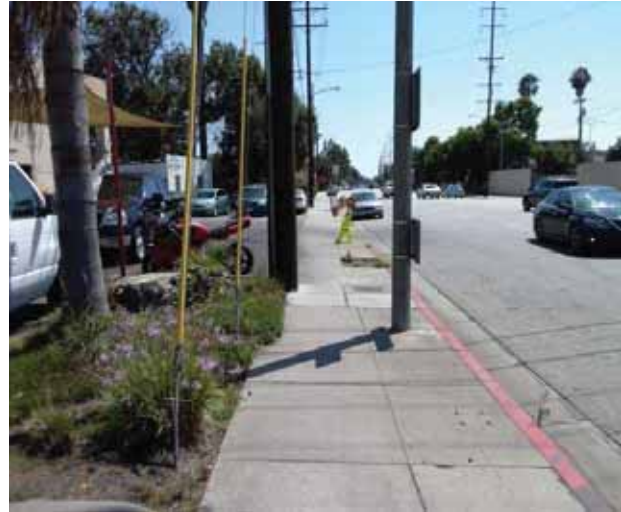
Code Reference ADA 206, 302, CA 11B-403.3

Repave the sidewalk surface with the recommended cross slope.

Recommendation Up to 2.08 percent

Repave surface \$1,092

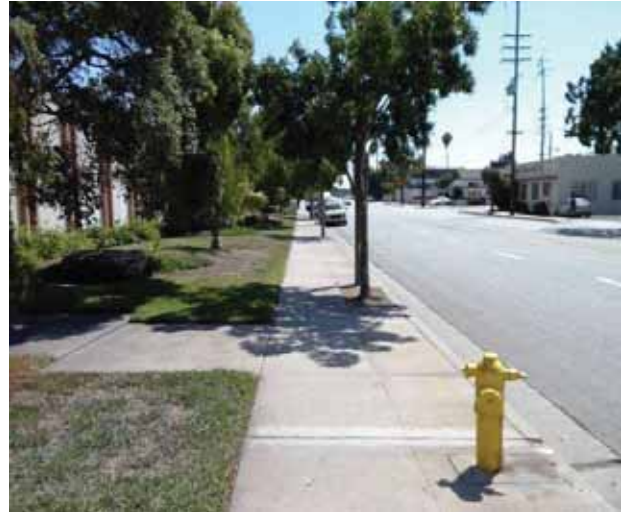
Code Reference ADA 206, 302, CA 11B-403.3

Repave the sidewalk surface with the recommended cross slope.

Recommendation Up to 2.08 percent

Repave surface \$1,092

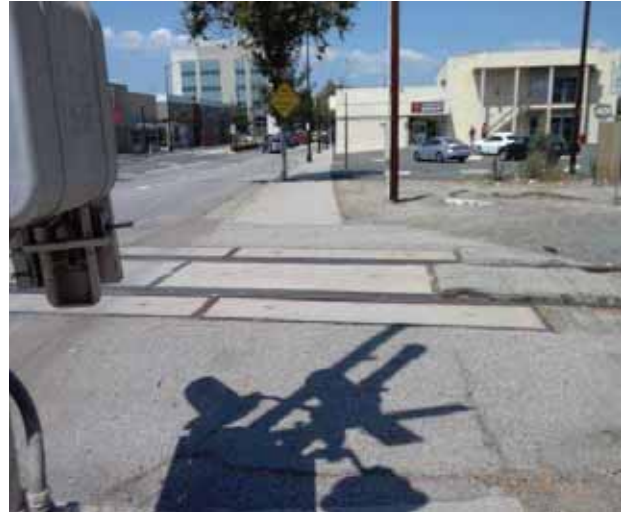
Code Reference ADA 206, 302

Notes : Surface is Rough And Uneven For 7 Feet

Repave the sidewalk surface with the recommended running slope.

Recommendation Up to 5.00 percent

Repave surface \$1,184

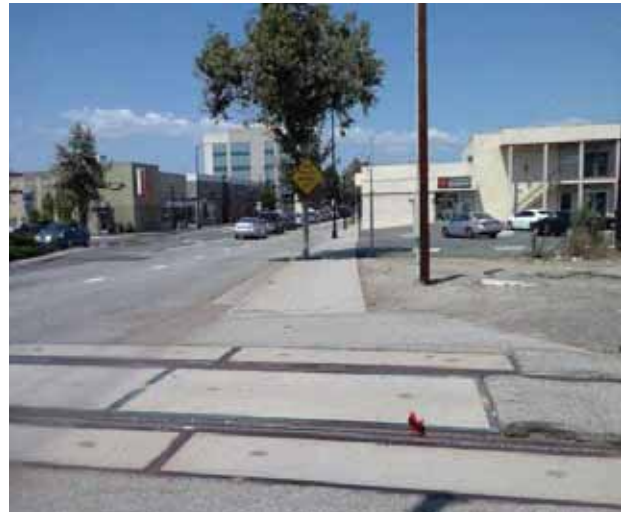
Code Reference ADA 302

Notes : Railroad Crossing Opening = 2.87"

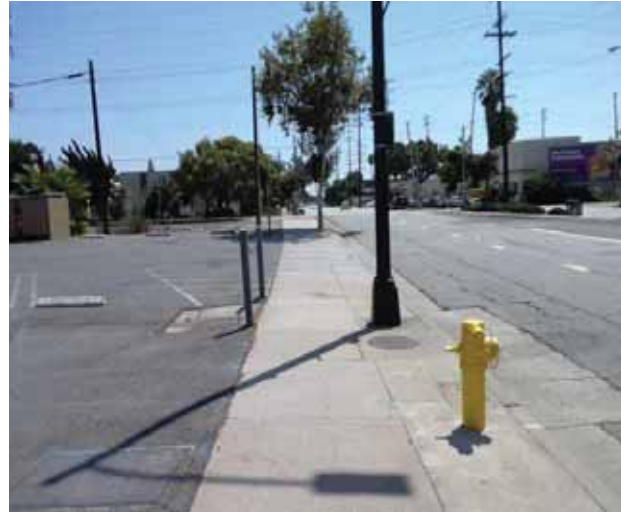
Code Reference ADA 206, 302, CA 11B-403.3

Notes : Surface is Rough And Uneven For 9 Feet

Repave the sidewalk surface with the recommended cross slope.

Recommendation Up to 2.08 percent

Repave surface \$1,092

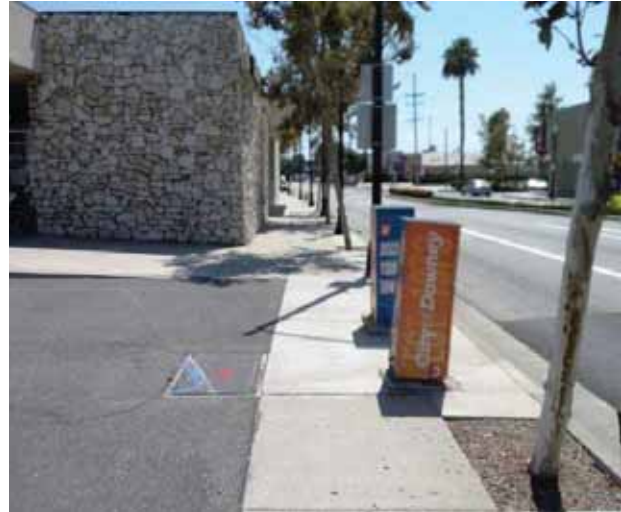
Code Reference ADA 206, 302, CA 11B-403.3

Repave the sidewalk surface with the recommended cross slope.

Recommendation Up to 2.08 percent

Repave surface \$1,092

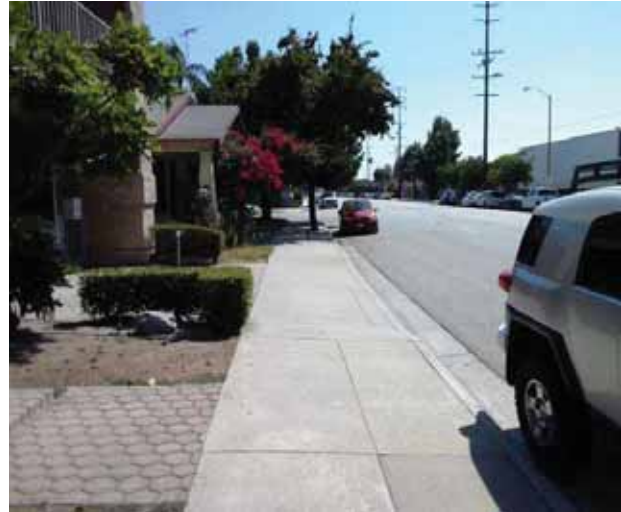
Code Reference ADA 206, 302, CA 11B-403.3

Repave the sidewalk surface with the recommended cross slope.

Recommendation Up to 2.08 percent

Repave surface \$1,092

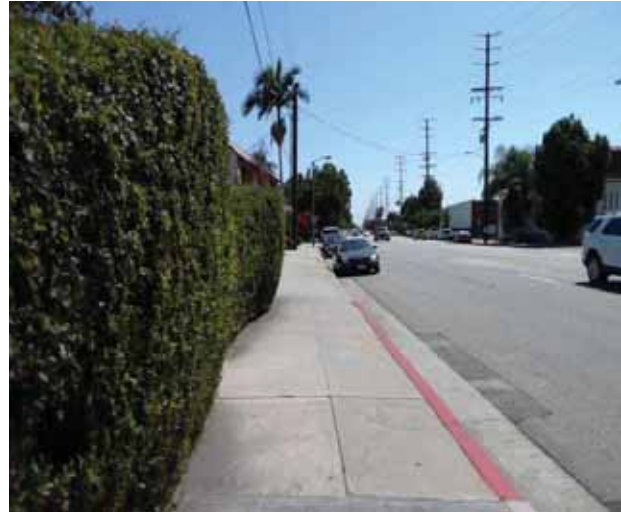
Code Reference ADA 206, 302, CA 11B-403.3

Repave the sidewalk surface with the recommended cross slope.

Recommendation Up to 2.08 percent

Repave surface \$1,092

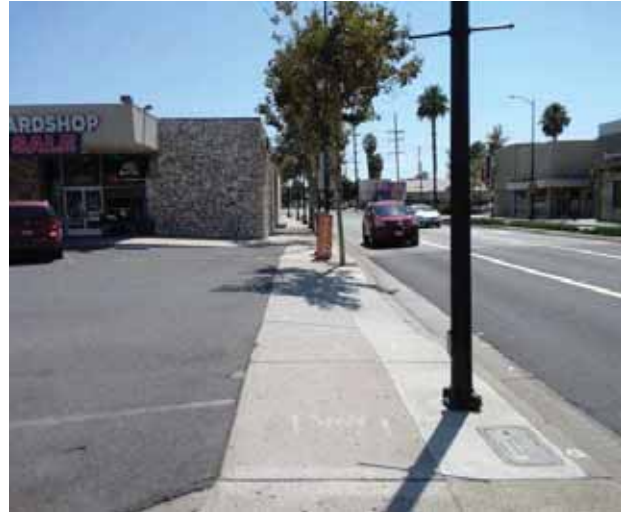
Code Reference ADA 206, 302

\$2,400

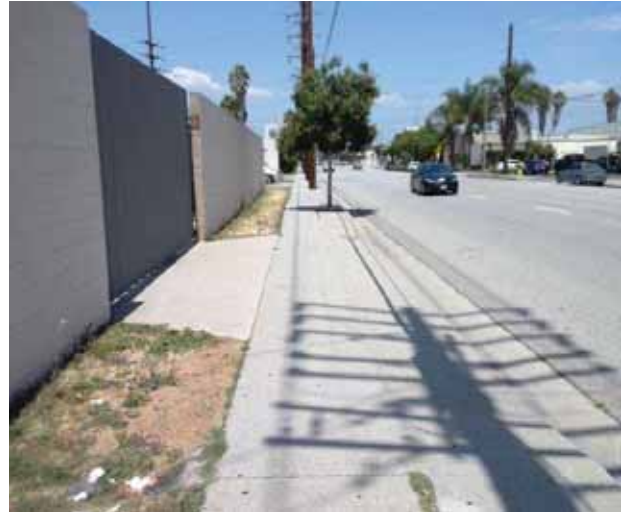
Code Reference ADA 705,CA 11B-705.1.2.5,CA 11B-247.1.2.5

Install compliant detectable warnings \$190

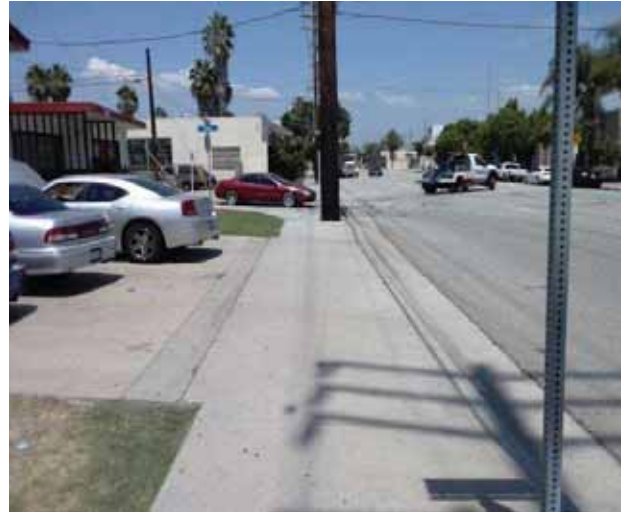
Code Reference ADA 705,CA 11B-705.1.2.5,CA 11B-247.1.2.5

Install compliant detectable warnings \$190

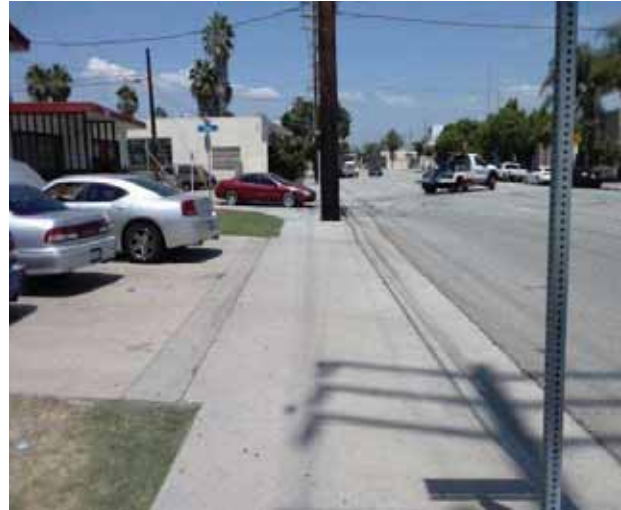
Code Reference ADA 206, 302, CA 11B-403.3

Recommendation Up to 2.08 percent

Repave surface \$1,092

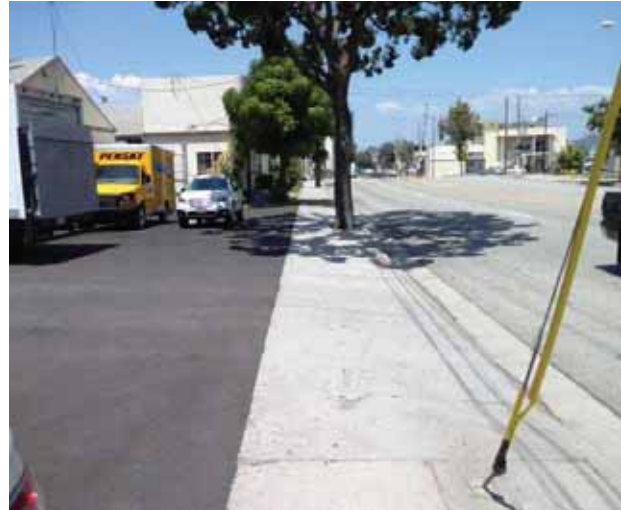
Code Reference ADA 705,CA 11B-705.1.2.5,CA 11B-247.1.2.5

Install compliant detectable warnings \$190

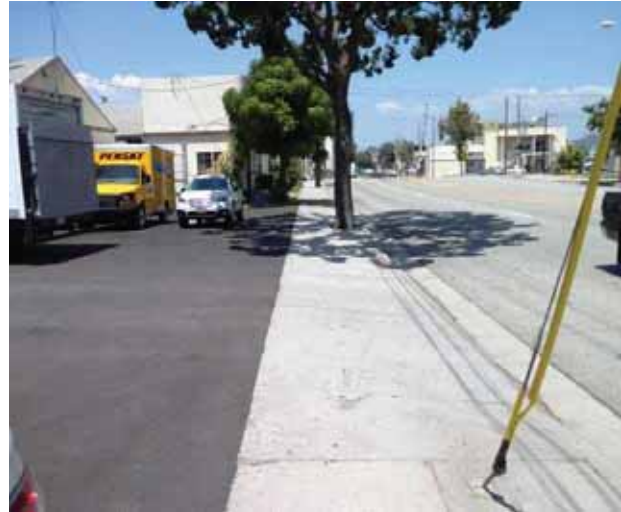
Code Reference ADA 206, 302, CA 11B-403.3

Recommendation Up to 2.08 percent

Repave surface \$1,092

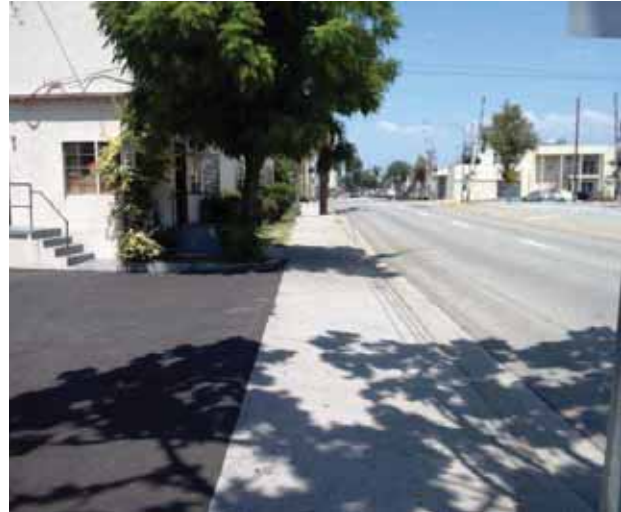
Code Reference ADA 705,CA 11B-705.1.2.5,CA 11B-247.1.2.5

Install compliant detectable warnings \$190

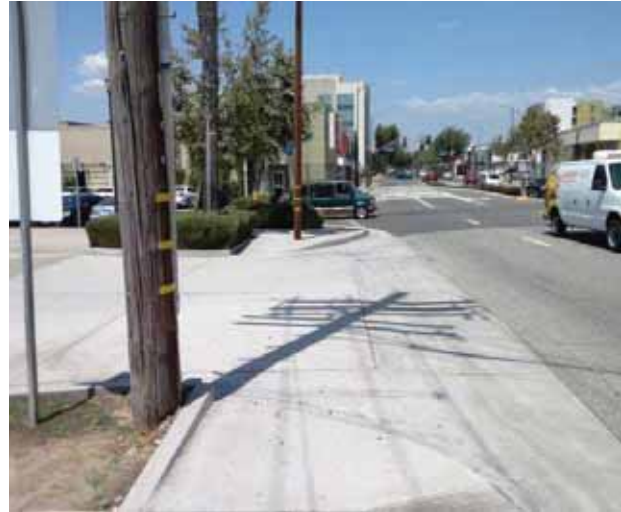
Code Reference ADA 705,CA 11B-705.1.2.5,CA 11B-247.1.2.5

Install compliant detectable warnings \$190

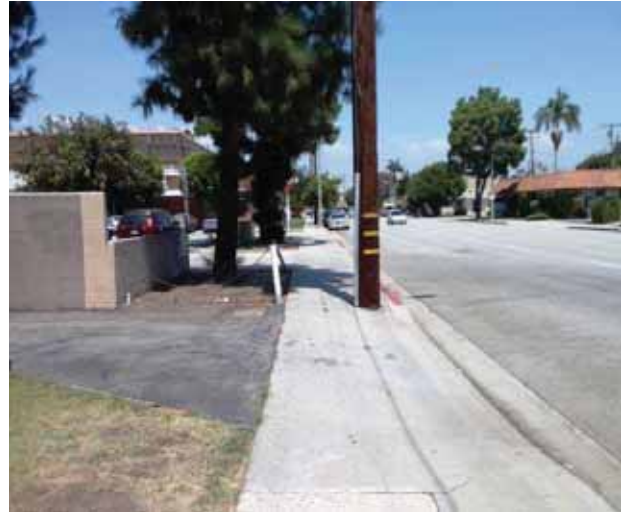
Code Reference ADA 206, 302, CA 11B-403.3

Recommendation Up to 2.08 percent

Repave surface \$1,092

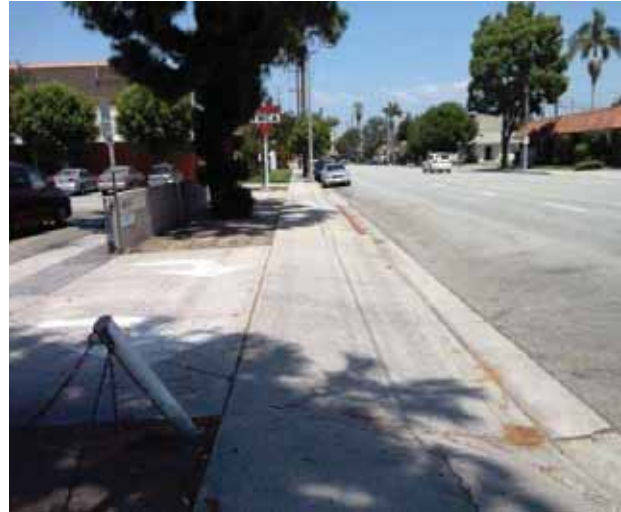
Code Reference ADA 705,CA 11B-705.1.2.5,CA 11B-247.1.2.5

Install compliant detectable warnings \$190

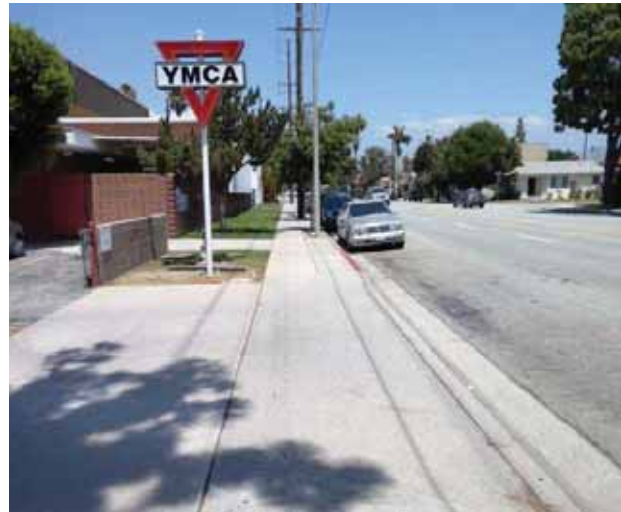
Code Reference ADA 705,CA 11B-705.1.2.5,CA 11B-247.1.2.5

Install compliant detectable warnings \$190

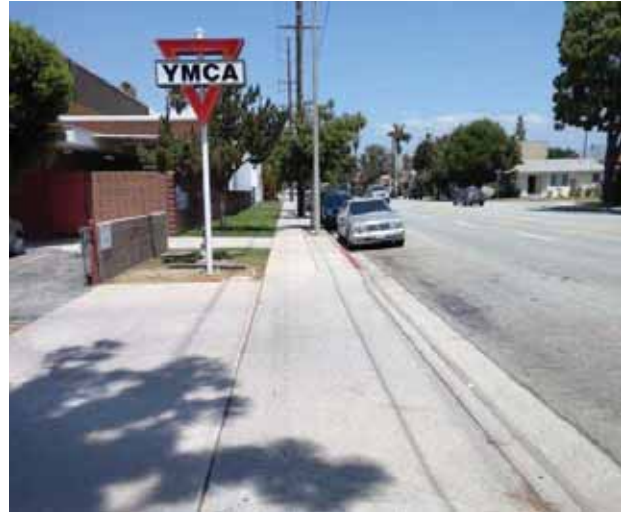
Code Reference ADA 206, 302, CA 11B-403.3

Recommendation Up to 2.08 percent

Repave surface \$1,092

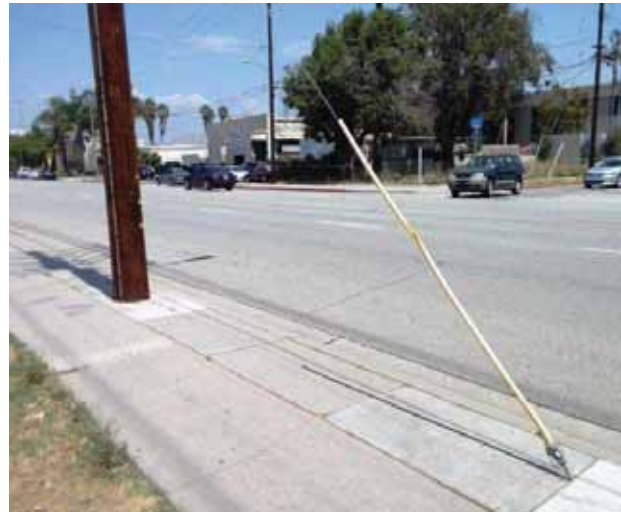
Sidewalks , Hazards & Gratings : Overhead Obstruction Height

Code Reference ADA 206, 307.4, CA 11B-307.4

Recommendation At least 80.00 inches

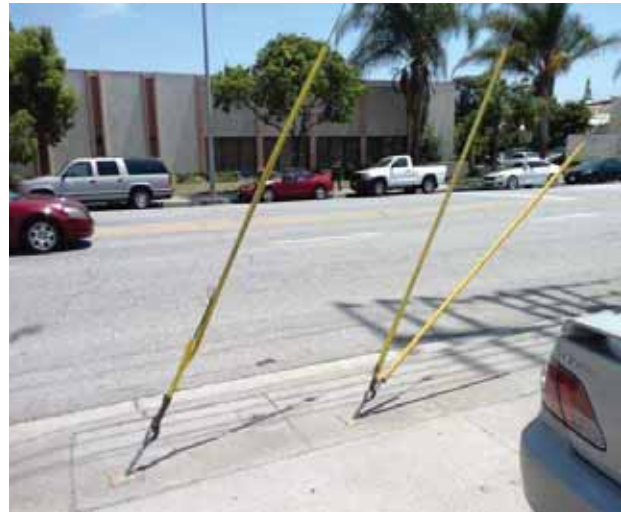
Sidewalks , Hazards & Gratings : Overhead Obstruction Height

Code Reference ADA 206, 307.4, CA 11B-307.4

Recommendation At least 80.00 inches

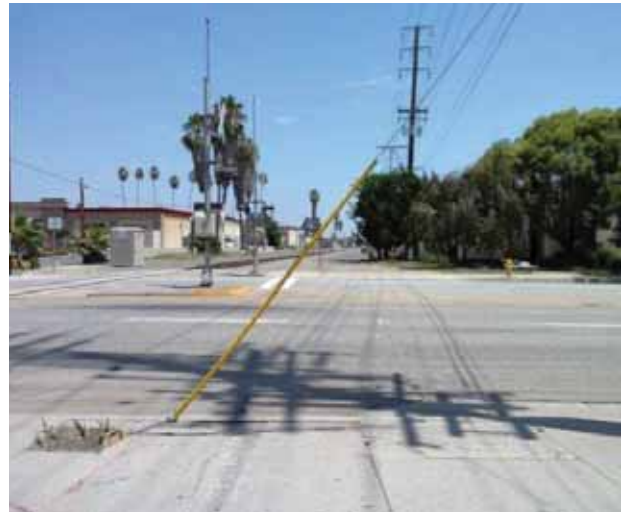
Sidewalks , Hazards & Gratings : Overhead Obstruction Height

Code Reference ADA 206, 307.4, CA 11B-307.4

Recommendation At least 80.00 inches

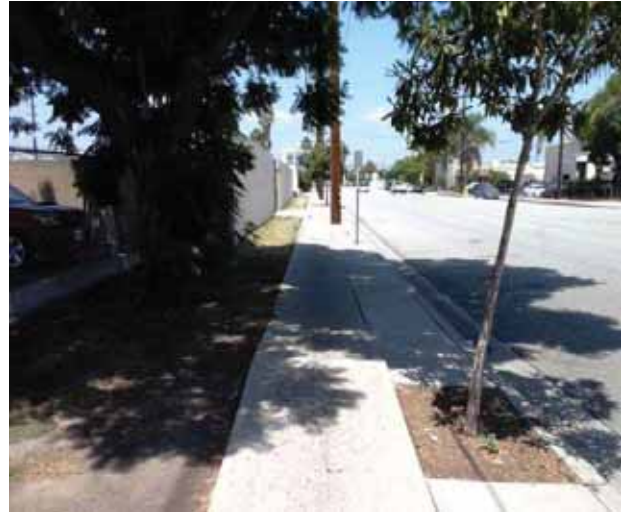
Code Reference ADA 206, 302

Repave the sidewalk surface with the recommended running slope.

Recommendation Up to 5.00 percent

Repave surface \$1,184

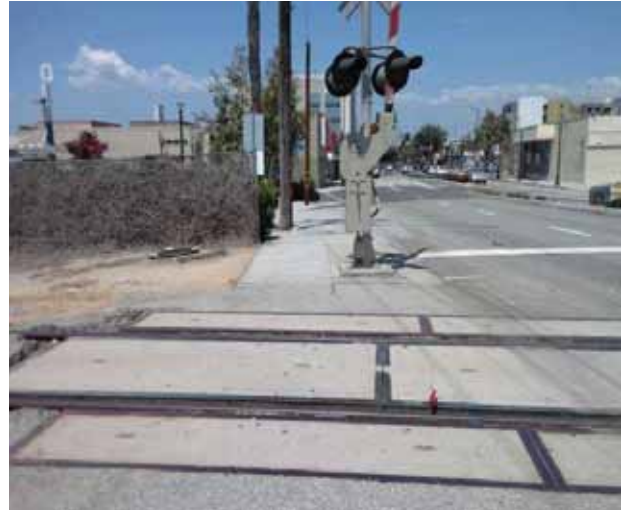
Code Reference ADA 302

Notes : Railroad Crossing Opening = 2.5"

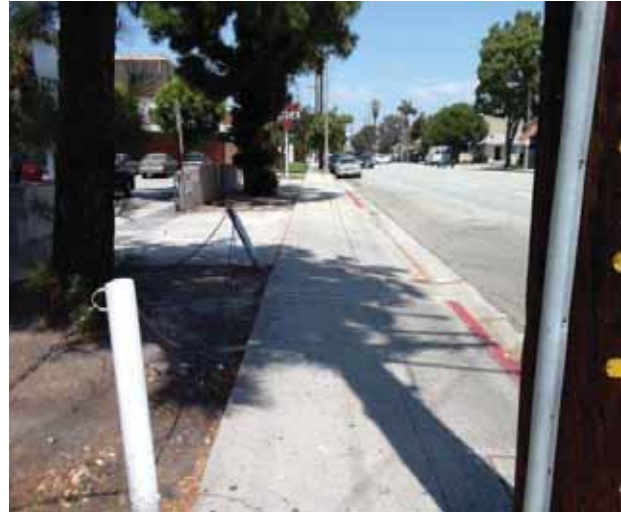
Code Reference ADA 206, 302, CA 11B-403.3

Repave the sidewalk surface with the recommended cross slope.

Recommendation Up to 2.08 percent

Repave surface \$1,092
