Accessibility Survey

City of Downey Downey Avenue & De Palma Street

Date of Inspection
1/31/2017

Prepared By
Disability Access Consultants
(800) 743-7067

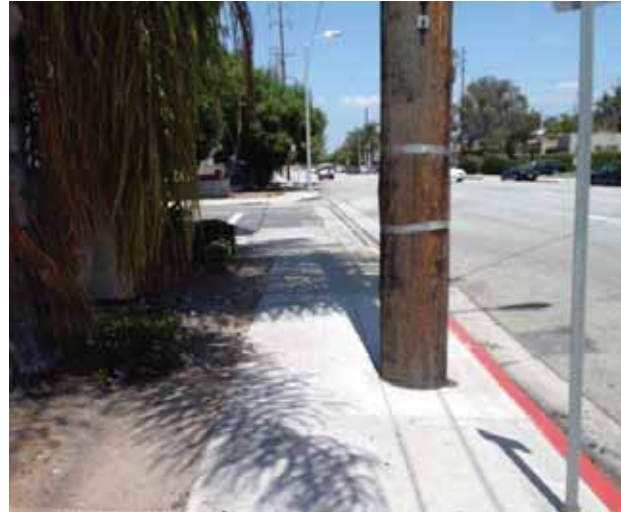
Code Reference ADA 206, 302, CA 11B-403.3

Repave the sidewalk surface with the recommended cross slope.

Recommendation Up to 2.08 percent

Repave surface \$1,092

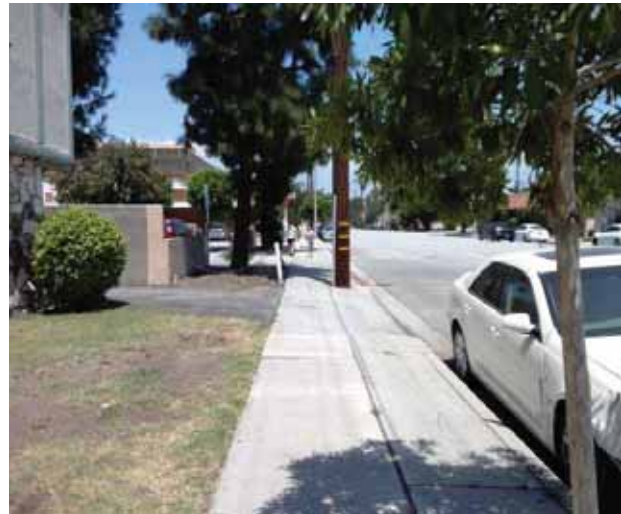
Code Reference ADA 206, 302

\$2,400
