Accessibility Survey

6th Street - Brookshire Avenue to Downey Avenue

Date of Inspection
7/18/2017

Disability Access Consultants

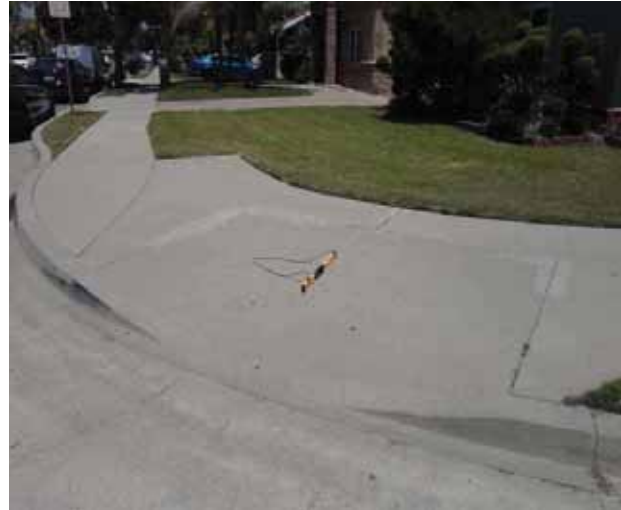
Recommendation

Recommendation Up to 10.00 percent

Install flared sides \$1,300

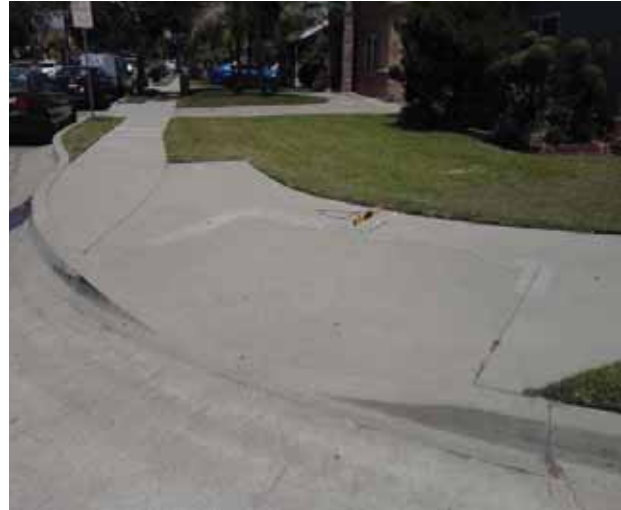
Recommendation

Recommendation Up to 0.50 inches

Patch lip at curb ramp \$255

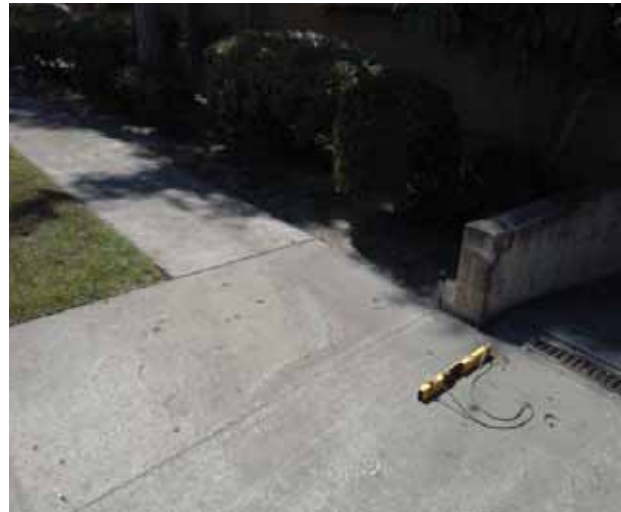
Recommendation

Recommendation Up to 5.00 percent

Repave landing \$1,260

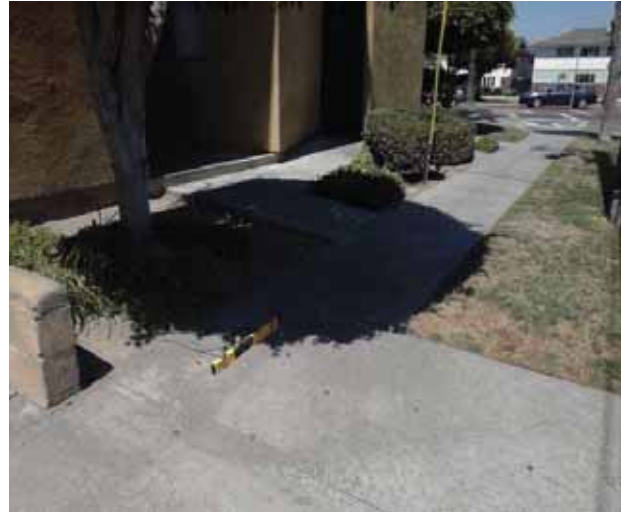
On-Site Finding Not Found

Recommendation See Recommendation

Provide detectable warning to surface \$248

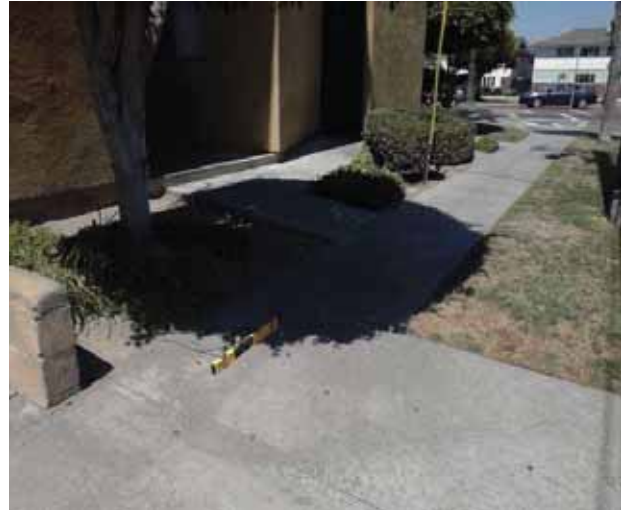
Recommendation

Recommendation Up to 8.33 percent

Install curb ramp \$1,300

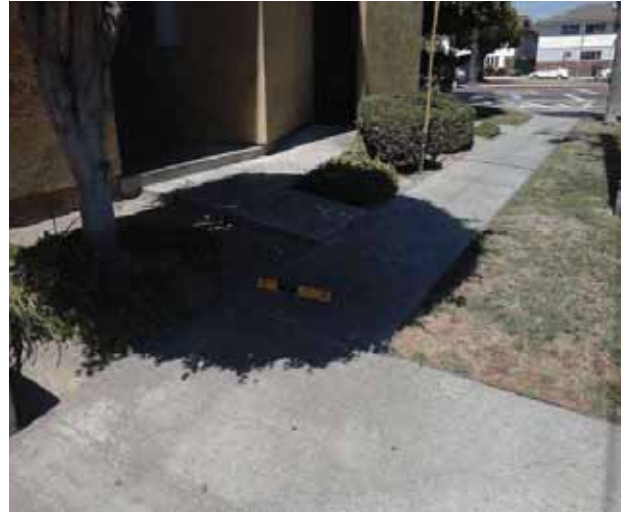
Recommendation

Recommendation Up to 2.08 percent

Provide compliant landing \$1,260

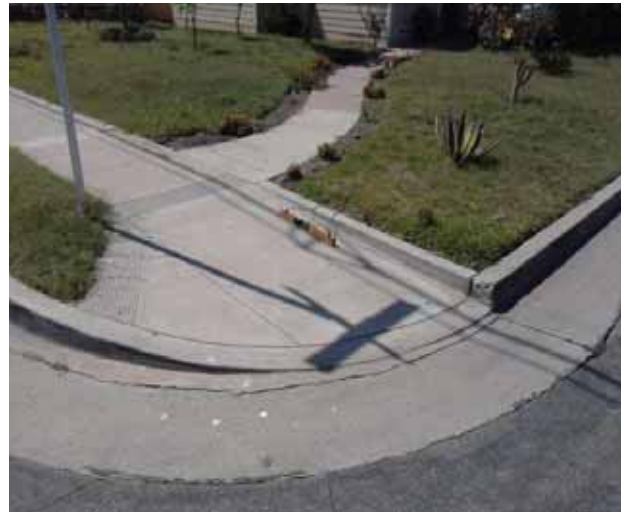
On-Site Finding Not Found

Recommendation See Recommendation

Provide detectable warning to surface \$248

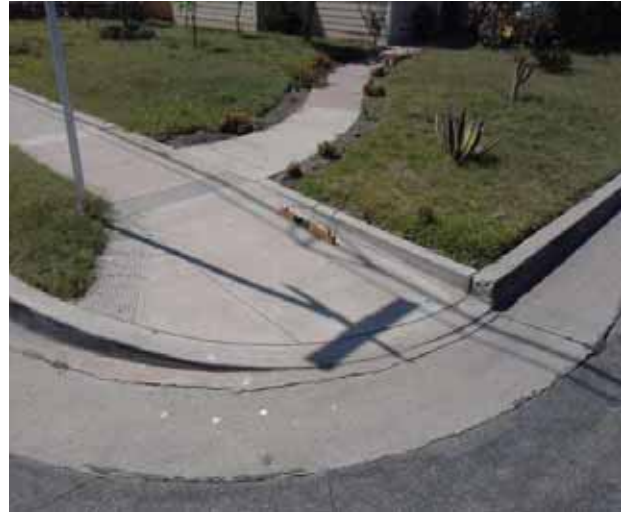
Recommendation

Recommendation Up to 8.33 percent

Install curb ramp \$1,300

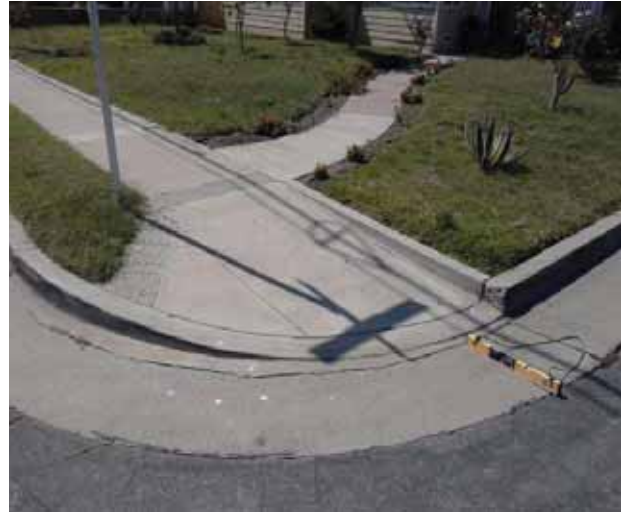
Recommendation

Recommendation Up to 5.00 percent

Repave landing \$1,260

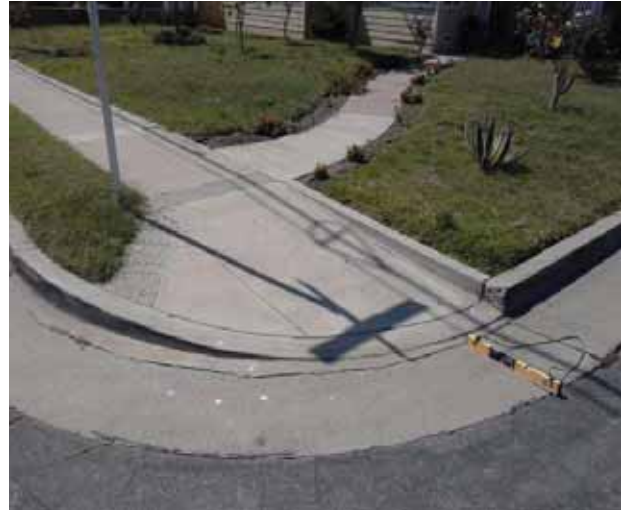
Recommendation

Recommendation Up to 0.50 inches

Patch lip at curb ramp \$255

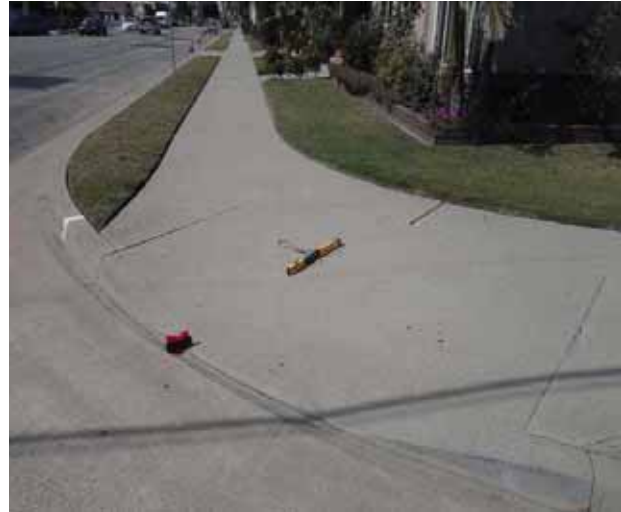
On-Site Finding Not Found

Recommendation See Recommendation

Provide detectable warning to surface \$248

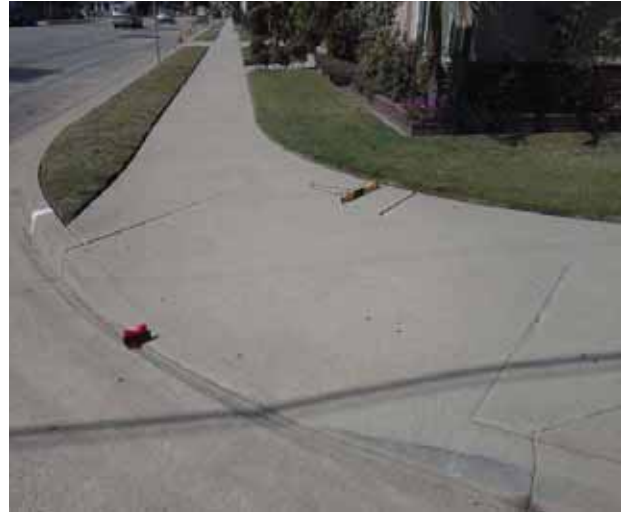
Recommendation

Recommendation Up to 0.50 inches

Patch lip at curb ramp \$255

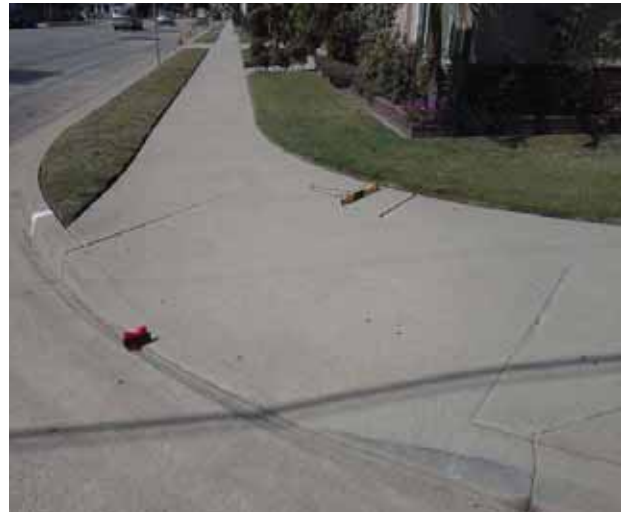
Recommendation

Recommendation Up to 2.08 percent

Provide compliant landing \$1,260

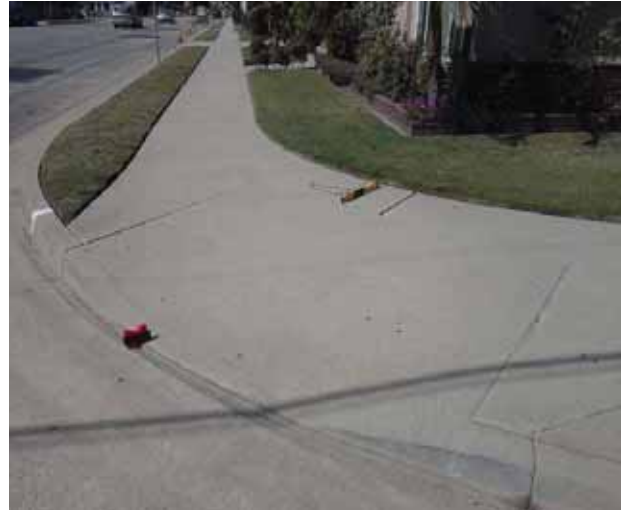
Recommendation

Recommendation At least 48.00 inches

Provide compliant landing \$240

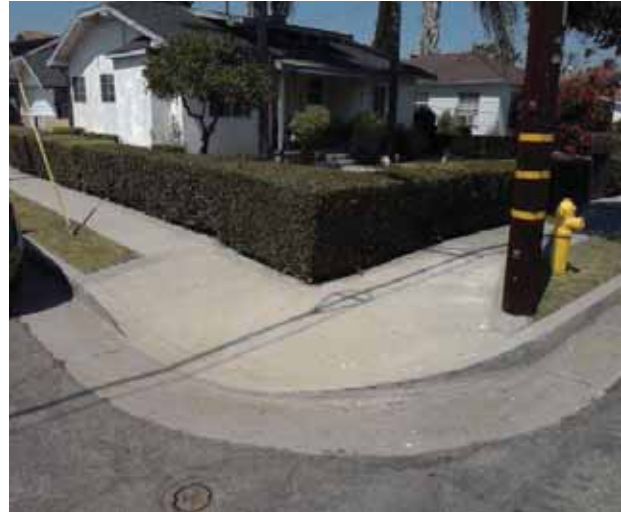
On-Site Finding Not Found

Recommendation See Recommendation

Provide detectable warning to surface \$248

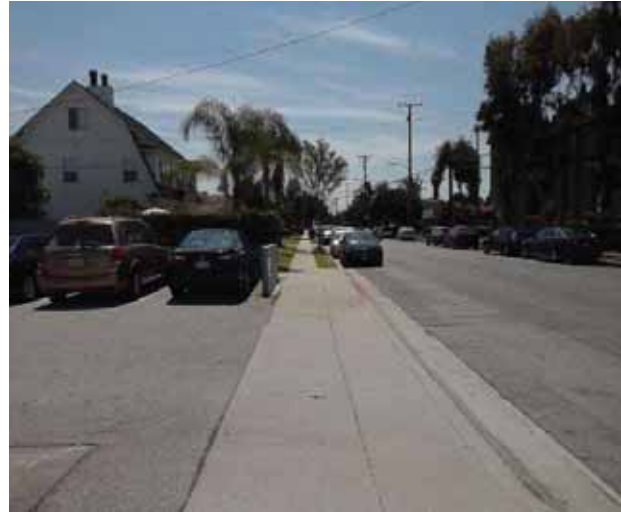
Recommendation

Recommendation Up to 2.08 percent

Repave surface \$1,092

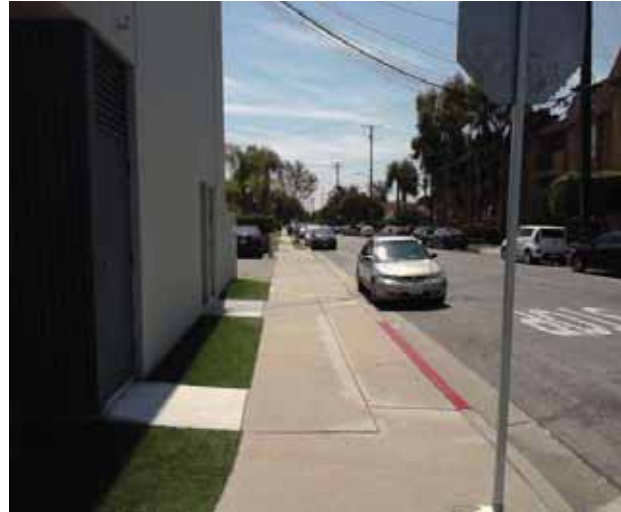
Recommendation Up to 2.08 percent

Repave the sidewalk surface with the recommended cross slope.

Repave surface \$1,092

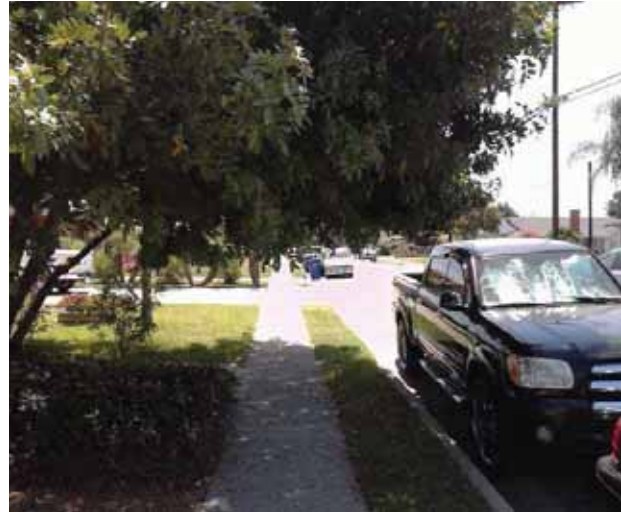
Sidewalks , Hazards & Gratings : Overhead Obstruction Height

Recommendation At least 80.00 inches

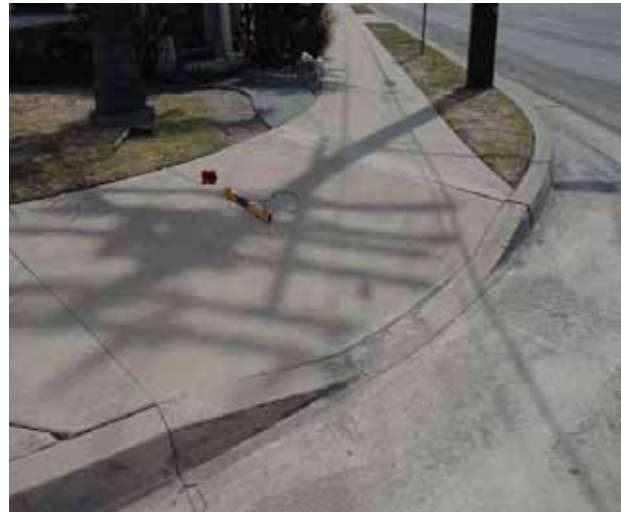
Code Reference CA 11B-406.5.12

Provide detectable warning to surface \$248

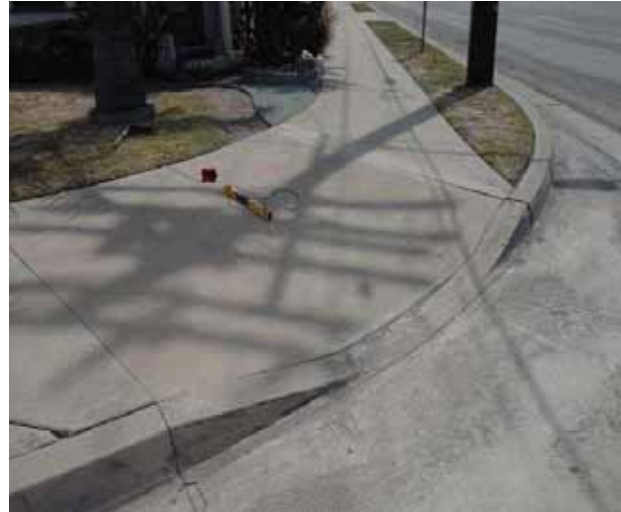
Recommendation At least 48.00 inches

Code Reference ADA 406, 406.1, 405.5, CA 11B-406.5.2

Install curb ramp \$1,300

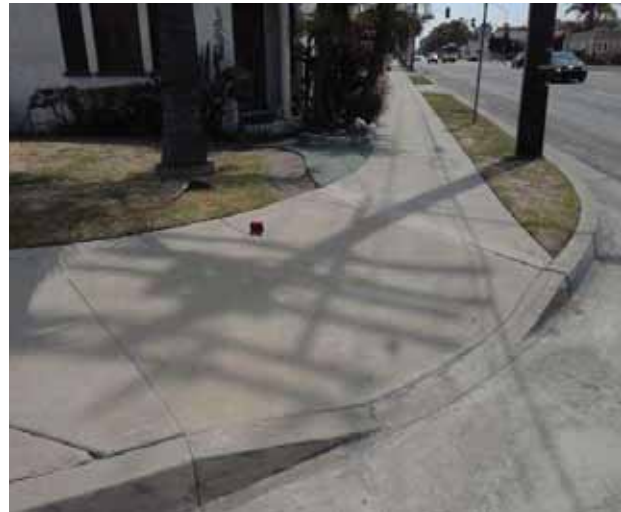
Code Reference ADA 302, 406.2

Patch lip at curb ramp \$155

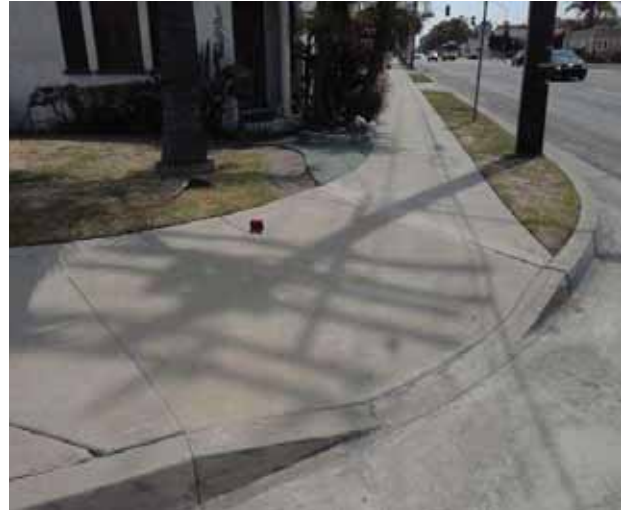
Recommendation At least 48.00 inches

Code Reference ADA 406, 406.4, CA 11B-406.5.3

Provide compliant landing \$240

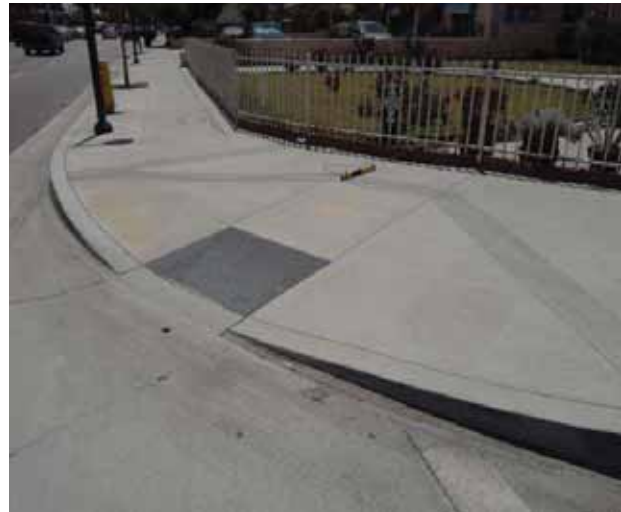
Recommendation Up to 2.08 percent

Code Reference ADA 402, 406.4, 403.3, 406.1, CA 11B-406.5.3

Provide compliant landing \$1,260

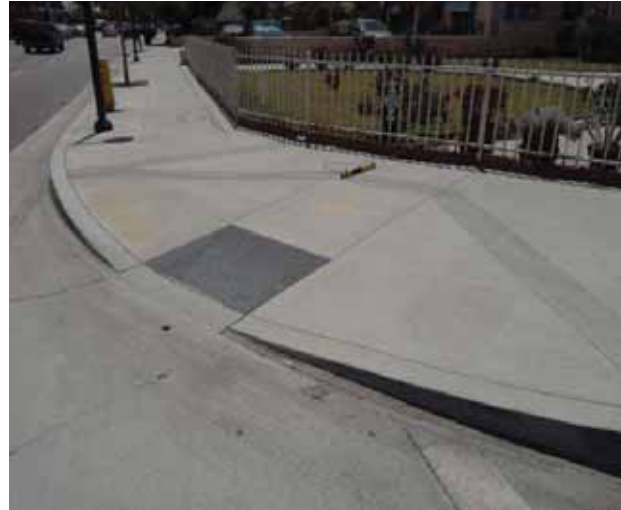
Recommendation At least 48.00 inches

Code Reference ADA 406, 406.4, CA 11B-406.5.3

Provide compliant landing \$240

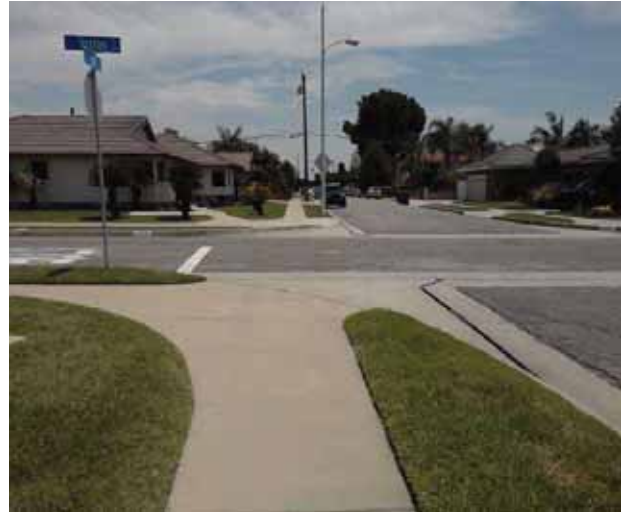
Code Reference ADA 206, 302,CA 11B-403.3

Repave the sidewalk surface with the recommended cross slope.

Recommendation Up to 2.08 percent

Repave surface \$1,092

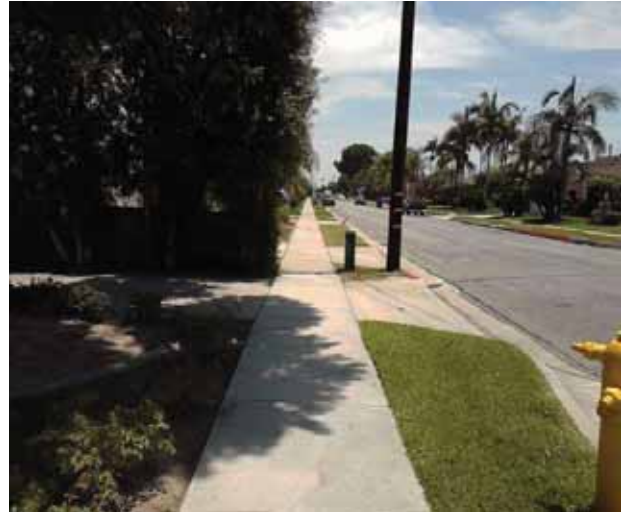
Code Reference ADA 206, 302, CA 11B-403.3

Repave the sidewalk surface with the recommended cross slope.

Recommendation Up to 2.08 percent

Repave surface \$1,092

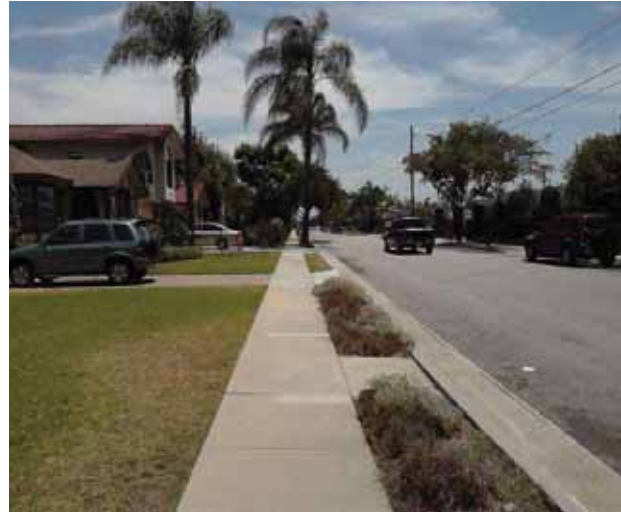
Code Reference ADA 206, 302, CA 11B-403.3

Repave the sidewalk surface with the recommended cross slope.

Recommendation Up to 2.08 percent

Repave surface \$1,092

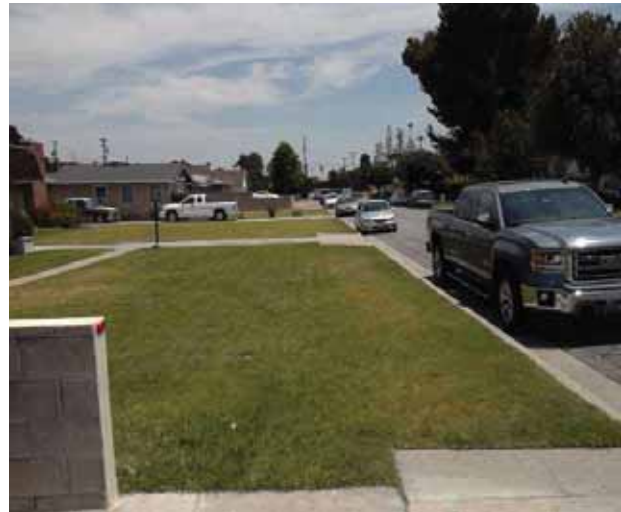
Sidewalks : Missing Sidewalk

Section of sidewalk is missing and consists of dirt, grass or gravel.

Provide a compliant sidewalk for the missing section.

\$1,260

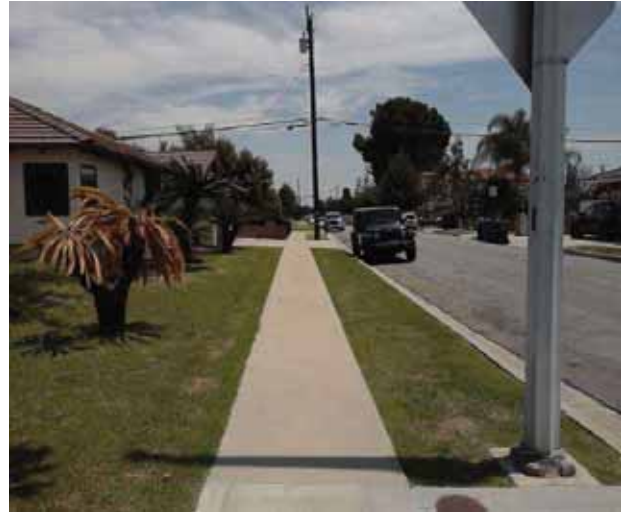
Code Reference ADA 206, 302,CA 11B-403.3

Repave the sidewalk surface with the recommended cross slope.

Recommendation Up to 2.08 percent

Repave surface \$1,092

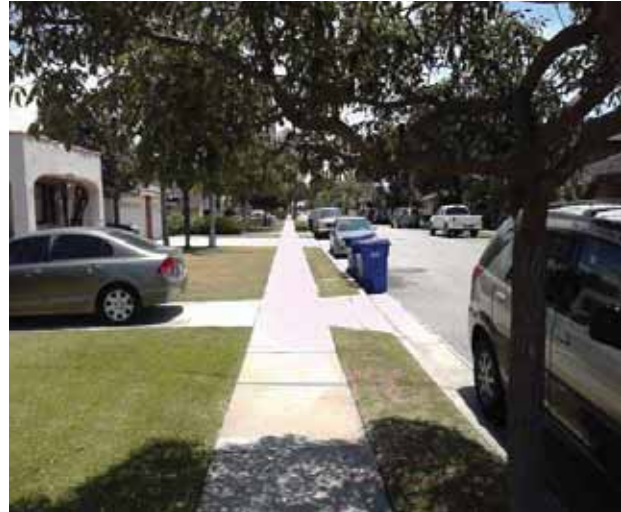
Sidewalks , Hazards & Gratings : Overhead Obstruction Height

Recommendation At least 80.00 inches

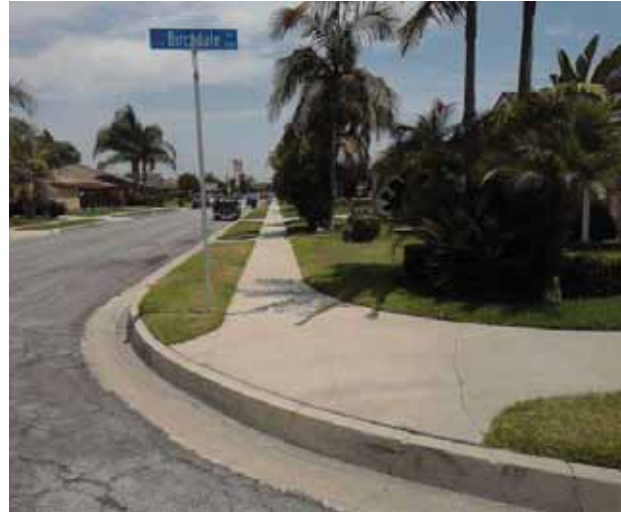
Sidewalks , Hazards & Gratings : Curb is on Path of Travel

Install curb ramp \$2,500

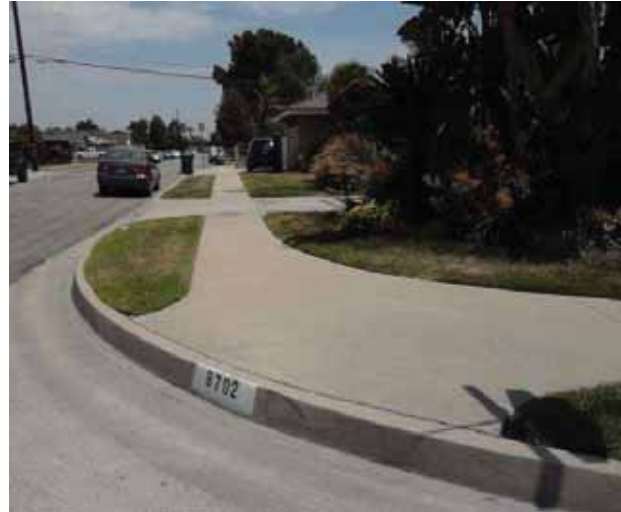
Sidewalks , Hazards & Gratings : Curb is on Path of Travel

Install curb ramp \$2,500

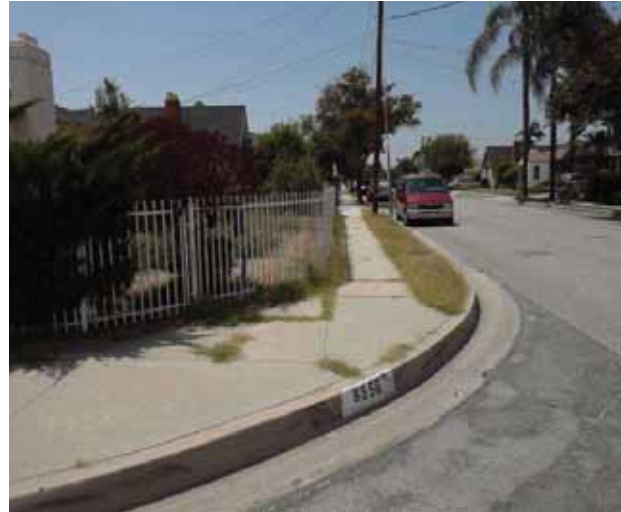
Sidewalks , Hazards & Gratings : Curb is on Path of Travel

Install curb ramp \$2,500

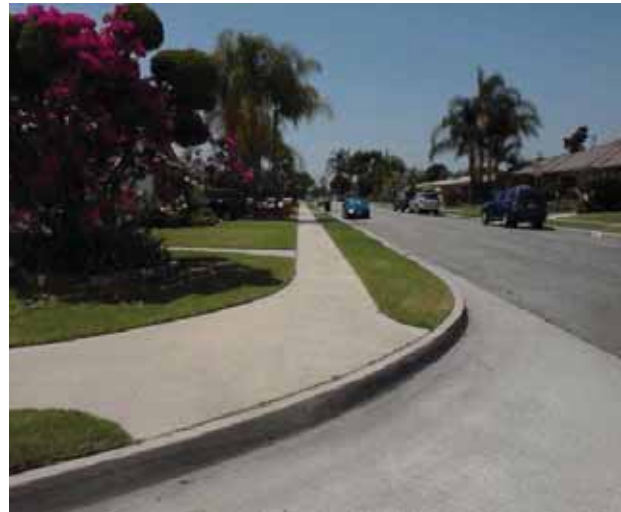
Sidewalks , Hazards & Gratings : Curb is on Path of Travel

Install curb ramp \$2,500

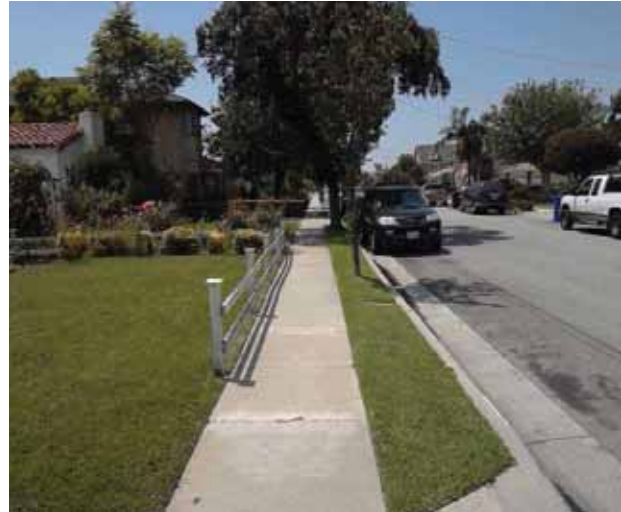
Code Reference ADA 206, 302,CA 11B-403.3

Repave the sidewalk surface with the recommended cross slope.

Recommendation Up to 2.08 percent

Repave surface \$1,092

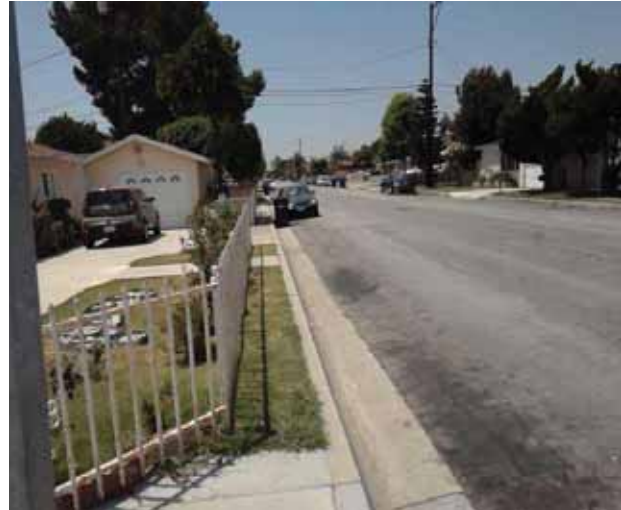
Sidewalks : Missing Sidewalk

Section of sidewalk is missing and consists of dirt, grass or gravel.

Provide a compliant sidewalk for the missing section.

\$1,260

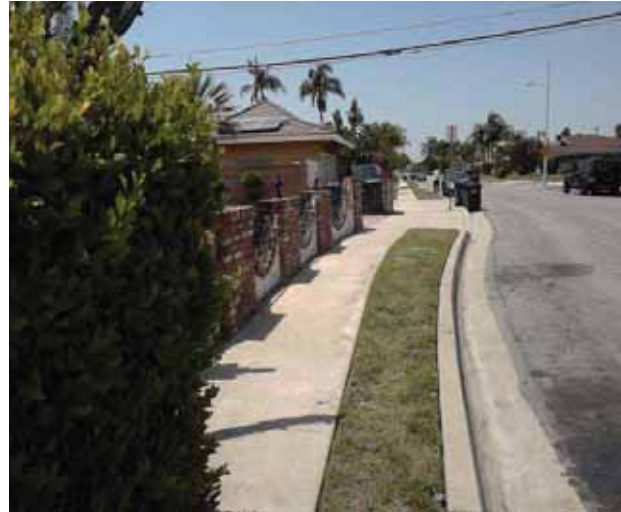
Code Reference ADA 206, 302,CA 11B-403.3

Repave the sidewalk surface with the recommended cross slope.

Recommendation Up to 2.08 percent

Repave surface \$1,092

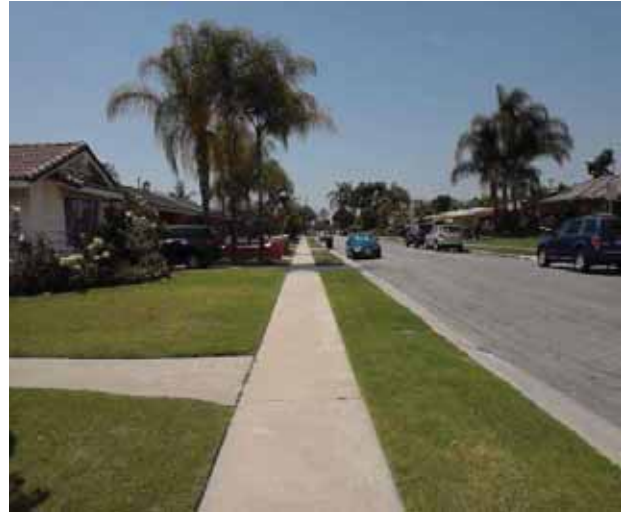
Code Reference ADA 206, 302,CA 11B-403.3

Repave the sidewalk surface with the recommended cross slope.

Recommendation Up to 2.08 percent

Repave surface \$1,092

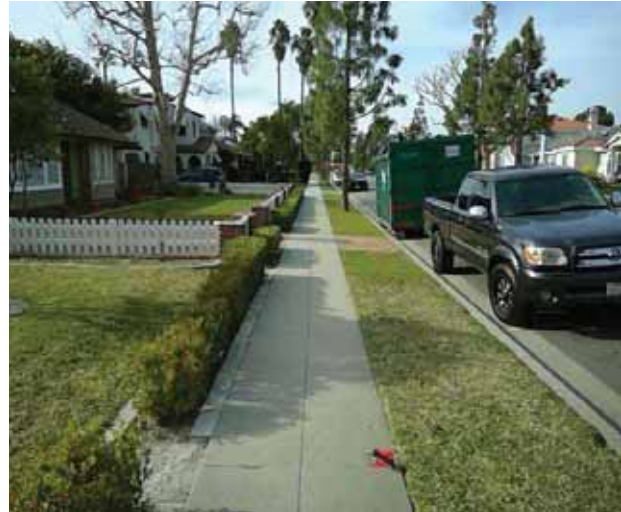
There is a change in elevation greater than recommended value.

Ensure that the change in elevation is within the recommended value.

Recommendation Up to 0.25 inches

Remove tripping hazards \$198

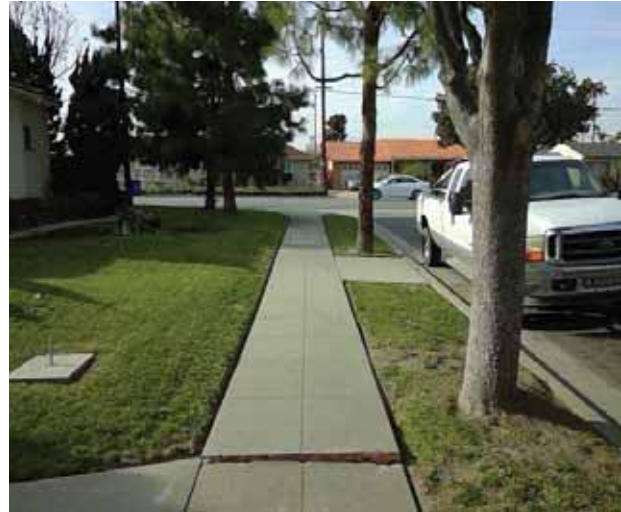
There is a change in elevation greater than recommended value.

Ensure that the change in elevation is within the recommended value.

Recommendation Up to 0.25 inches

Remove tripping hazards \$198

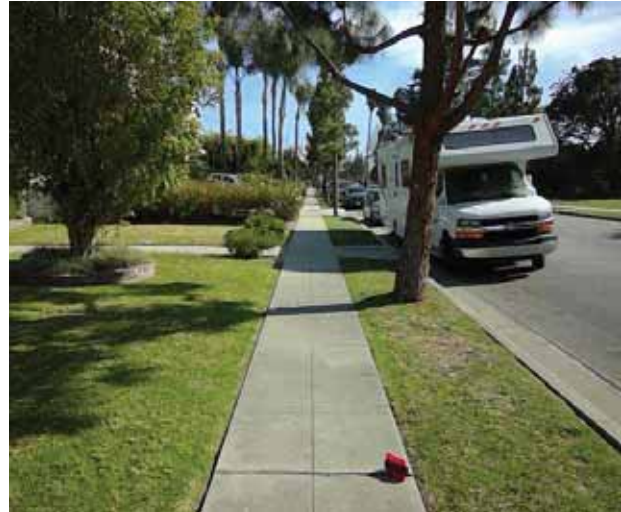
There is a change in elevation greater than recommended value.

Ensure that the change in elevation is within the recommended value.

Recommendation Up to 0.25 inches

Remove tripping hazards \$198

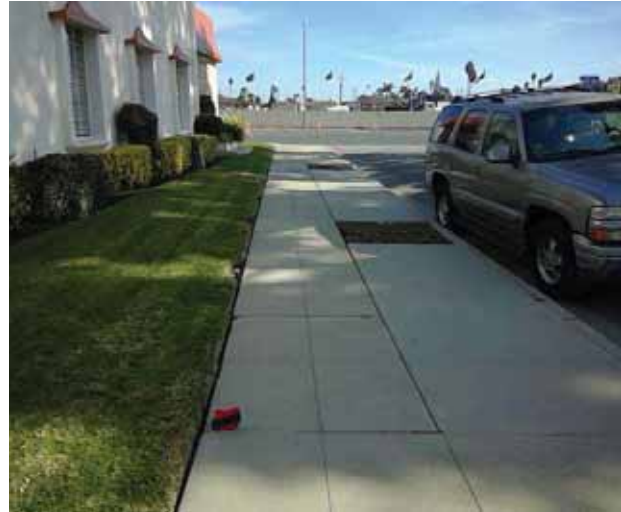
There is a change in elevation greater than recommended value.

Ensure that the change in elevation is within the recommended value.

Recommendation Up to 0.25 inches

Remove tripping hazards \$198

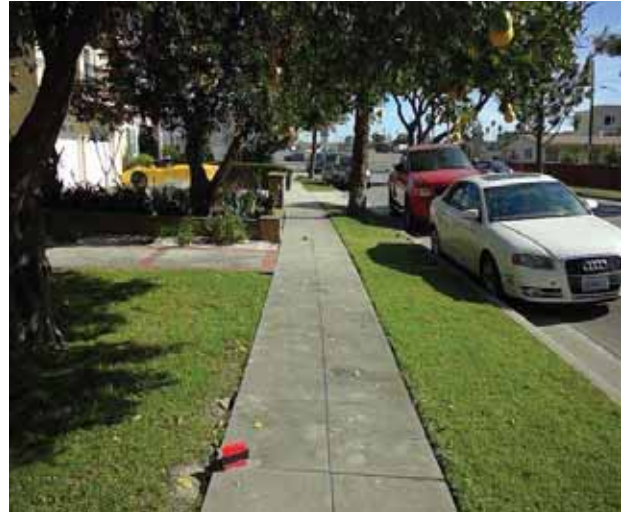
There is a change in elevation greater than recommended value.

Ensure that the change in elevation is within the recommended value.

Recommendation Up to 0.25 inches

Remove tripping hazards \$198

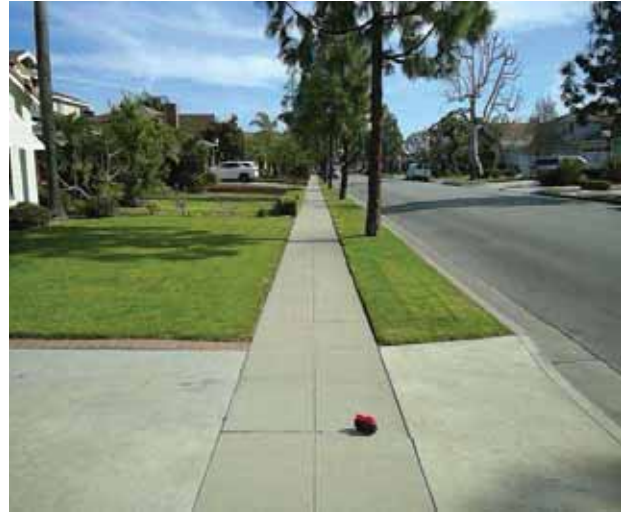
There is a change in elevation greater than recommended value.

Ensure that the change in elevation is within the recommended value.

Recommendation Up to 0.25 inches

Remove tripping hazards \$198

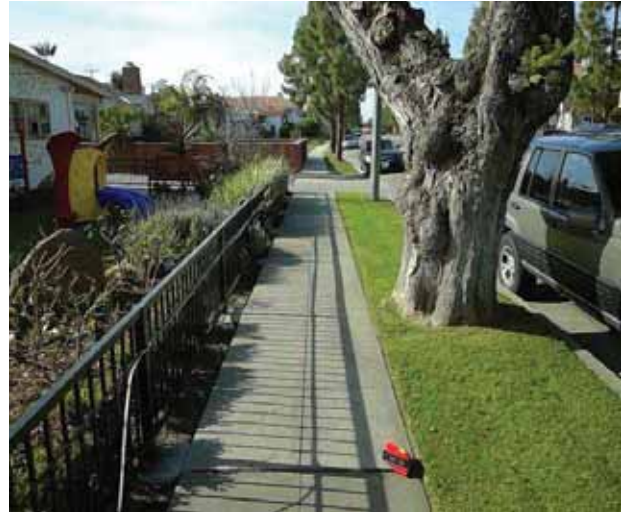
There is a change in elevation greater than recommended value.

Ensure that the change in elevation is within the recommended value.

Recommendation Up to 0.25 inches

Remove tripping hazards \$198

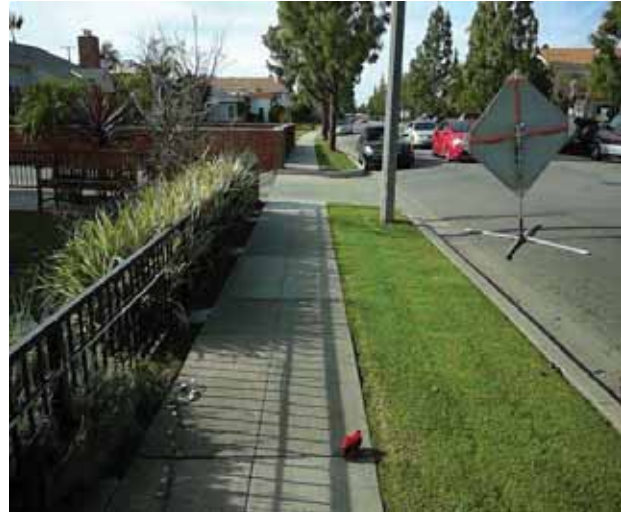
There is a change in elevation greater than recommended value.

Ensure that the change in elevation is within the recommended value.

Recommendation Up to 0.25 inches

Remove tripping hazards \$198

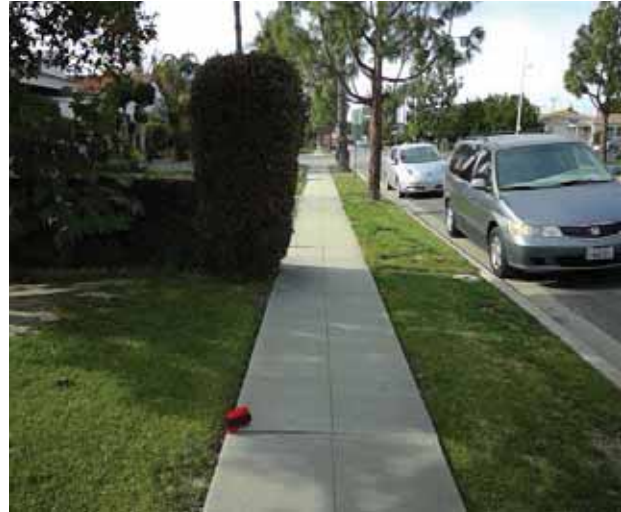
There is a change in elevation greater than recommended value.

Ensure that the change in elevation is within the recommended value.

Recommendation Up to 0.25 inches

Remove tripping hazards \$198

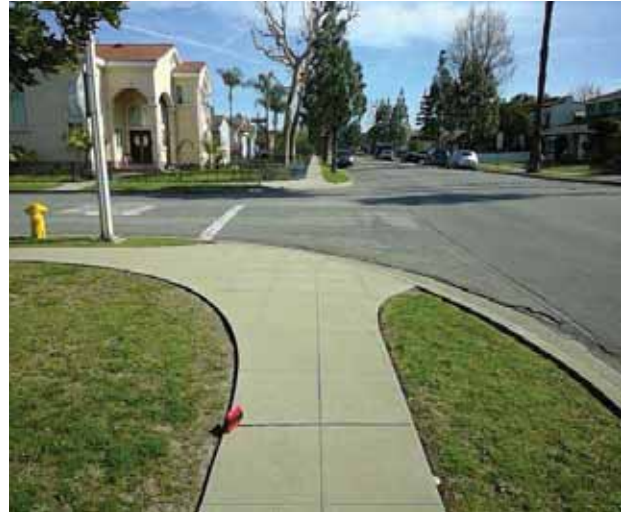
There is a change in elevation greater than recommended value.

Ensure that the change in elevation is within the recommended value.

Recommendation Up to 0.25 inches

Remove tripping hazards \$198

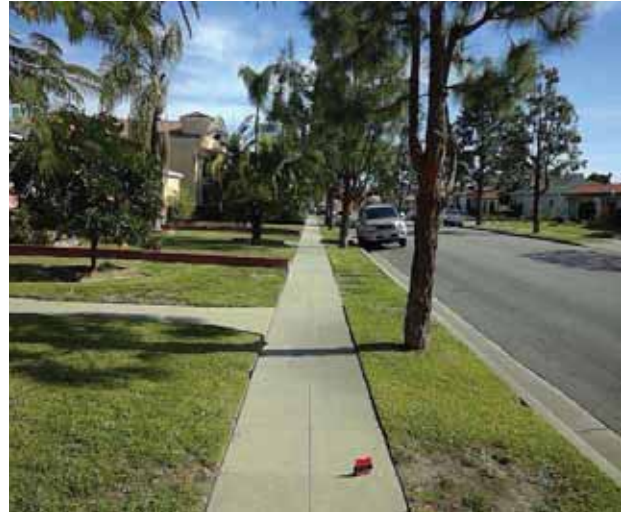
There is a change in elevation greater than recommended value.

Ensure that the change in elevation is within the recommended value.

Recommendation Up to 0.25 inches

Remove tripping hazards \$198

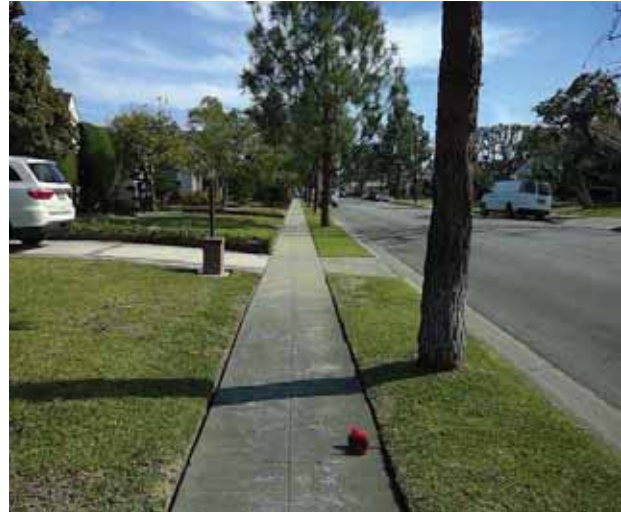
There is a change in elevation greater than recommended value.

Ensure that the change in elevation is within the recommended value.

Recommendation Up to 0.25 inches

Remove tripping hazards \$198

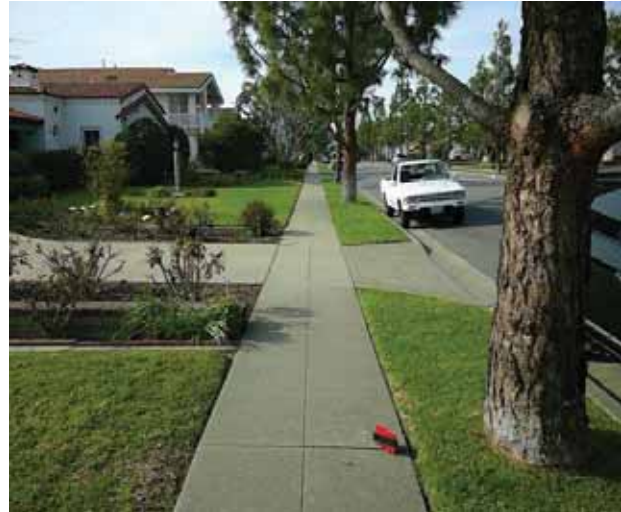
There is a change in elevation greater than recommended value.

Ensure that the change in elevation is within the recommended value.

Remove tripping hazards \$198

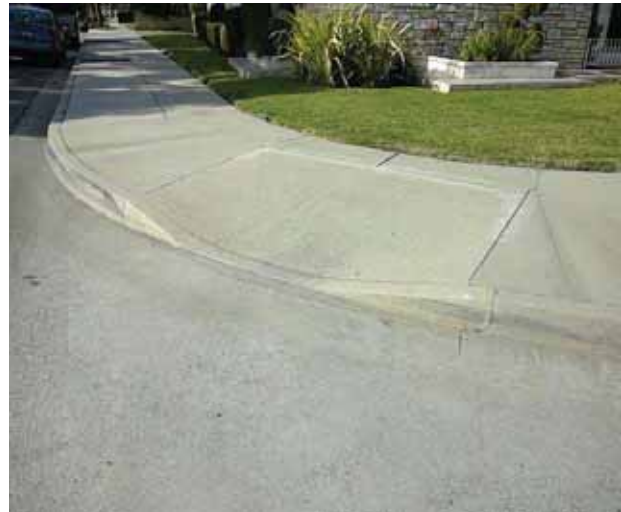
Code Reference CA 11B-406.5.12

Provide detectable warning to surface \$248

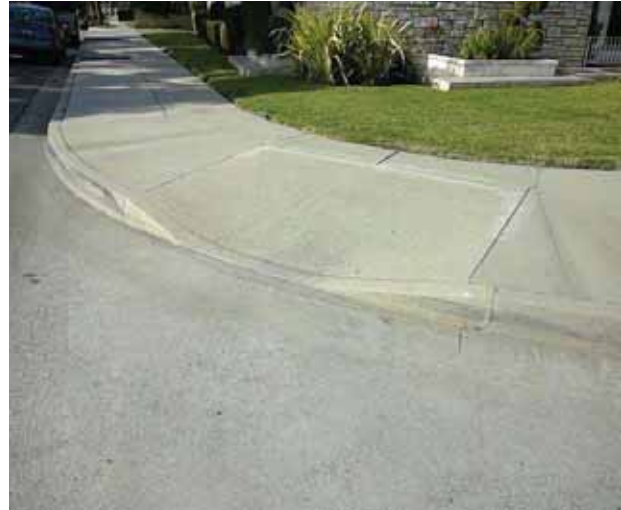
Code Reference ADA 406, 406.1, 405.2, CA 11B-406

Install curb ramp \$1,300

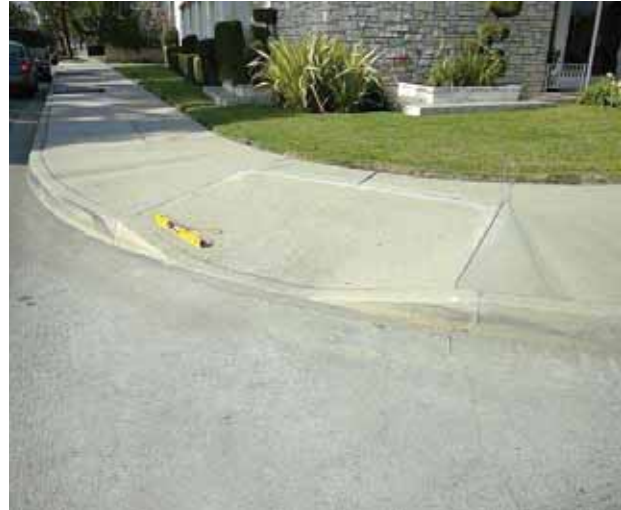
Code Reference ADA 302, 406.2

Patch lip at curb ramp \$255

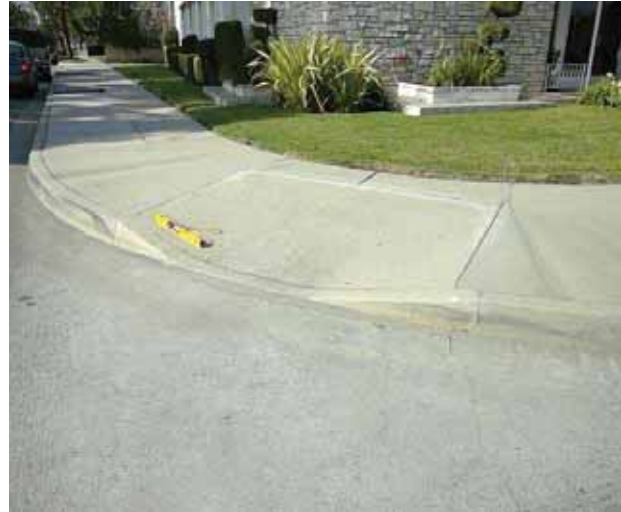
Recommendation At least 48.00 inches

Code Reference ADA 406, 406.4, CA 11B-406.5.3

Provide compliant landing \$240

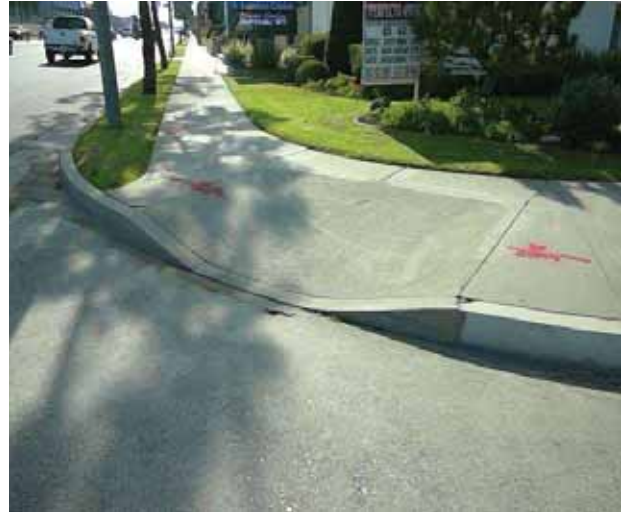
On-Site Finding Not Found

Code Reference CA 11B-406.5.12

Provide detectable warning to surface \$248

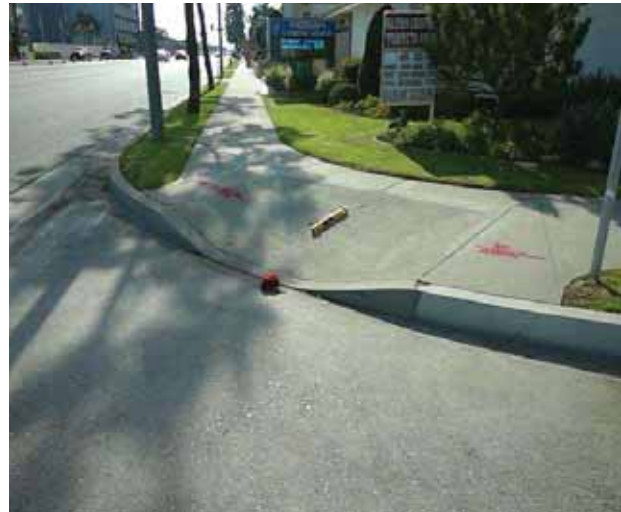
Recommendation Up to 5.00 percent

Code Reference ADA 406, 406.2, CA 11B-406.5.8

Repave landing \$1,260

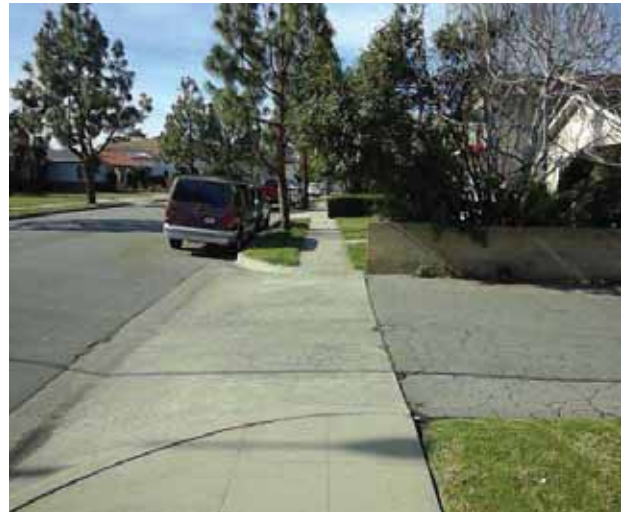
Recommendation Up to 2.08 percent

Code Reference ADA 206, 302, CA 11B-403.3

Repave surface \$1,092

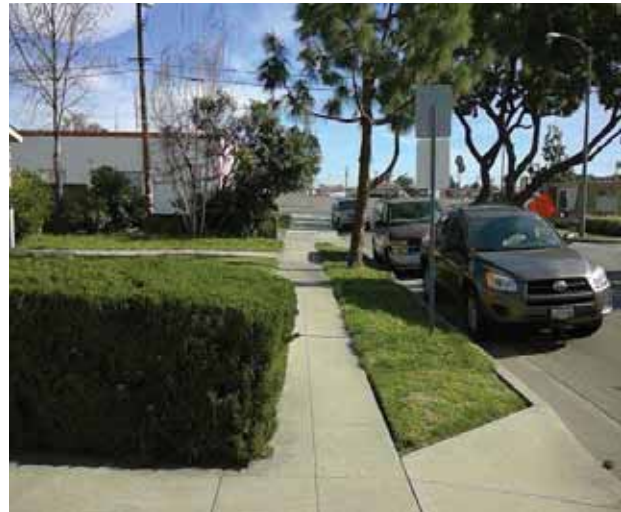
Sidewalks , Hazards & Gratings : Sidewalk Width at Obstruction

Recommendation At least 48.00 inches

Sidewalk width at the obstruction shall have the recommended value.

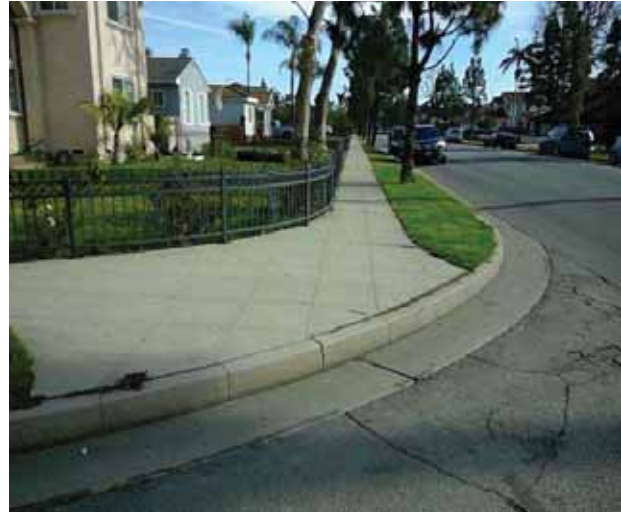
Sidewalks , Hazards & Gratings : Curb is on Path of Travel

Code Reference ADA 402, 303, 406, 403.4, 303.4

Install curb ramp \$2,500

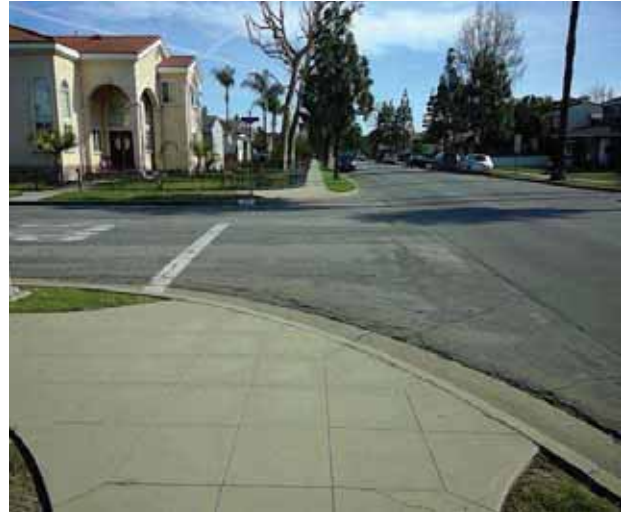
Sidewalks , Hazards & Gratings : Curb is on Path of Travel

Code Reference ADA 402, 303, 406, 403.4, 303.4

Install curb ramp \$2,500

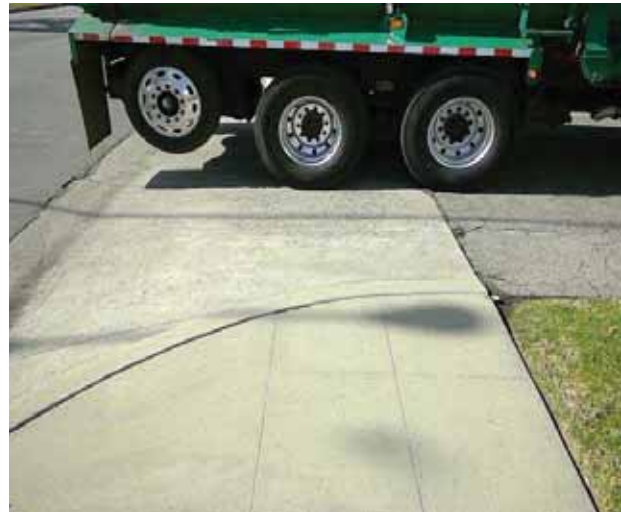
Sidewalks , Hazards & Gratings : Curb is on Path of Travel

Code Reference ADA 402, 303, 406, 403.4, 303.4

Install curb ramp \$2,500

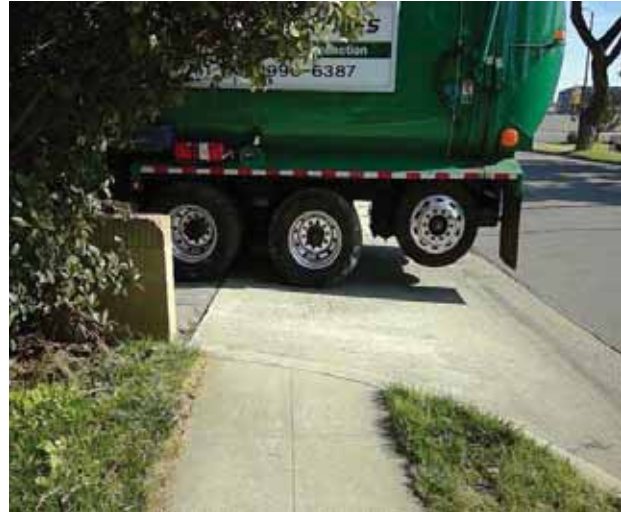
Sidewalks , Hazards & Gratings : Curb is on Path of Travel

Code Reference ADA 402, 303, 406, 403.4, 303.4

Install curb ramp \$2,500

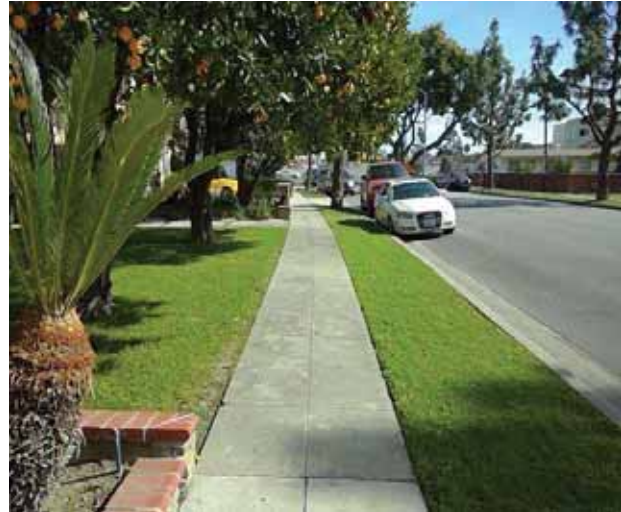
Recommendation Up to 2.08 percent

Code Reference ADA 206, 302, CA 11B-403.3

Repave the sidewalk surface with the recommended cross slope.

Repave surface \$1,092

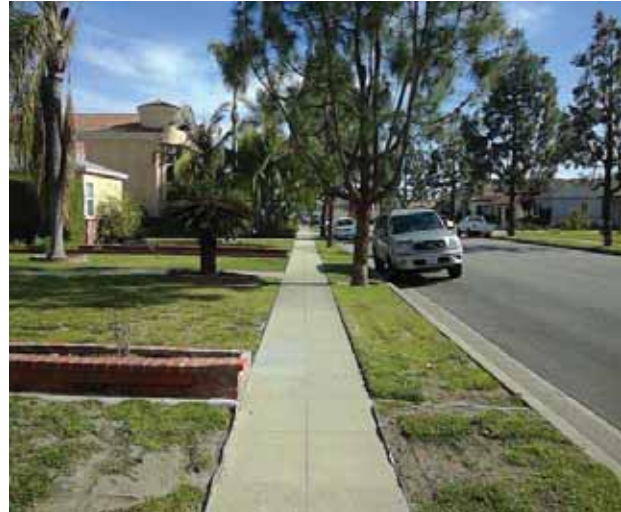
Recommendation Up to 2.08 percent

Code Reference ADA 206, 302,CA 11B-403.3

Repave the sidewalk surface with the recommended cross slope.

Repave surface \$1,092
