Accessibility Survey

6th Street - Brookshire Avenue to Downey Avenue

Date of Inspection
7/18/2017

Disability Access Consultants

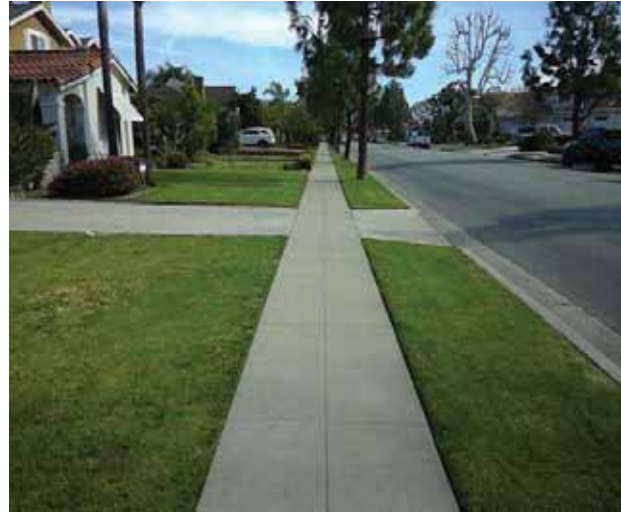
Recommendation Up to 2.08 percent

Code Reference ADA 206, 302, CA 11B-403.3

Repave the sidewalk surface with the recommended cross slope.

Repave surface \$1,092

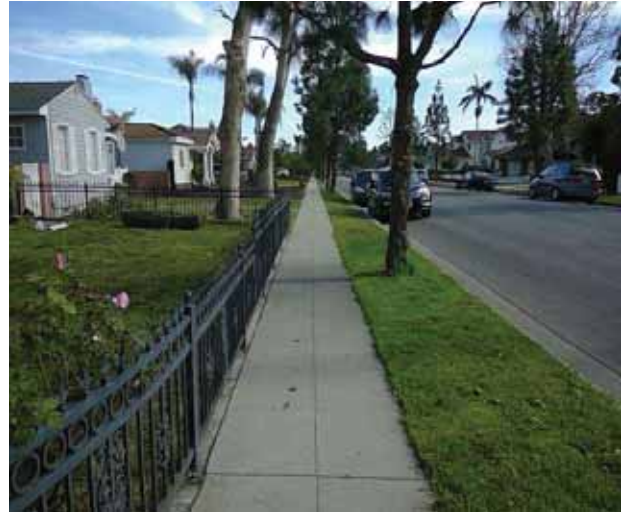
Recommendation Up to 2.08 percent

Code Reference ADA 206, 302, CA 11B-403.3

Repave the sidewalk surface with the recommended cross slope.

Repave surface \$1,092

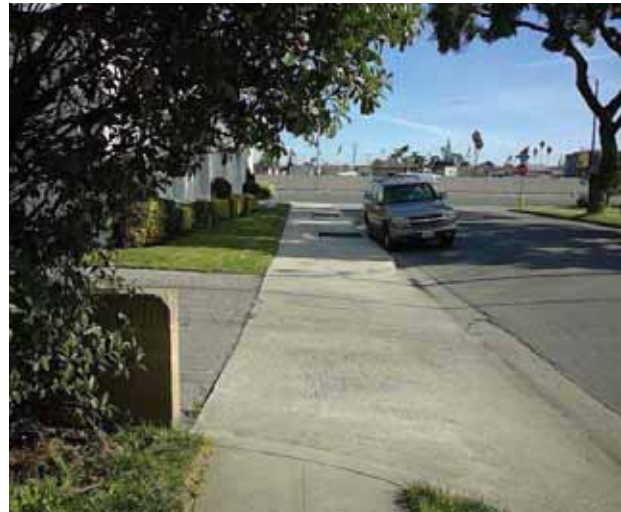
Sidewalks , Hazards & Gratings : Overhead Obstruction Height

Recommendation At least 80.00 inches

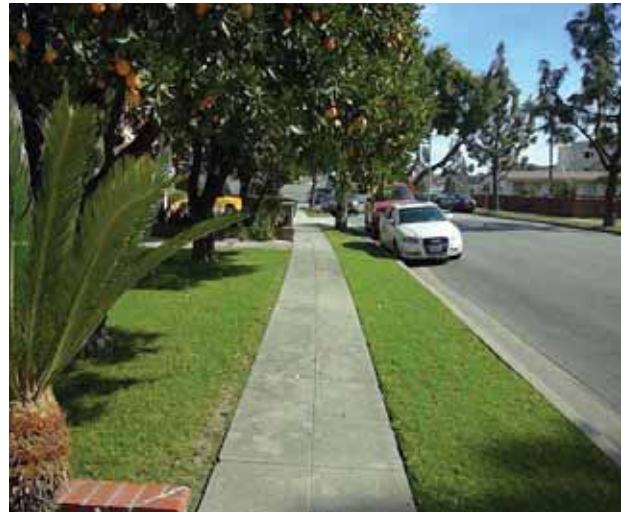
Sidewalks , Hazards & Gratings : Overhead Obstruction Height

Recommendation At least 80.00 inches

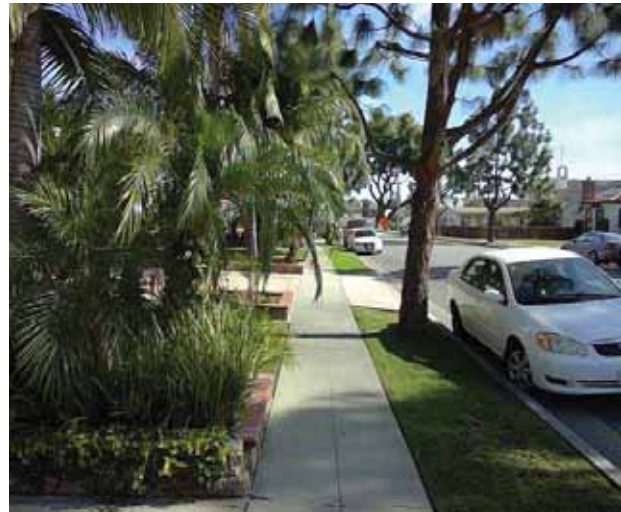
Sidewalks , Hazards & Gratings : Overhead Obstruction Height

Recommendation At least 80.00 inches

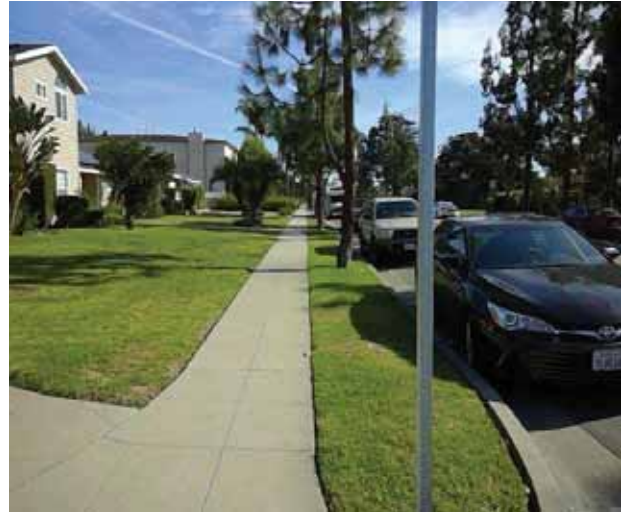
On-Site Finding Not Found

Code Reference ADA 206, 302

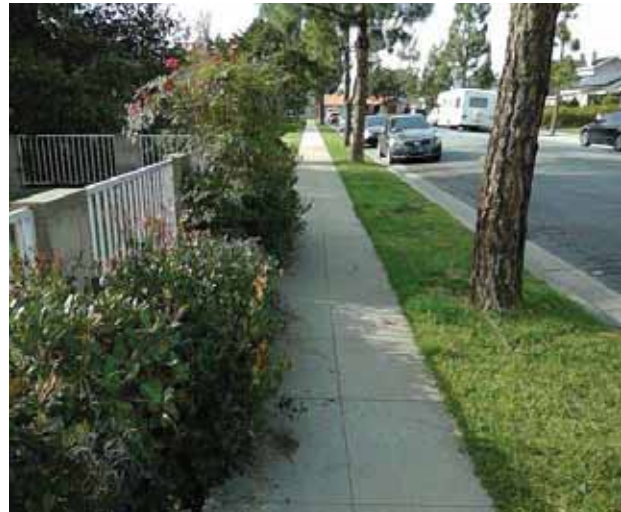
Sidewalks , Hazards & Gratings : Sidewalk Width at Obstruction

Recommendation At least 48.00 inches

Sidewalk width at the obstruction shall have the recommended value.

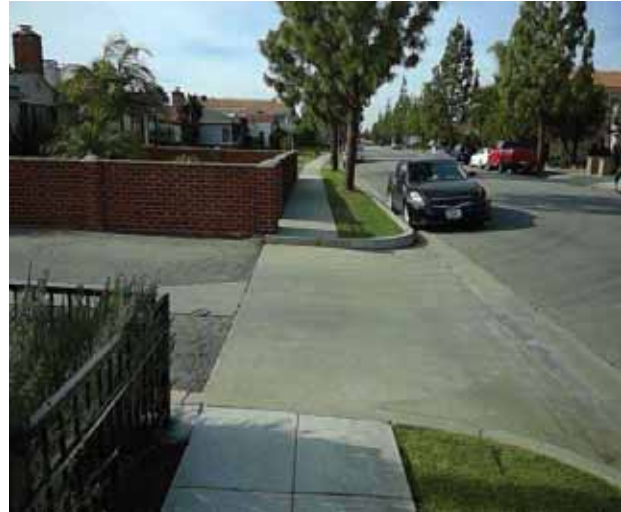
Sidewalks , Hazards & Gratings : Curb is on Path of Travel

Code Reference ADA 402, 303, 406, 403.4, 303.4

Install curb ramp \$2,500

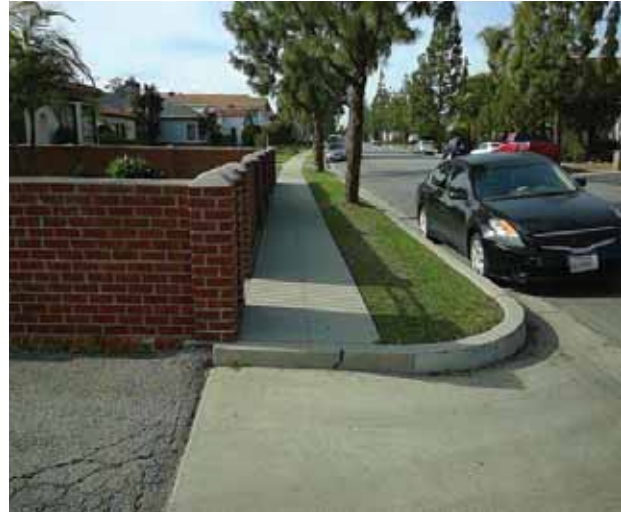
Sidewalks , Hazards & Gratings : Curb is on Path of Travel

Code Reference ADA 402, 303, 406, 403.4, 303.4

Install curb ramp \$2,500

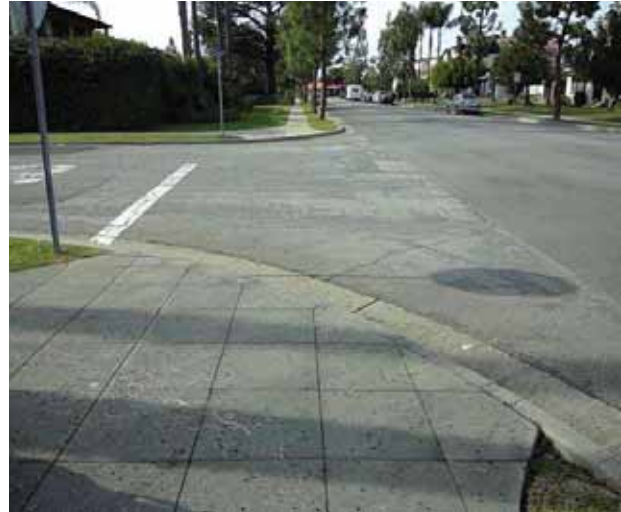
Sidewalks , Hazards & Gratings : Curb is on Path of Travel

Code Reference ADA 402, 303, 406, 403.4, 303.4

Install curb ramp \$2,500

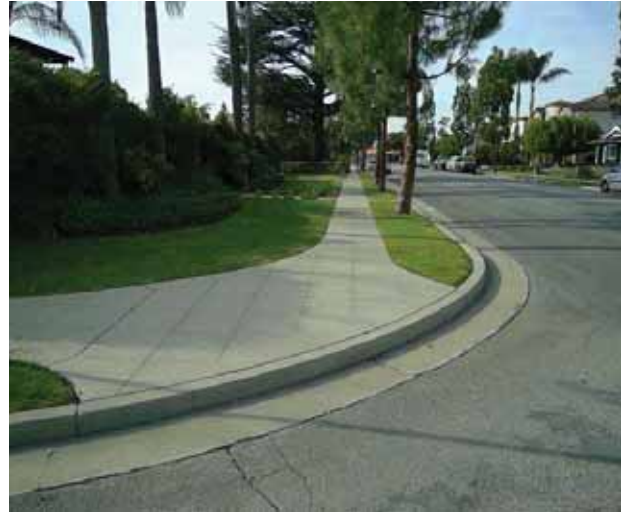
Sidewalks , Hazards & Gratings : Curb is on Path of Travel

Code Reference ADA 402, 303, 406, 403.4, 303.4

Install curb ramp \$2,500

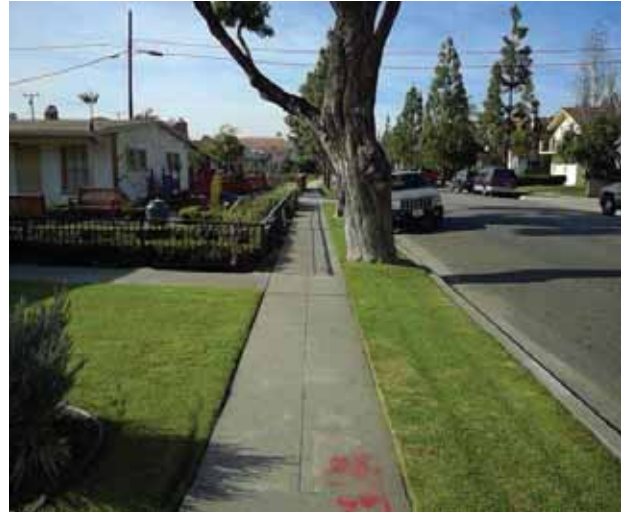
Recommendation Up to 2.08 percent

Code Reference ADA 206, 302, CA 11B-403.3

Repave the sidewalk surface with the recommended cross slope.

Repave surface \$1,092

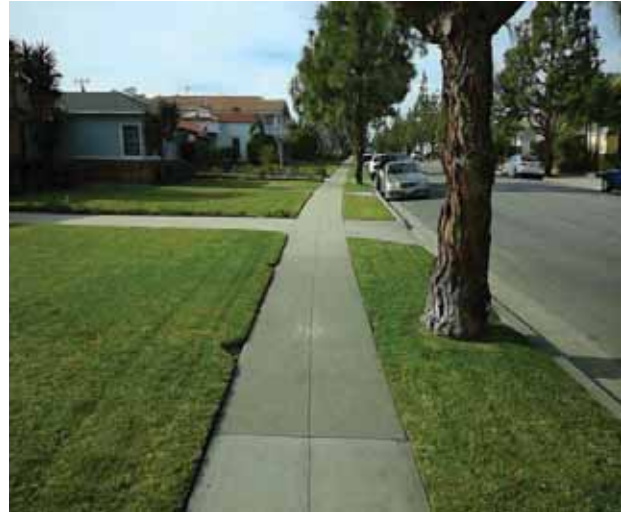
Recommendation Up to 2.08 percent

Code Reference ADA 206, 302,CA 11B-403.3

Repave the sidewalk surface with the recommended cross slope.

Repave surface \$1,092

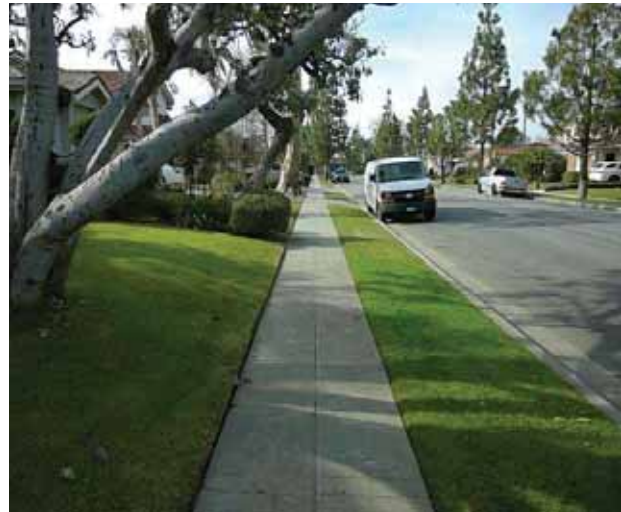
Recommendation Up to 2.08 percent

Code Reference ADA 206, 302,CA 11B-403.3

Repave the sidewalk surface with the recommended cross slope.

Repave surface \$1,092

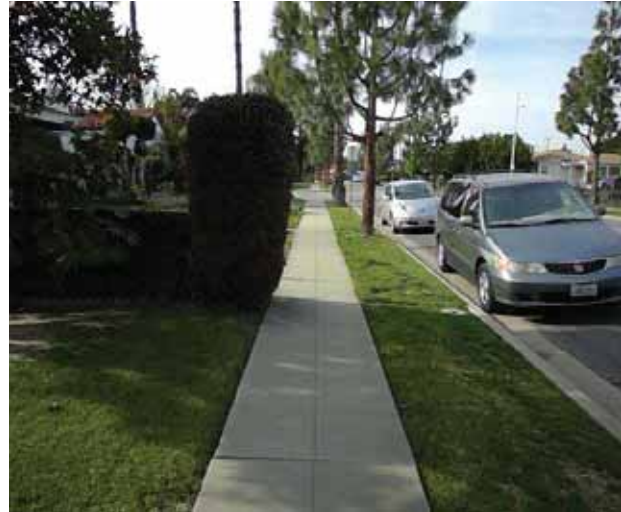
Recommendation Up to 2.08 percent

Code Reference ADA 206, 302, CA 11B-403.3

Repave the sidewalk surface with the recommended cross slope.

Repave surface \$1,092

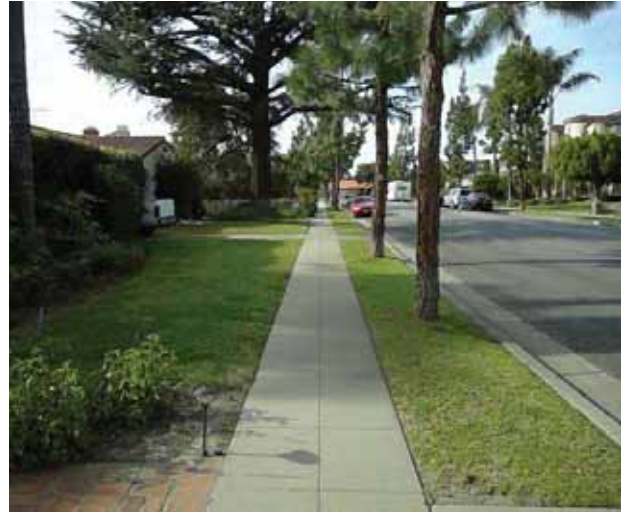
Recommendation Up to 2.08 percent

Code Reference ADA 206, 302, CA 11B-403.3

Repave the sidewalk surface with the recommended cross slope.

Repave surface \$1,092

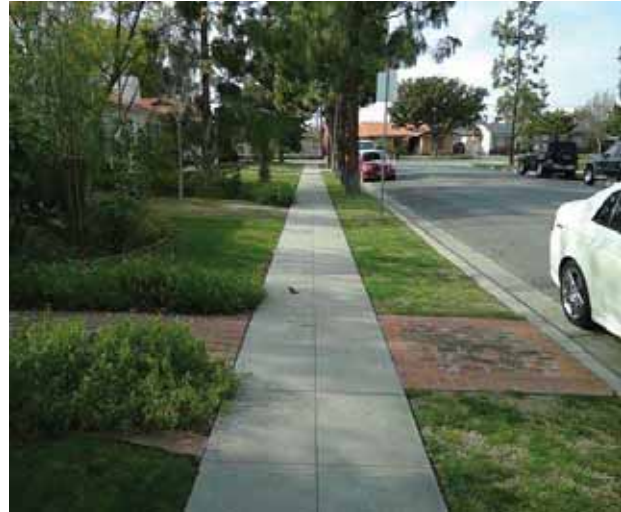
Recommendation Up to 2.08 percent

Code Reference ADA 206, 302, CA 11B-403.3

Repave the sidewalk surface with the recommended cross slope.

Repave surface \$1,092

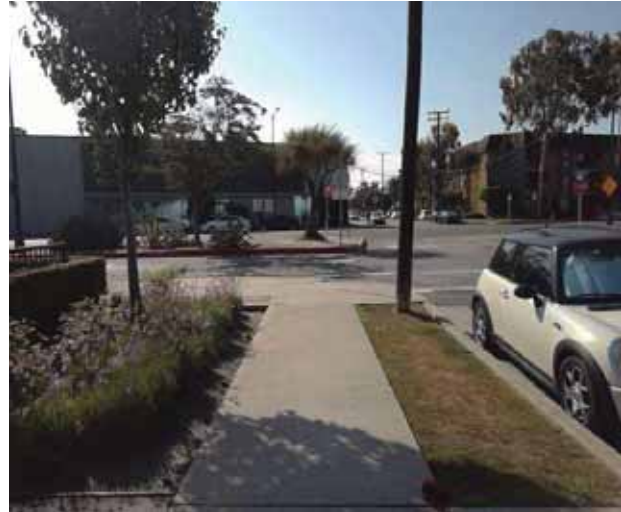
There is a change in elevation greater than recommended value.

Ensure that the change in elevation is within the recommended value.

Remove tripping hazards \$198

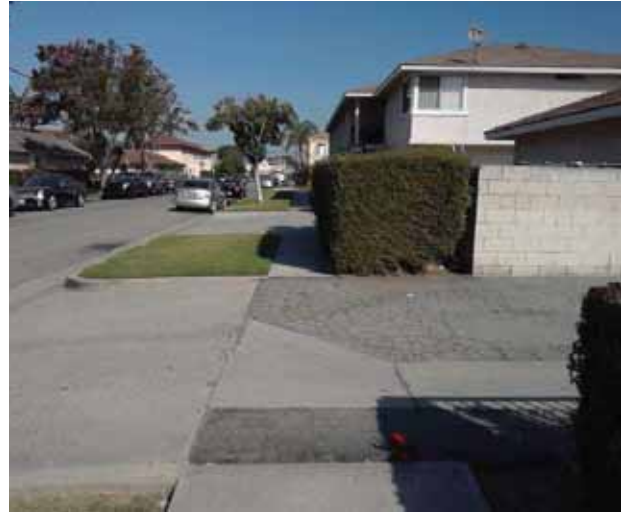
There is a change in elevation greater than recommended value.

Ensure that the change in elevation is within the recommended value.

Remove tripping hazards \$198

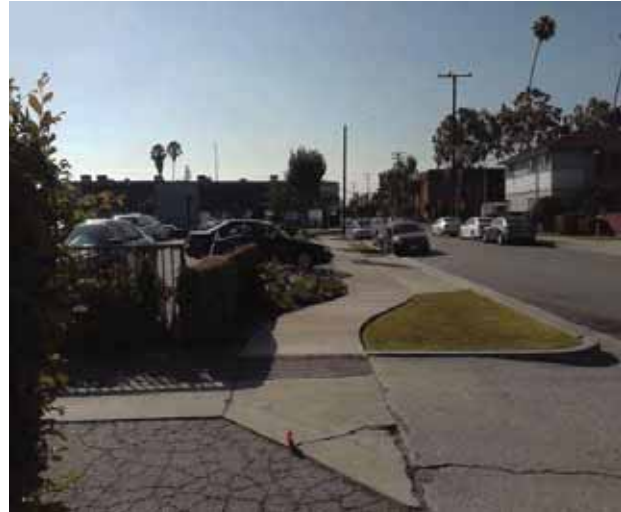
There is a change in elevation greater than recommended value.

Ensure that the change in elevation is within the recommended value.

Remove tripping hazards \$198

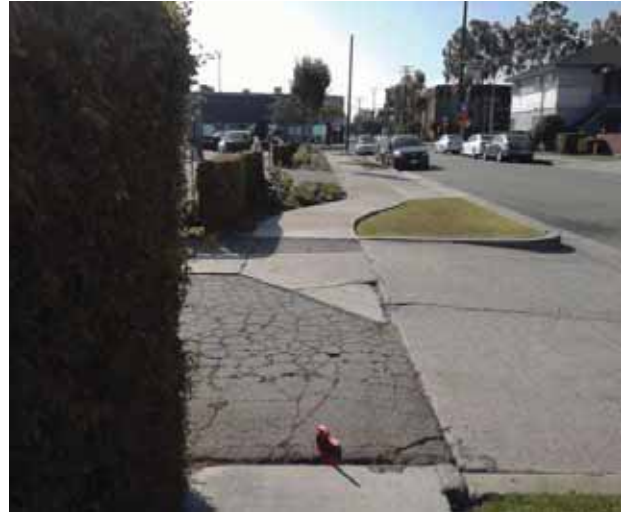
There is a change in elevation greater than recommended value.

Ensure that the change in elevation is within the recommended value.

Remove tripping hazards \$198

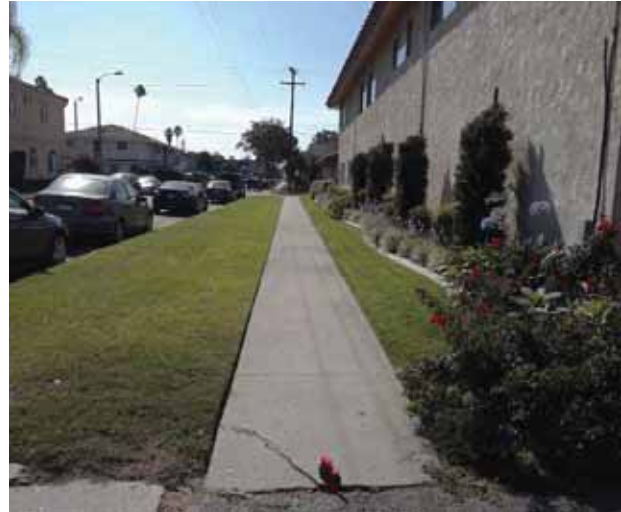
There is a change in elevation greater than recommended value.

Remove tripping hazards \$198

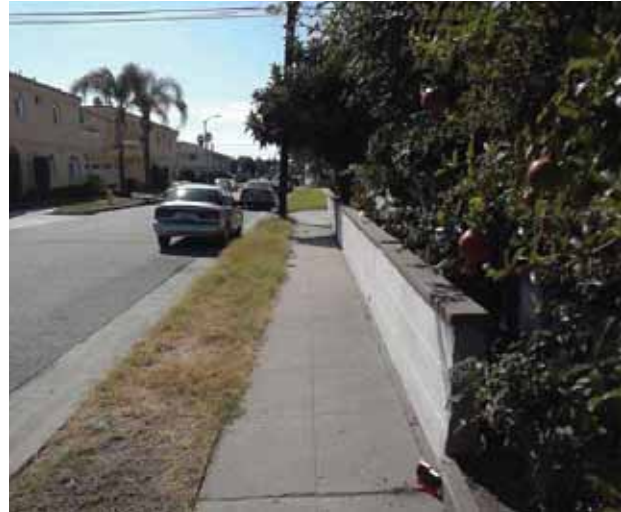
Code Reference ADA 206, 302

Remove tripping hazards \$198

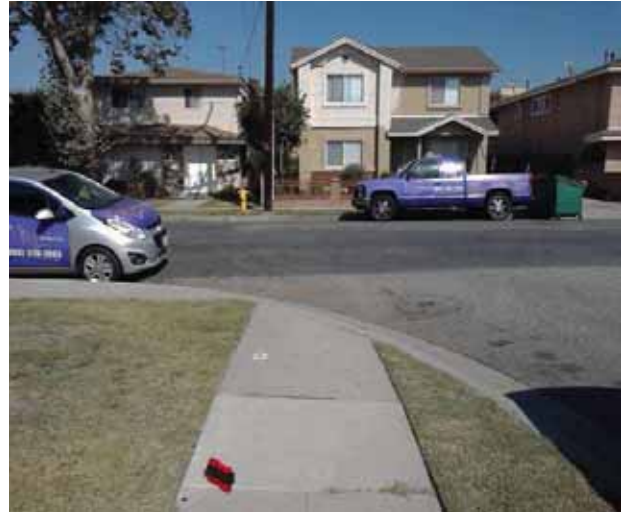
Code Reference ADA 206, 302

Remove tripping hazards \$198

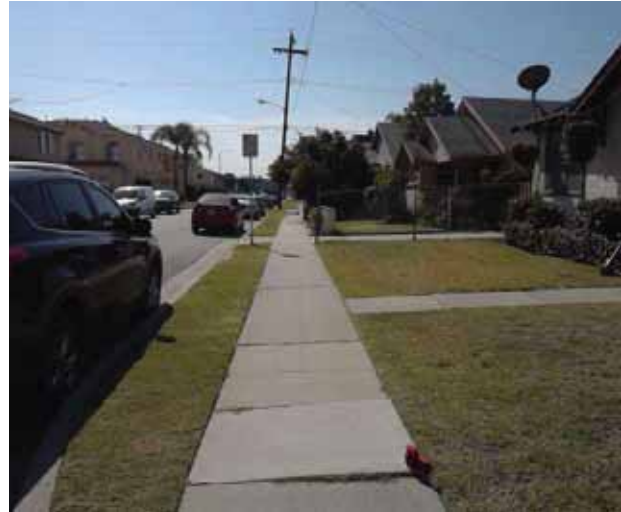
There is a change in elevation greater than recommended value.

Ensure that the change in elevation is within the recommended value.

Recommendation Up to 0.25 inches

Remove tripping hazards \$198

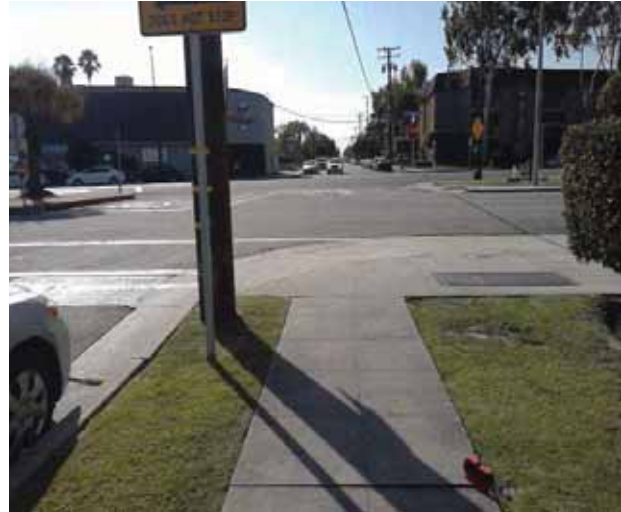
There is a change in elevation greater than recommended value.

Ensure that the change in elevation is within the recommended value.

Recommendation Up to 0.25 inches

Remove tripping hazards \$198

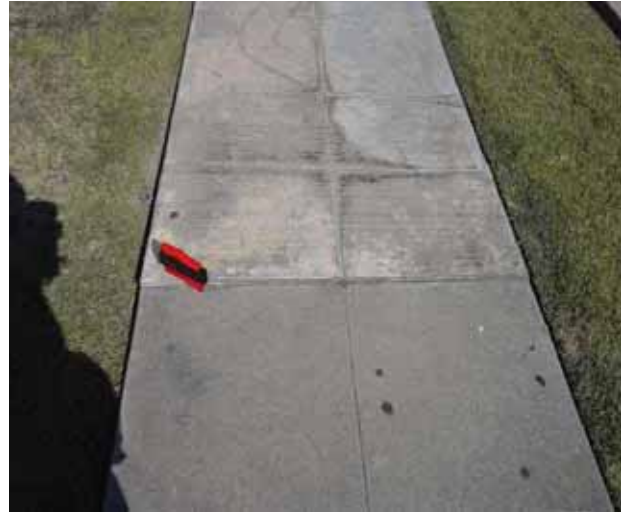
There is a change in elevation greater than recommended value.

Ensure that the change in elevation is within the recommended value.

Recommendation Up to 0.25 inches

Remove tripping hazards \$198

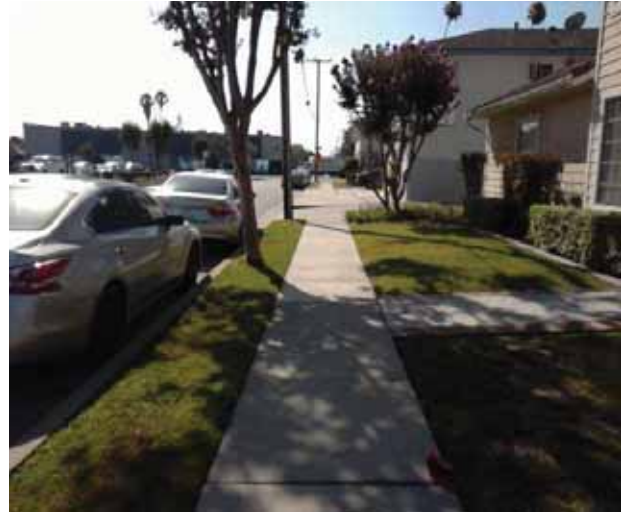
There is a change in elevation greater than recommended value.

Ensure that the change in elevation is within the recommended value.

Recommendation Up to 0.25 inches

Remove tripping hazards \$198

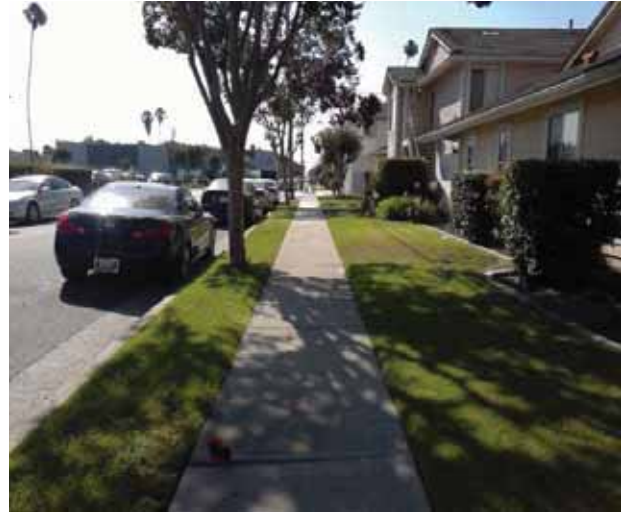
There is a change in elevation greater than recommended value.

Ensure that the change in elevation is within the recommended value.

Recommendation Up to 0.25 inches

Remove tripping hazards \$198

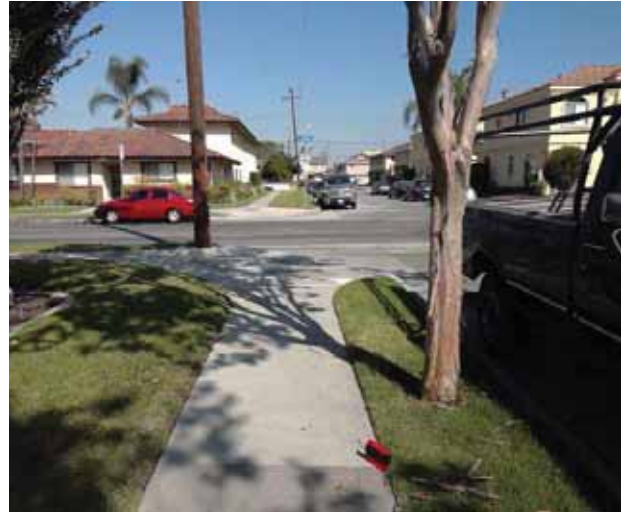
There is a change in elevation greater than recommended value.

Ensure that the change in elevation is within the recommended value.

Recommendation Up to 0.25 inches

Remove tripping hazards \$198

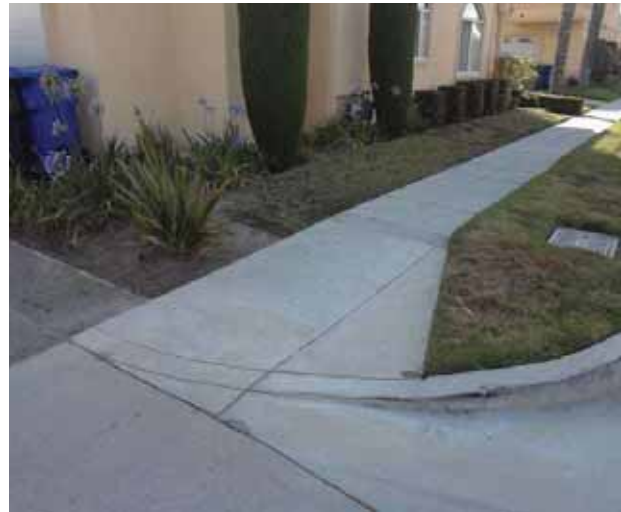
On-Site Finding Not Found

Provide detectable warning to surface \$248

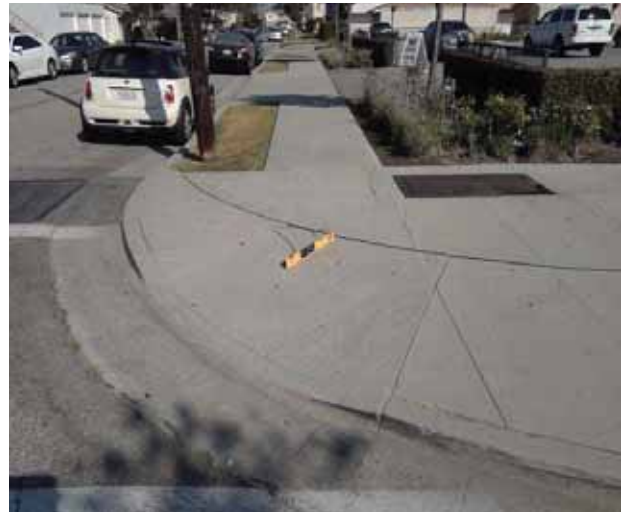
On-Site Finding Not Found

Provide detectable warning to surface \$248

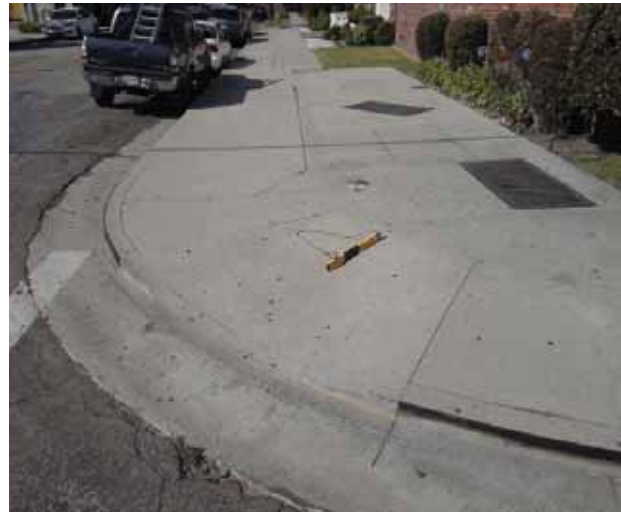
On-Site Finding Not Found

Provide detectable warning to surface \$248

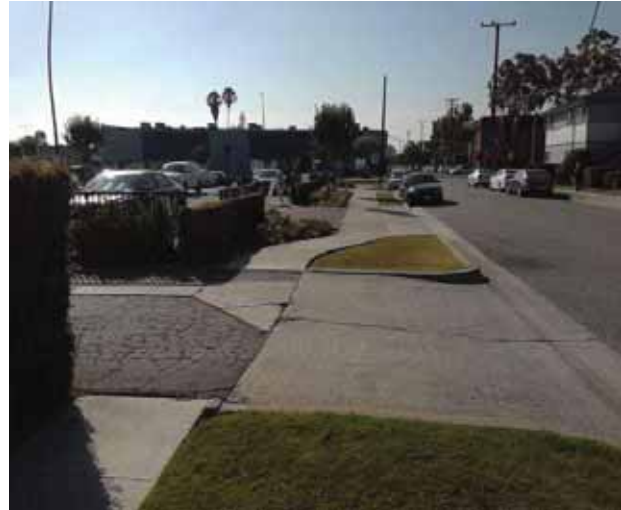
On-Site Finding Not Found

Install compliant detectable warnings \$190

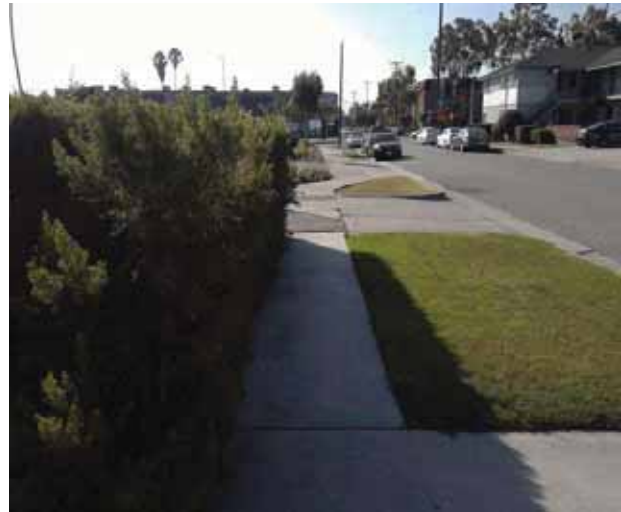
Sidewalks , Hazards & Gratings : Sidewalk Width at Obstruction

Sidewalk width at the obstruction shall have the recommended value.

Recommendation At least 48.00 inches

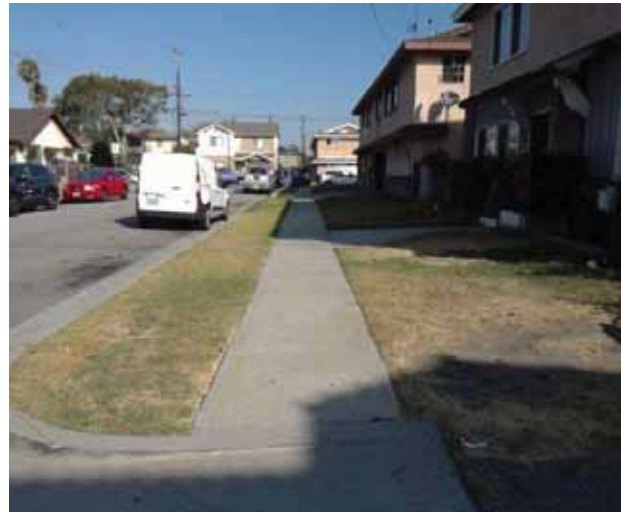
Sidewalks , Hazards & Gratings : Curb is on Path of Travel

Install curb ramp \$2,500

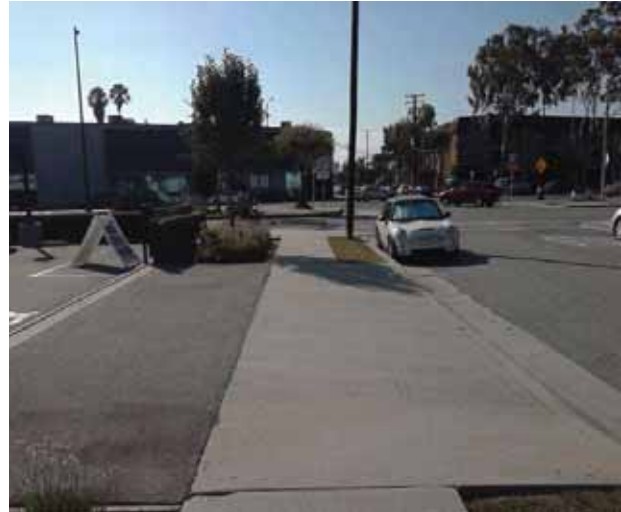
On-Site Finding Not Found

Install compliant detectable warnings \$190

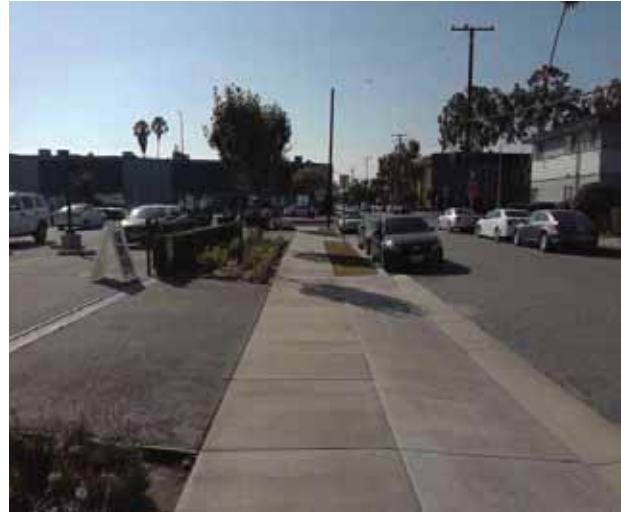
On-Site Finding Not Found

Install compliant detectable warnings \$190

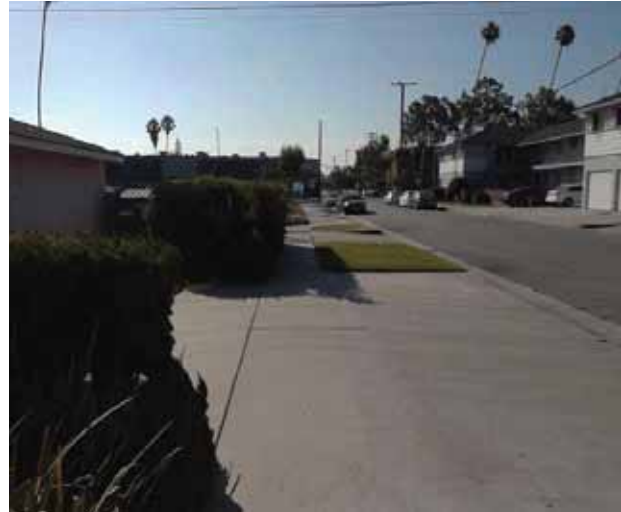
On-Site Finding Not Found

Install compliant detectable warnings \$190

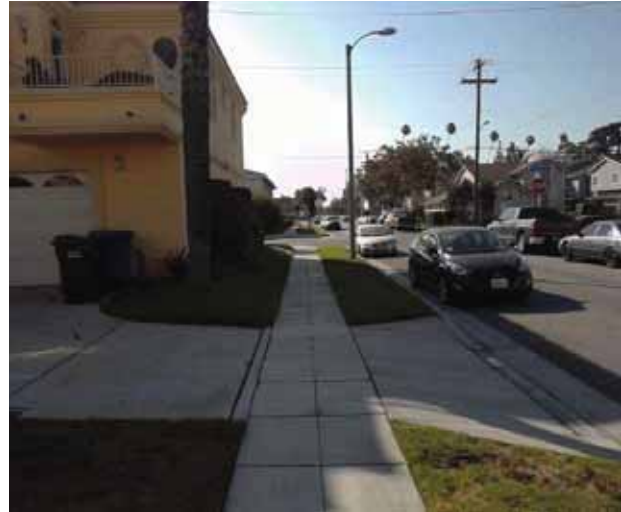
On-Site Finding Not Found

Install compliant detectable warnings \$190

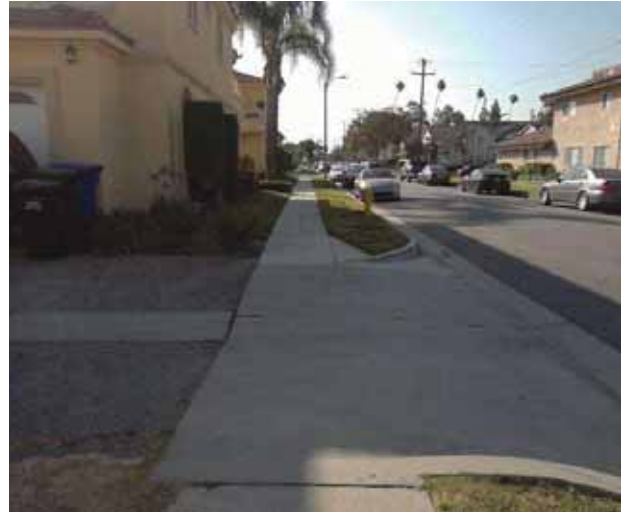
On-Site Finding Not Found

Install compliant detectable warnings \$190

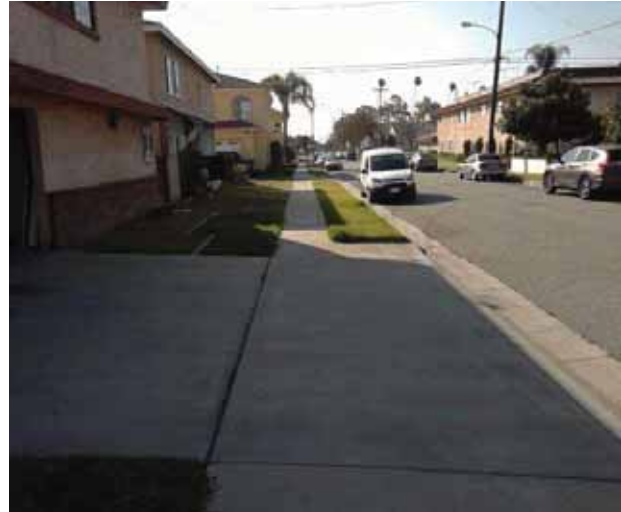
On-Site Finding Not Found

Install compliant detectable warnings \$190

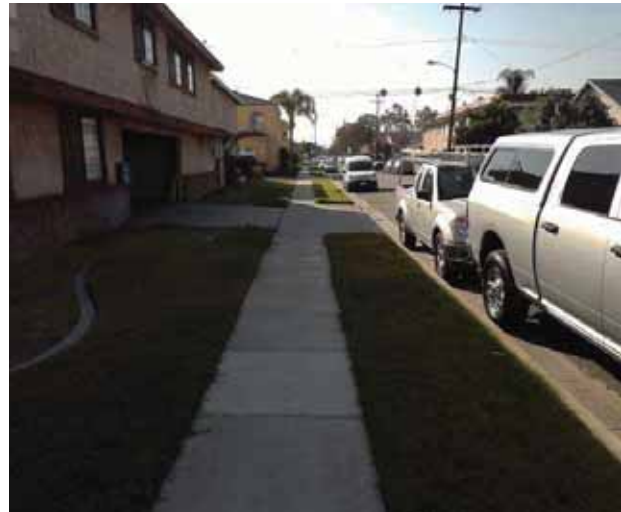
On-Site Finding Not Found

\$2,400

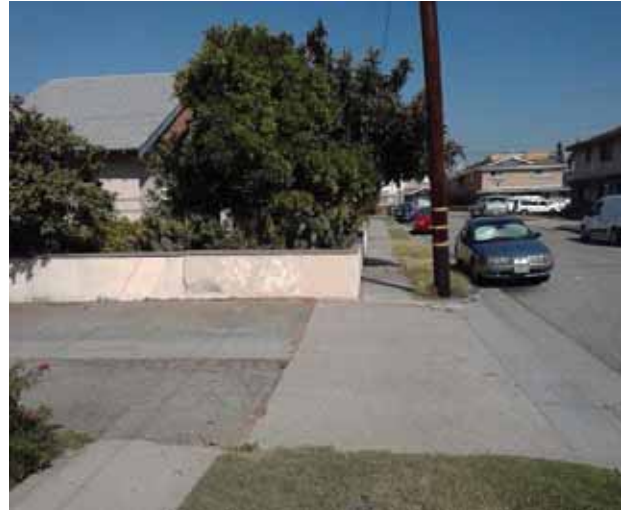
On-Site Finding Not Found

Install compliant detectable warnings \$190

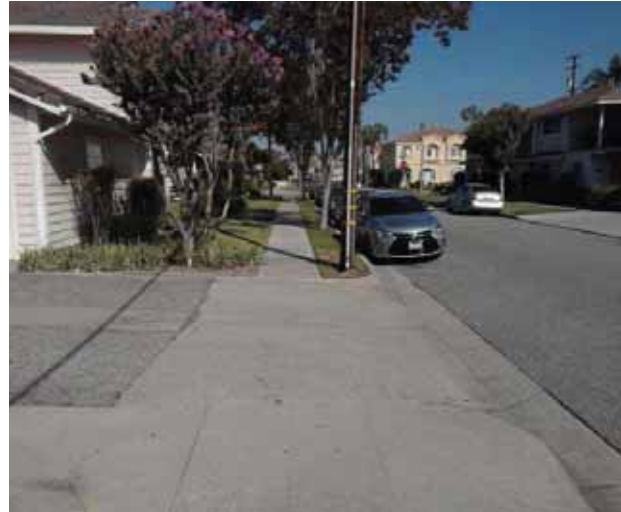
On-Site Finding Not Found

Install compliant detectable warnings \$190

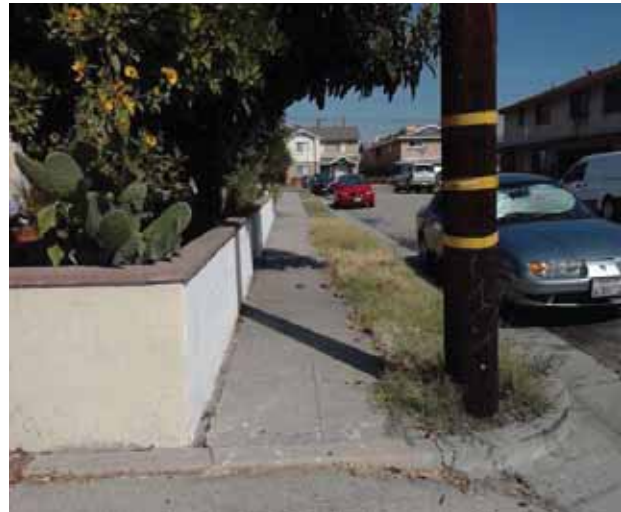
Sidewalks , Hazards & Gratings : Curb is on Path of Travel

Install curb ramp \$2,500

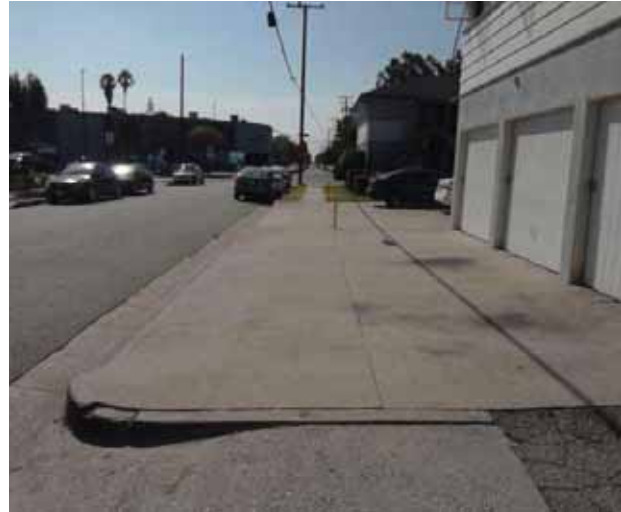
Sidewalks , Hazards & Gratings : Curb is on Path of Travel

Install curb ramp \$2,500

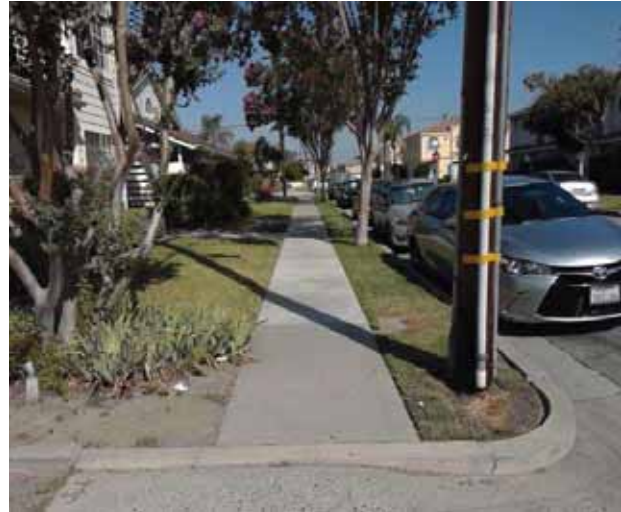
Sidewalks , Hazards & Gratings : Curb is on Path of Travel

Install curb ramp \$2,500

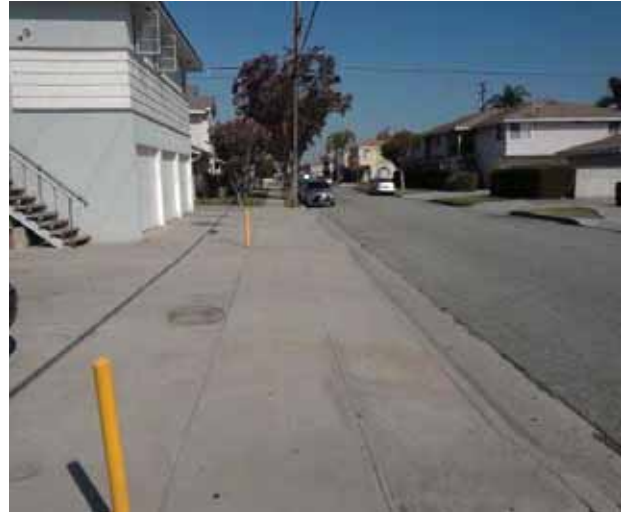
On-Site Finding Not Found

Install compliant detectable warnings \$190

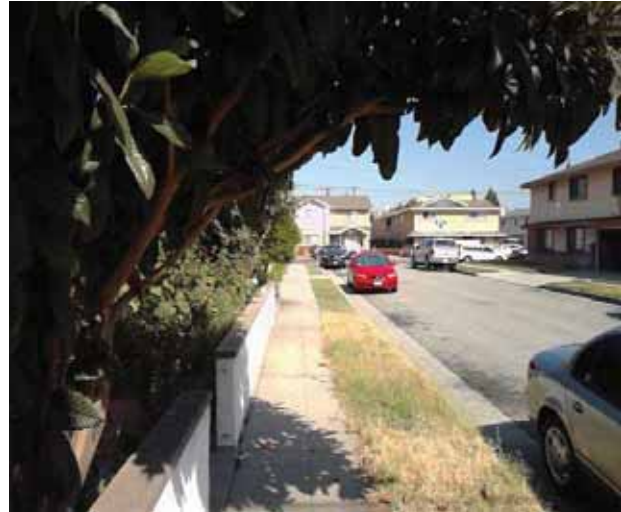
Sidewalks , Hazards & Gratings : Overhead Obstruction Height

Recommendation At least 80.00 inches

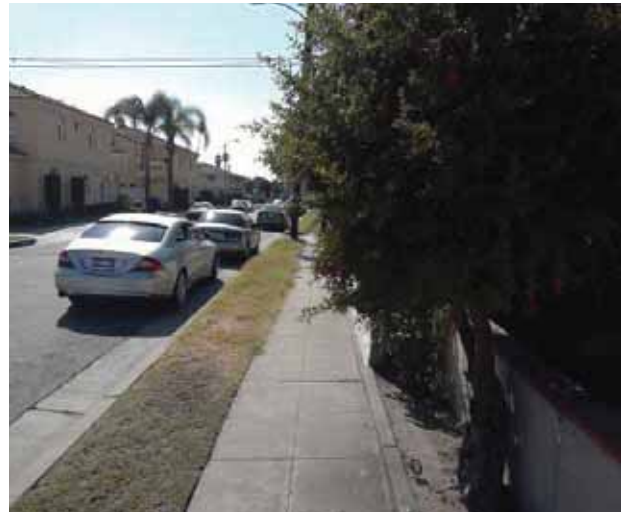
Sidewalks , Hazards & Gratings : Overhead Obstruction Height

Recommendation At least 80.00 inches

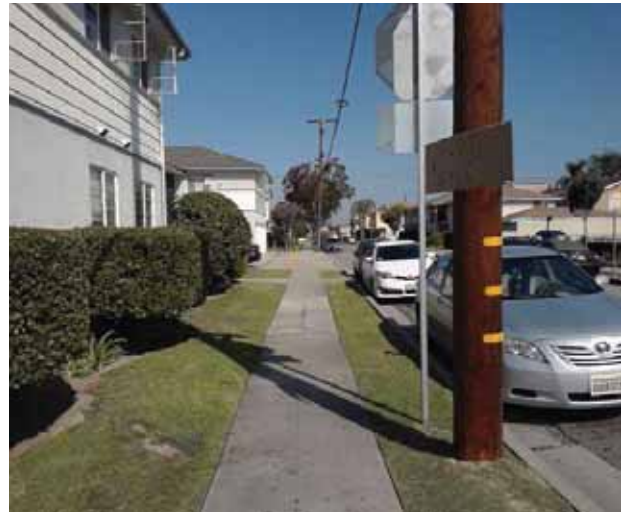
On-Site Finding Not Found

Recommendation See Recommendation
